Special Purpose Building Report

10 Smith Street, Smithtown, NSW

BUILDING REPORT

*2 Smith Street,
Smithtown, NSW*

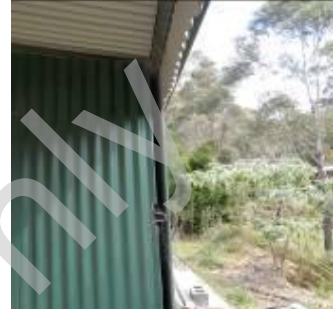
Missing Cladding

Defect Type - F

Repair Priority - Medium

Relevant Specialist - Licensed Builder/Qualified Carpenter

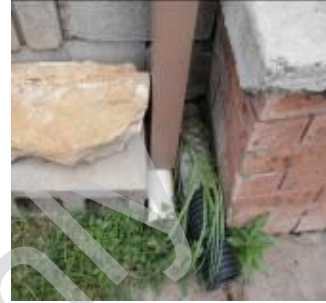
Downpipe

Defect Type - F

Repair Priority - Medium

Relevant Specialist - Licensed Plumber

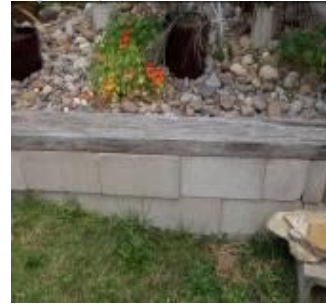
Retaining Wall

Defect Type - A

Repair Priority - Medium,

Relevant Specialist - Licensed Builder

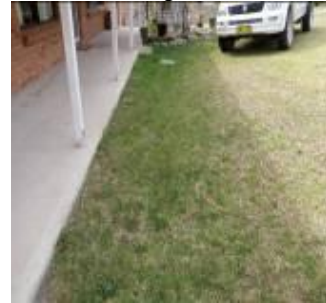
Area of Drainage

Defect Type - C

Repair Priority - High

Relevant Specialist - Licensed Builder/Licensed Plumber

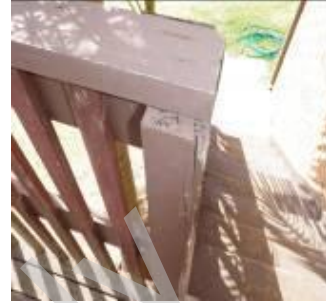
Woodrot to Upright

Defect Type - D

Repair Priority - Medium

Relevant Specialist - Qualified Glazier/Handyman

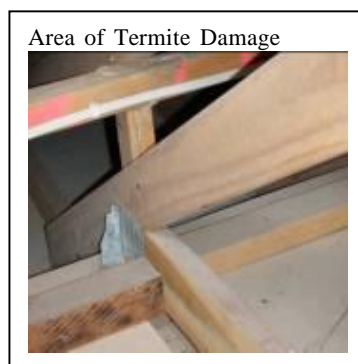
Location - E, C

Relevant Specialist - Licensed Pest Controller/Licensed Builder
Qualified Carpenter
