Property Evaluation Reports

10 Smith Street
Smithtown ACT

BUILDING REPORT

Date: *1st January 2011*

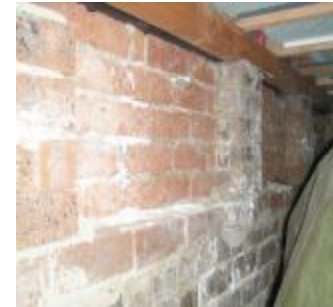
The external ground level is higher than the sub floor floor level in this area and there may be issues with the drainage or waterproofing of this wall. A Licensed Builder should be engaged to further investigate the cause of the moisture and provide advice on the repairs required.

Defect Type - C

Repair Priority - High, FI

Efflorescence to Wall

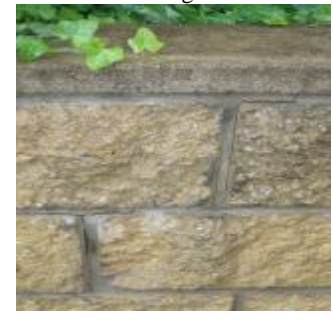
1-3MM CRACKING VISIBLE TO MINOR STRUCTURE

This is only an aesthetic issue and repairs can be carried out at some stage in the future during routine maintenance.

Defect Type - A

Repair Priority - Low

Area of Cracking

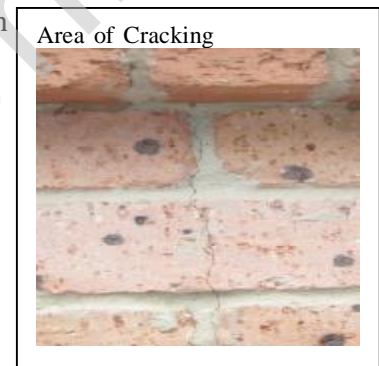
HAIRLINE CRACKING VISIBLE

May or may not pose a structural concern. This inspection has been carried out in accordance with Australian Standard AS4349.1-2007 which states that determining whether cracking is a structural defect does not simply relate to the width of the crack. It is therefore important to have a structural engineer assess the cracking.

Defect Type - A

Repair Priority - Unable to Determine

Location - W

Relevant Specialist - Structural Engineer

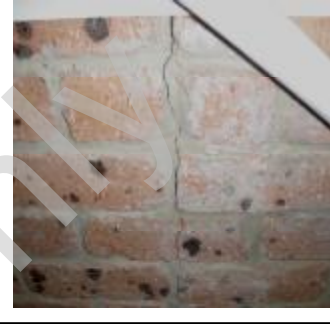
3-5MM CRACKING VISIBLE

May or may not pose a structural concern. This inspection has been carried out in accordance with Australian Standard AS4349.1-2007 which states that determining whether cracking is a structural defect does not simply relate to the width of a crack. It is therefore important to have a structural engineer assess the cracking.

Defect Type - A

Repair Priority - Unable to Determine

Area of Cracking

Relevant Specialist - Structural Engineer

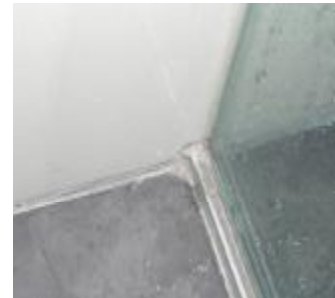
LEAKING SCREEN

Defect Type - C

Repair Priority - Medium

Area of Leak

Relevant Specialist - Qualified Glazier/Handyman
