## Building Condition Report

10 Smith Street, Smith Town

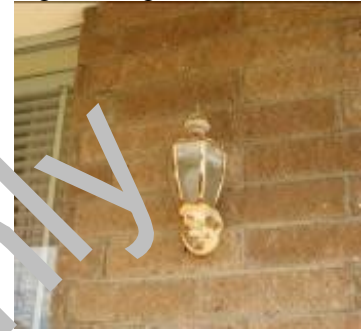
Light Fitting

The light fitting is rusted.

Replace the light fitting.

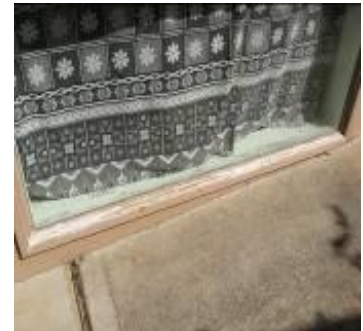
Window Sill

There is woodrot in the timber sill.

Replace woodrot affected timbers.

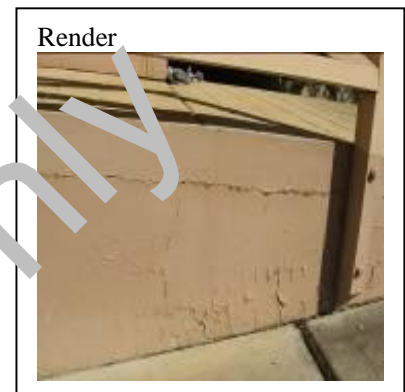
There is settlement cracking in the concrete.

The affected brickwork may require repairs in the future.

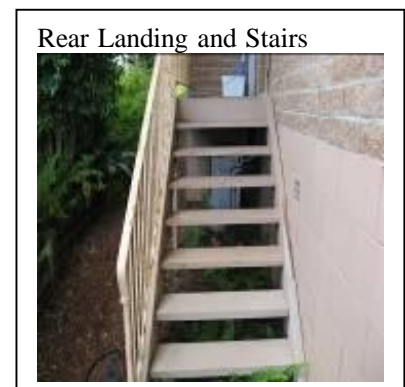
The rear landing, stairs and balustrade were found to be in poor condition and it is recommended this structure be replaced.

The landing, stairs and balustrade are in poor condition.

The entire structure needs to be replaced.

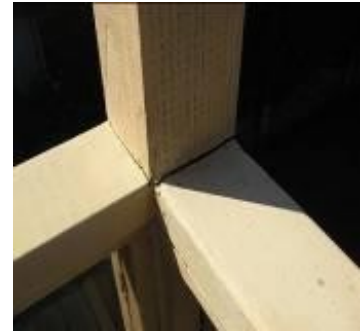
Balustrade Woodrot

There is woodrot in the rails.

The woodrot affected timbers need to be replaced.

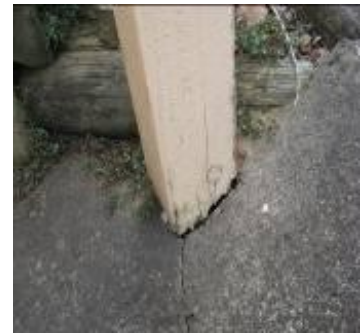
Post

There is woodrot in the base of the post.

The post needs to be replaced.

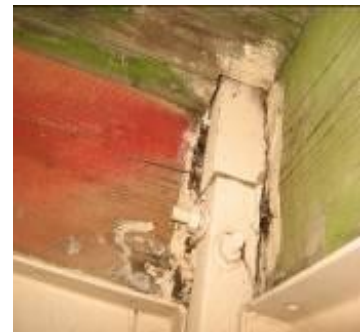
Deck Beams

There is woodrot in the beams.

Repairs or replacement may be required in the future.

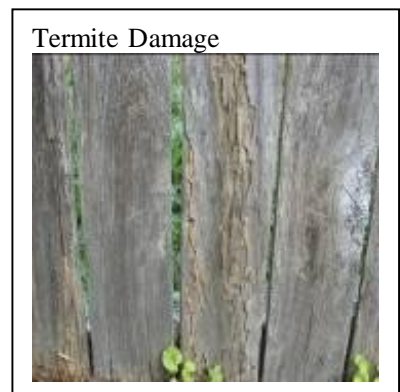
The fence to the south of the property has termite damage and it is recommended the affected timber be replaced using timbers that are treated and provide good resistance to termite attack. Regular pest inspections should be carried out to monitor for signs of further termite attack.

There is termite damage to the fence.

Repair the fence where necessary.

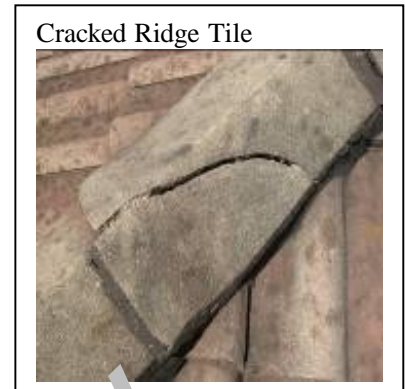
There is a cracked ridge tile to the northwest corner of the roof which should be replaced immediately to prevent further water entering the roof space.

There is a cracked ridge tile which will allow water to enter the roof space. The ridge pointing is cracked.

Replace the ridge tile immediately.

There may be some re-pointing required in the future.
