Owner Builder Warranty Report

10 Smith Street, Smith Town

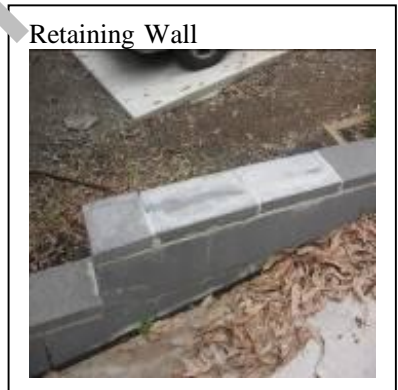
Retaining Walls

There are loose capping bricks.

Overall Condition: Fair

Re-secure the brickwork where necessary.

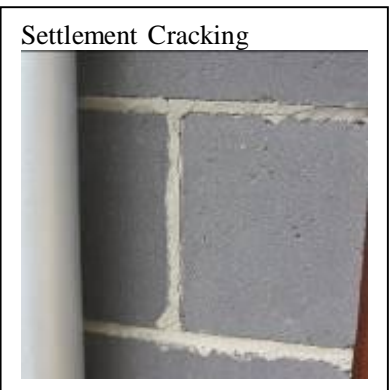
Brickwork

There is some cracking of the mortar.

This cracking is only a minor issue and is quite commonly found.

Overall Condition: Fair

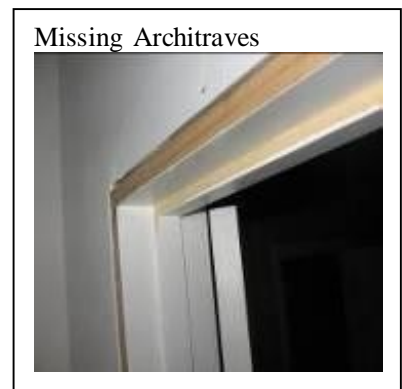
Wardrobe

There are no architraves fitted to the inside of the wardrobe.

Overall Condition: Fair

Fit the architraves where required.
