Premium Building Report

10 Smith Street
Smithtown ACT

BUILDING REPORT

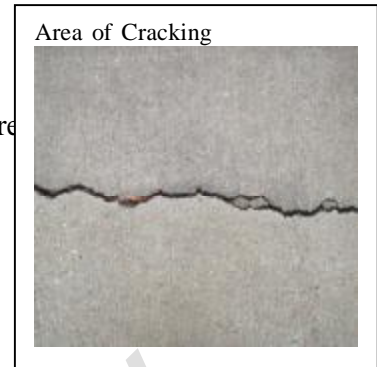
MAJOR CRACKING TO CONCRETE

Repairs are likely to be required at some stage in the near future

Defect Type - A

Repair Priority - Medium

Location - E

Relevant Specialist - Licensed Builder/Qualified Concreter

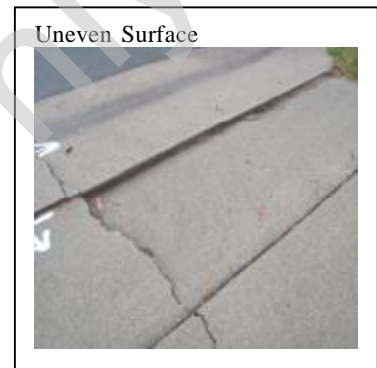
SIGNIFICANTLY UNEVEN CONCRETE SURFACE

Defect Type - A

Repair Priority - High, SH

Location - N

As advised by the owner of the property the driveway has been booked in for repairs by the appropriate authorities.

This may pose a safety risk and the affected sections require replacement.

Relevant Specialist - Licensed Builder/Qualified Concreter

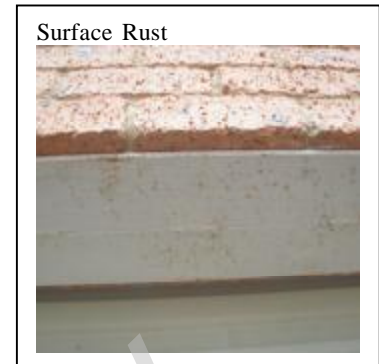
SURFACE RUST

Defect Type - D

Repair Priority - Medium

Location - E

The rust requires treatment to help prevent any further deterioration.

Relevant Specialist - Handyman

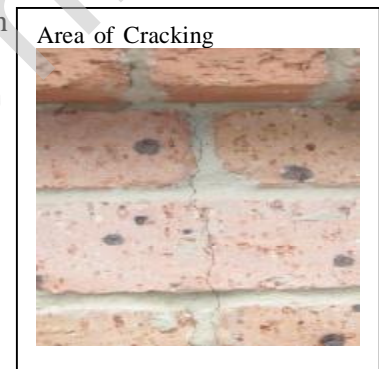
HAIRLINE CRACKING VISIBLE

May or may not pose a structural concern. This inspection has been carried out in accordance with Australian Standard AS4349.1-2007 which states that determining whether cracking is a structural defect does not simply relate to the width of the crack. It is therefore important to have a structural engineer assess the cracking.

Defect Type - A

Repair Priority - Unable to Determine

Location - W

Relevant Specialist - Structural Engineer

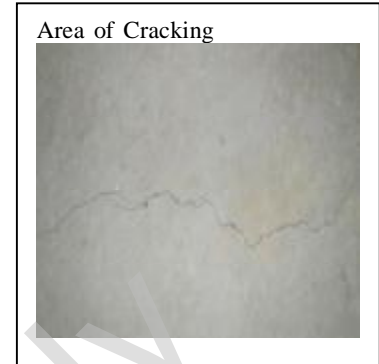
HAIRLINE CRACKING VISIBLE

Defect Type - A

Repair Priority - Low

Location - C,

Relevant Specialist - Structural Engineer
