Property Evaluation Reports

5 Smith Street, Amaroo, ACT

Property & Inspection Details

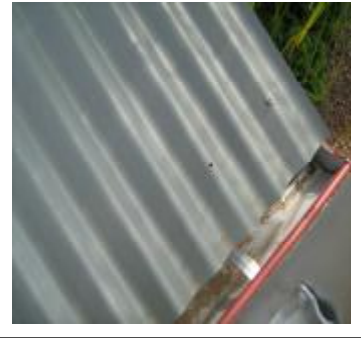
Roof (Generally)

Roof (Metal)

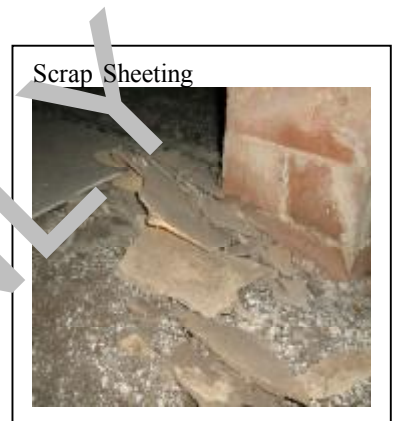
Sub Floor (Generally)

Fibro Cement Sheeting

There are scraps of fibre cement sheeting located in the sub floor area and given the age of the house this material may contains some asbestos content. Asbestos based materials are considered to be hazardous and should be handled and disposed of by a suitably qualified person if any repairs or renovations are to be carried out.

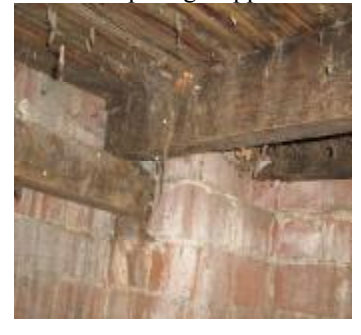
Bearer Requiring Support

INADEQUATE SUPPORT TO FLOOR FRAME BENEATH A BEARER

Additional support is required for the frame in this area. A Licensed Builder should be engaged to assess this area and provide advice on the correct method of repair.

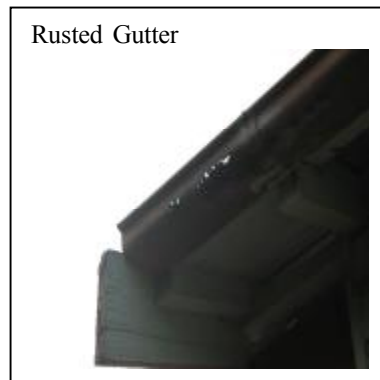
Rusted Gutter

RUSTED THROUGH

Replacement of the affected sections of guttering is required.
