Building Report

5 Smith Street, Moruya, NSW

BUILDING REPORT

Date: 26th May 2009

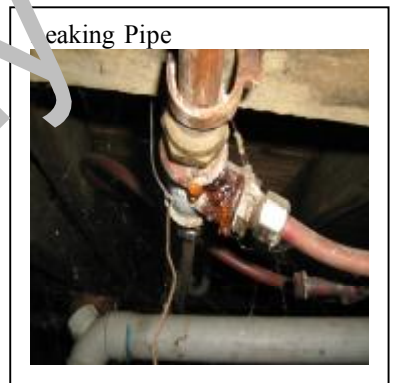
Carport South

LEAKING WATER PIPE

There is a leak to a join in a water pipe. This leak requires inspection by a Licensed Plumber who can provide advice on the correct method of repair.

Defect Type - E

Repair Priority - High

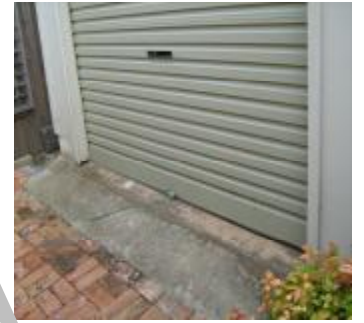
Affected Frame

The frame requires some repairs and resecuring.

Defect Type - D

Repair Priority - Medium

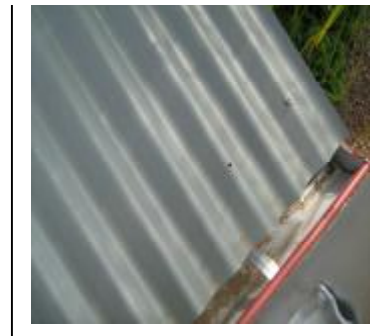
RUSTED THROUGH

The affected sections of the downpipe require replacement.

Defect Type - A

Repair Priority - High

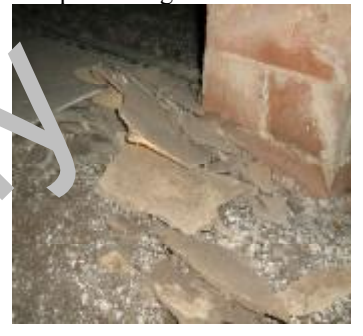
Scrap Sheeting

There are scraps of fibre cement sheeting located in the sub floor area and given the age of the house this material may contain some asbestos content. Asbestos based materials are considered to be hazardous and should be handled and disposed of by a suitably qualified person if any repairs or renovations are to be carried out.

Defect Type - A

Repair Priority - SH, FI

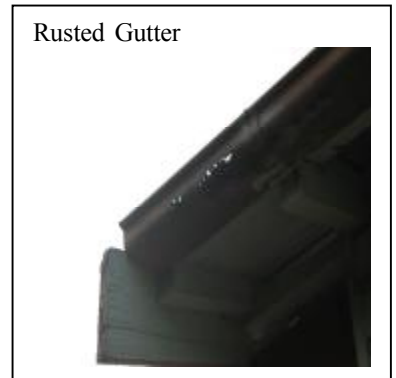
Rusted Gutter

RUSTED THROUGH

Defect Type - D

Repair Priority - High

Replacement of the affected sections of guttering is required.

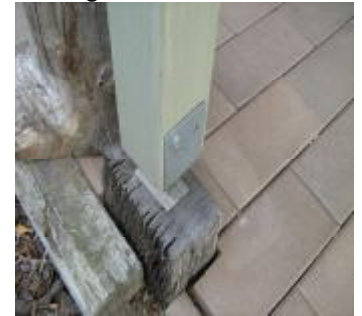
Missing Bolts

Defect Type - F

Repair Priority - High

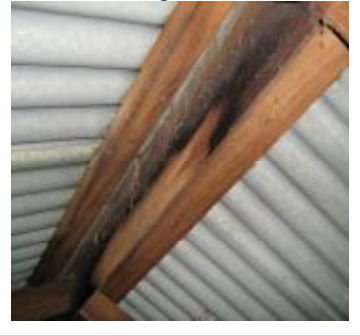
Water Staining

ROOF LEAKS

Defect Type - C

Repair Priority - High, FI
