90 Defect Liability Report

4 Smith Street
Smithtown NSW/ACT

4 Smith Street, Smithtown

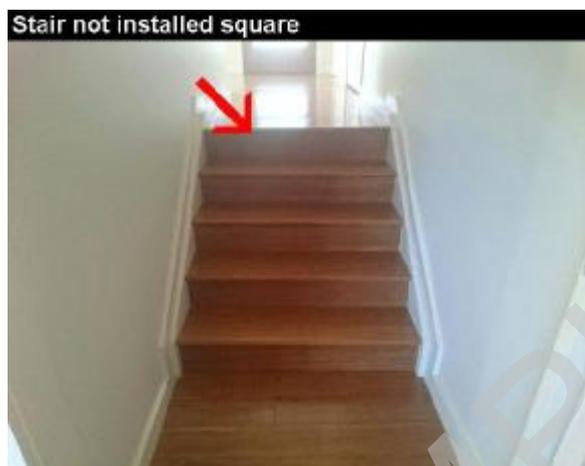
The stairs have not been constructed in accordance with the correct standards and may pose a trip hazard. A licensed builder should be engaged to provide advice on the repairs required. Must be fixed without delay.

Location: The item identified is located in the Entry

Repair priority: Immediate

Further inspection or advice required from specialist: Yes, by a Licensed builder

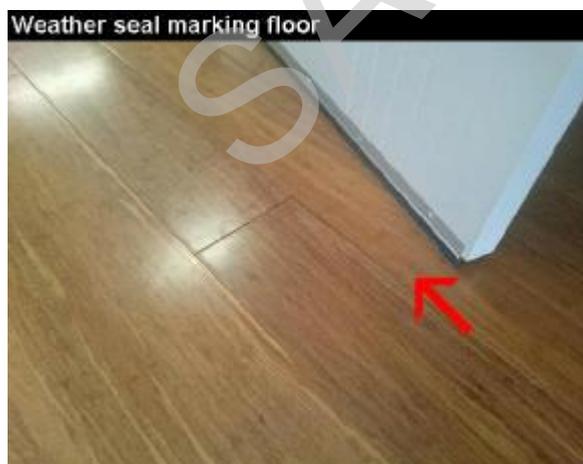
Door

CATCHING AT BASE

Location: The item identified is located in Garage

Adjustment of the weather strip is required to prevent any further damage.

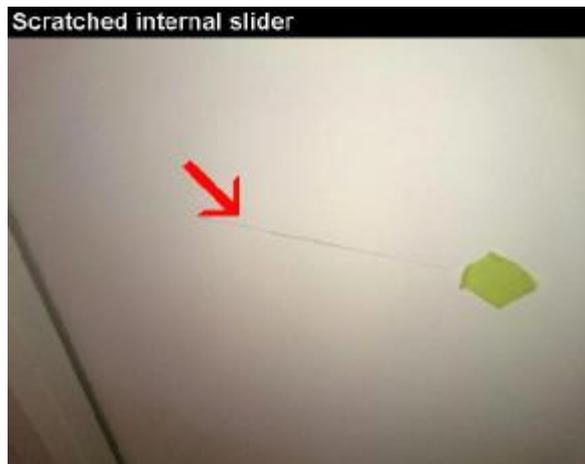
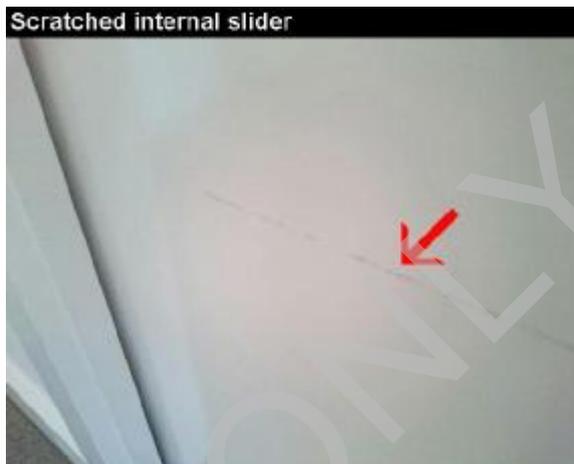
Door (Internal Sliding)

SCRATCHED DOOR

Location: The item identified is located in Entry, Hall one, and Main bedroom

Repair or replacement of the doors is required.

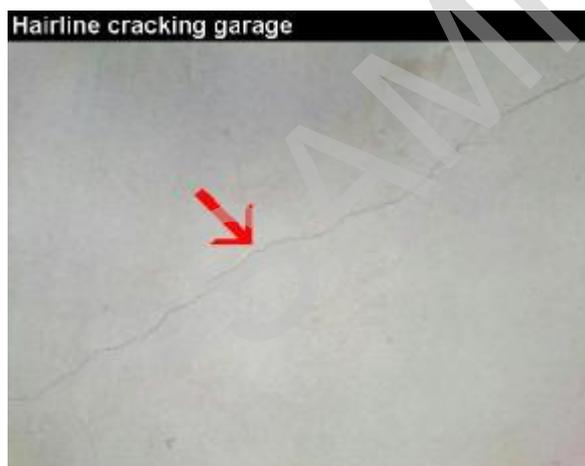
Floor (Concrete)

HAIRLINE CRACKING VISIBLE

Location: The item identified is located in Garage

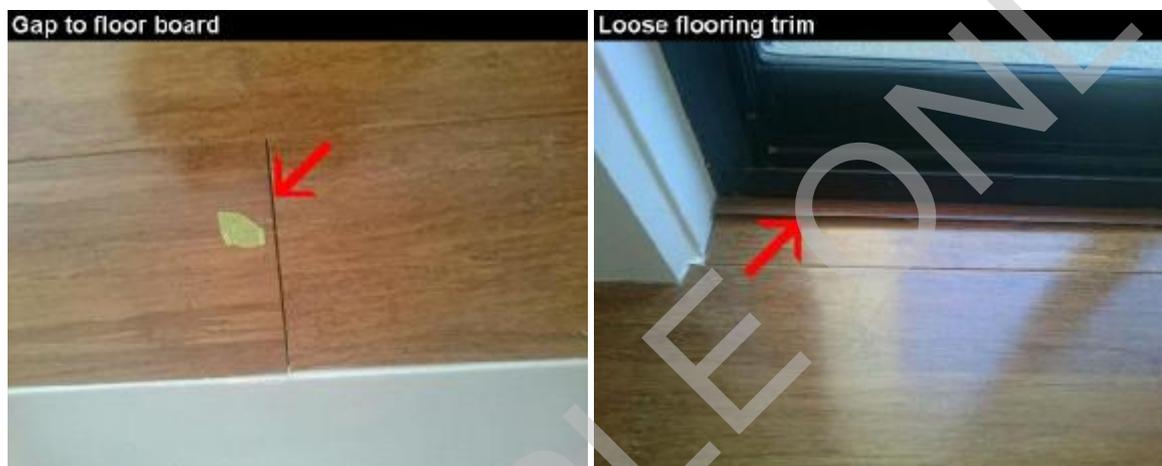
Floor (Timber)

GAP IN FLOOR BOARDS

LOOSE TRIM TO FLOOR BOARDS

Location: The item identified is located in Family room

Repairs to the affected area is required.

Repairs to the affected trim is required.

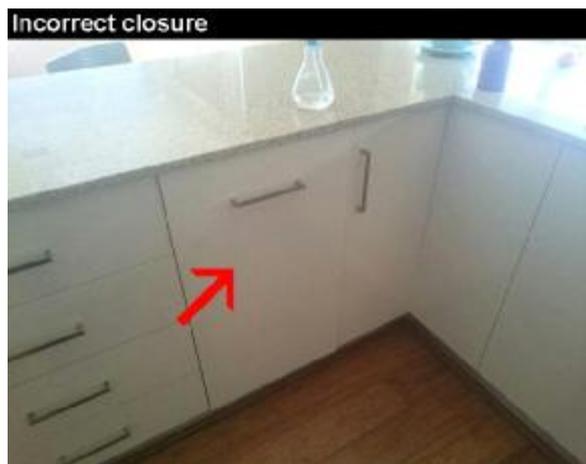
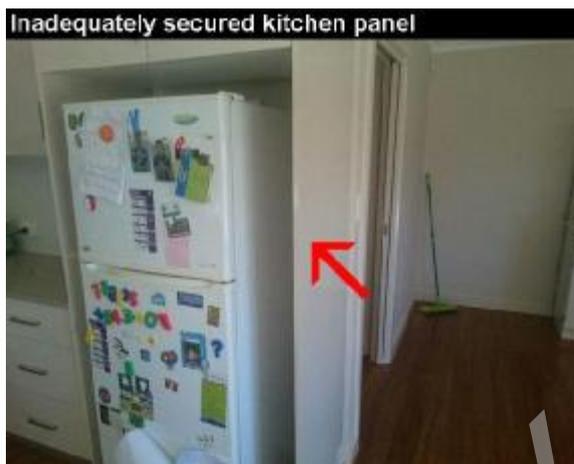
Kitchen Cupboards

INCORRECTLY OPERATING DRAWER

INADEQUATELY SECURED PANEL

Location: The item identified is located in Kitchen one

Repairs to the affected panel is required.

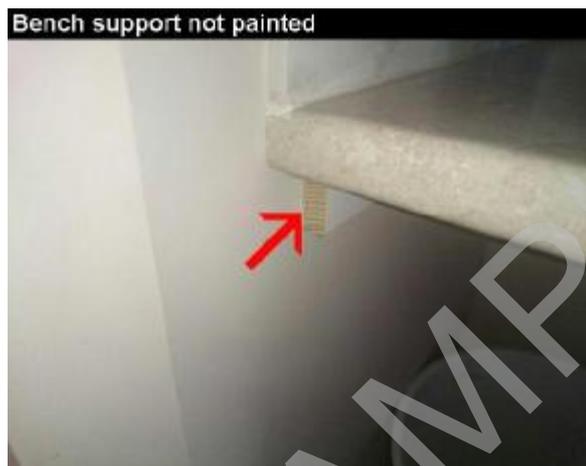
Laundry Cabinet

TIMBER SUPPORTS NOT PAINTED
Painting of the affected supports is required

Location: The item identified is located in Laundry one

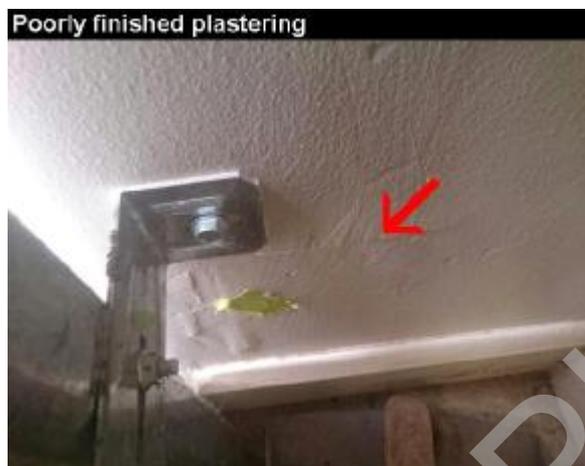
POORLY FINISHED

Poorly finished plastering

Repair and repainting of the affected area is required.

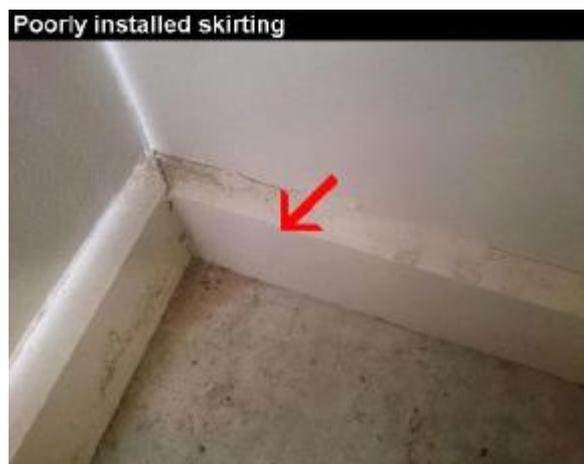
POORLY INSTALLED SKIRTING
Repairs to the affected area is required .

Location: The item identified is located in Garage

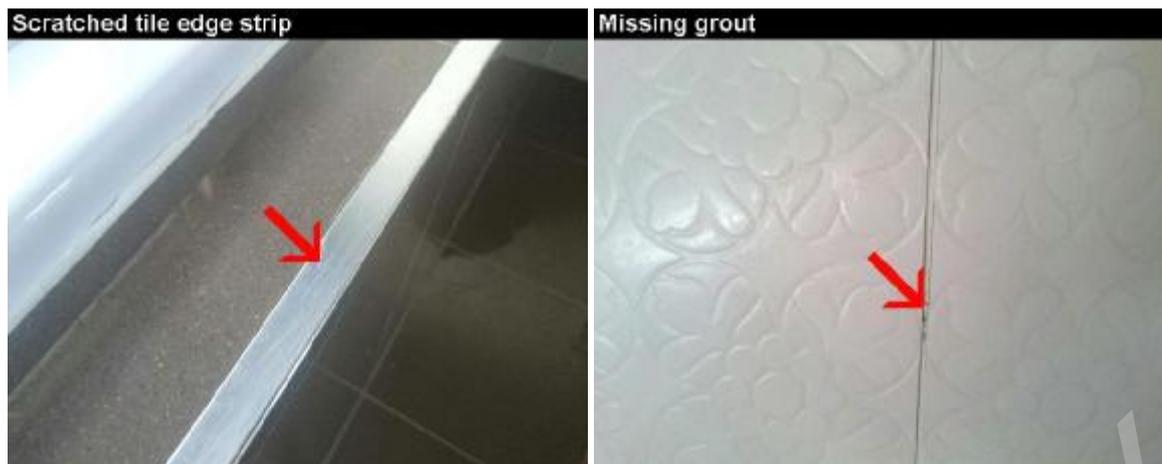
Tiles (Floor)

SCRATCHED FLOOR WASTE
Repair or replacement of the affected waste is required.

DAMAGED OR MISSING GROUT
Re-grouted of the affected area is required.

SCRATCHED TILE EDGE
Repair or replacement of the affected edge strip is required.

Location: The item identified is located in Bathroom

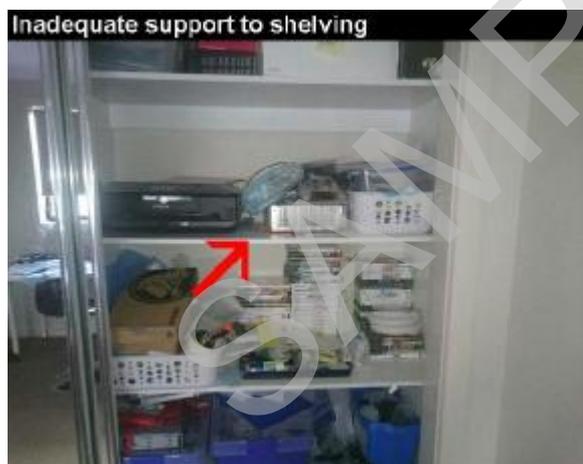
Wardrobe

DOORS NOT CORRECTLY INSTALLED

INADEQUATE SUPPORT TO SHELVES

Location: The item identified is located in Bedroom two and Laundry one

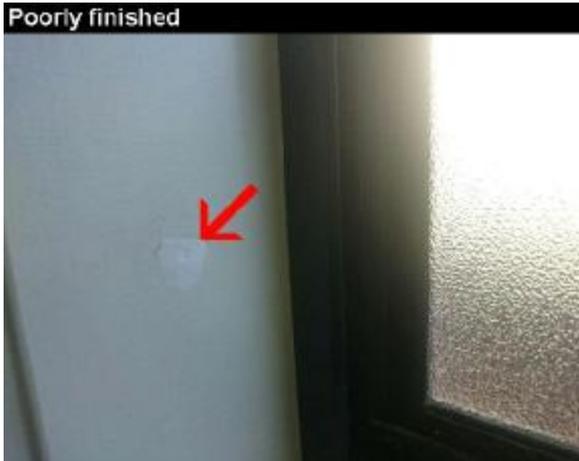
Window Frame

POORLY FINISHED

Location: The item identified is located in Bathroom one and Bedroom three

Repair and repaint of the affected area is required.

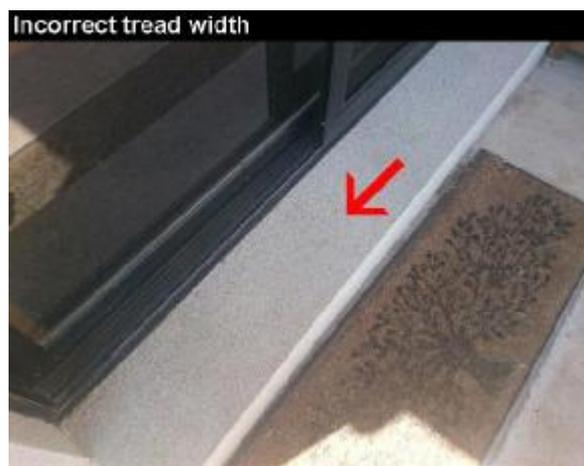
The step has not been constructed in accordance with the correct standards and may pose a trip hazard. A licensed builder should be engaged to provide advice on the repairs required. Must be fixed without delay.

Location: The item identified is located in the Northern elevation

Further inspection or advice required from specialist: Licensed Builder

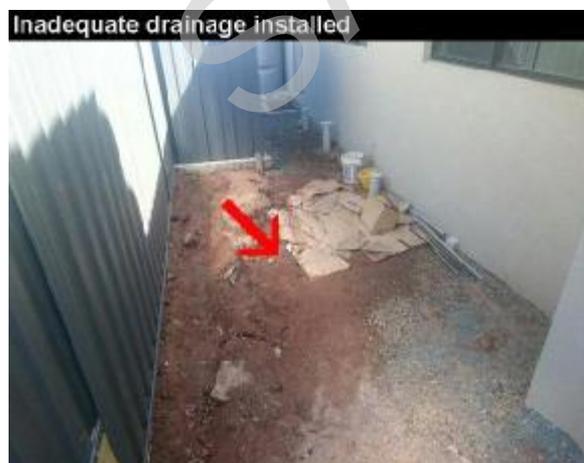
Surface Drainage

INADEQUATE DRAINAGE INSTALLED

Location: The item identified is located in the Southern elevation

Should be improved to ensure surface water tracks away from this area correctly and to prevent deterioration of other elements and/or loss of utility.

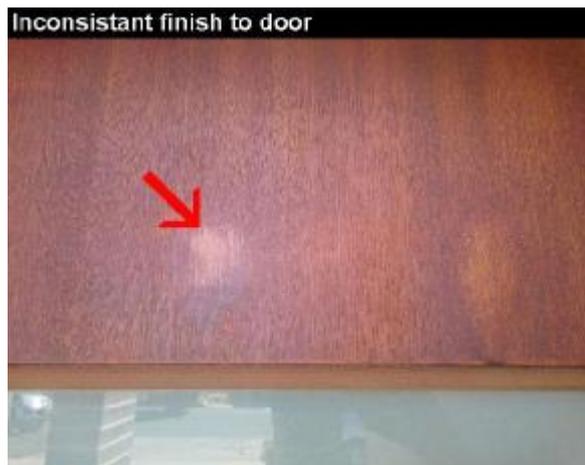
Door

Location: The item identified is located in the Eastern elevation

Sanding and staining of the door is required.

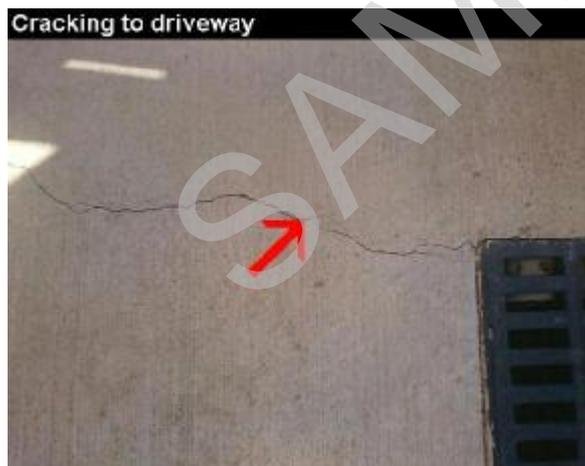
Driveway

MINOR CRACKING TO CONCRETE

Not a major concern and is quite common. Some repairs may be required in the future.

Location: The item identified is located in the Eastern elevation

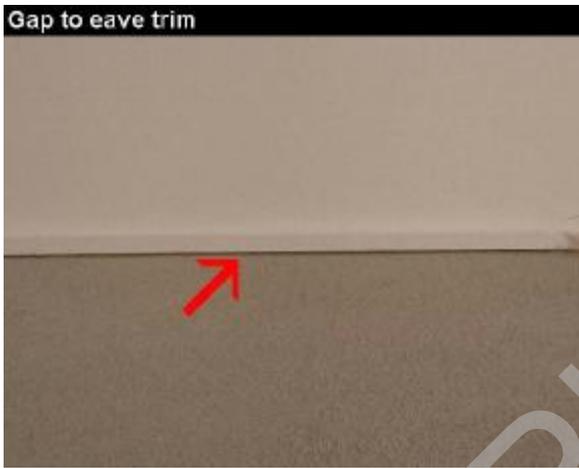
Eaves

GAP BETWEEN TRIM AND WALL
Sealing of the affected areas is required.

LOOSE PAINT TO TRIM

Location: The item identified is located in the Southern elevation

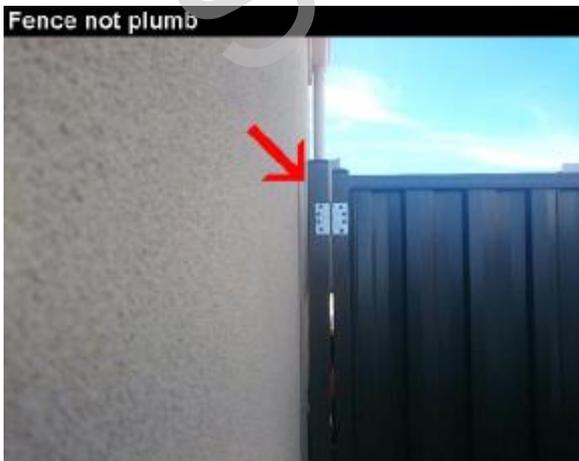
Fences

POST NOT PLUMB

Location: The item identified is located in the Southern elevation

Repairs to the affected post is required.

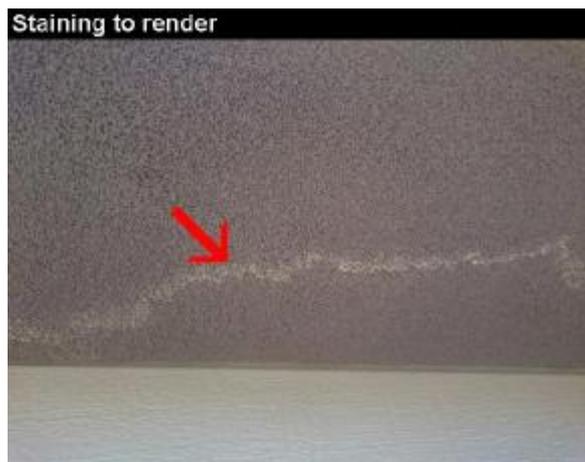
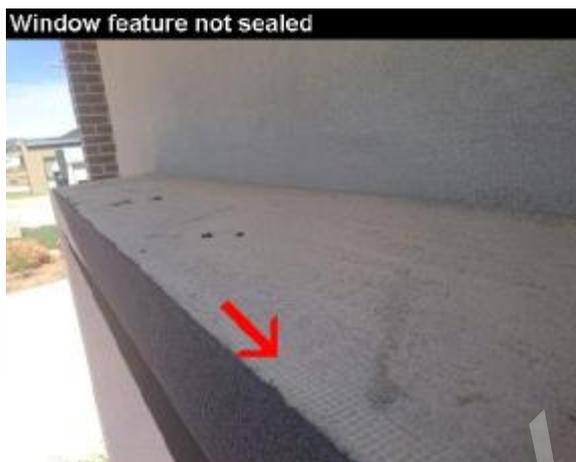
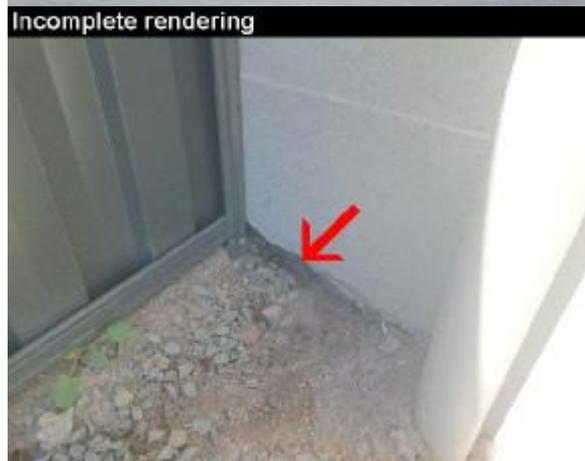
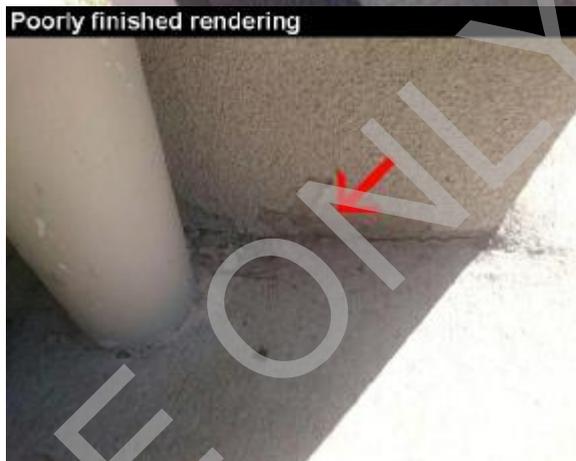
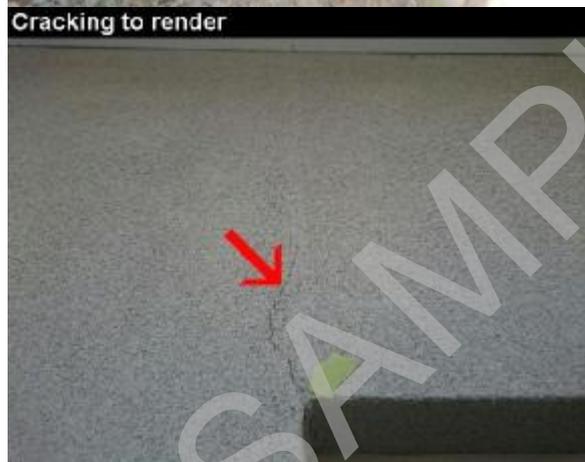
Render

WATER STAINING TO RENDER

The cause of this staining was not obvious at the time of inspection. A licensed builder should be engaged to assess the staining and provide advice on any repairs required.

SHRINKAGE CRACKING VISIBLE

Aesthetic issue only. The installation of a control joint may assist with the cracking in this area.

Location: The item identified is located in the Southern elevation

Repairs to the affected area is required.

Sealing of the feature above the window is required to prevent any deterioration.

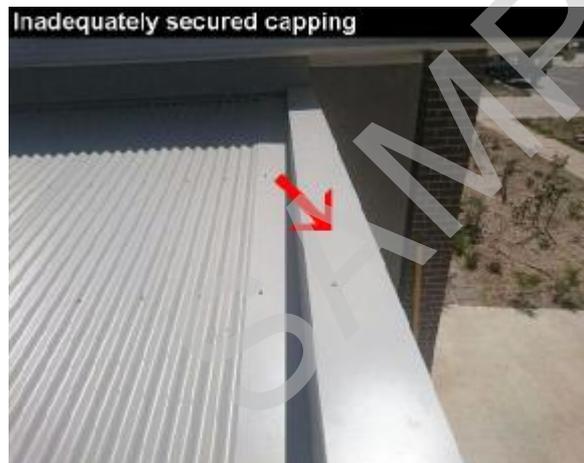
LOOSE CAPPING

Location: The item identified is located in the Main dwelling

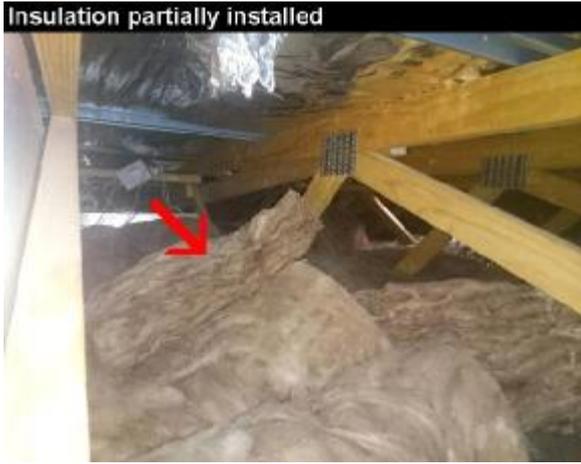
Location: The item identified is located in the Main dwelling

Further inspection or advice required from specialist: Licensed Builder
