Fundamental Building & Timber Pest Report

4 Smith Place
Smithtown NSW/ACT

19/02/2016.

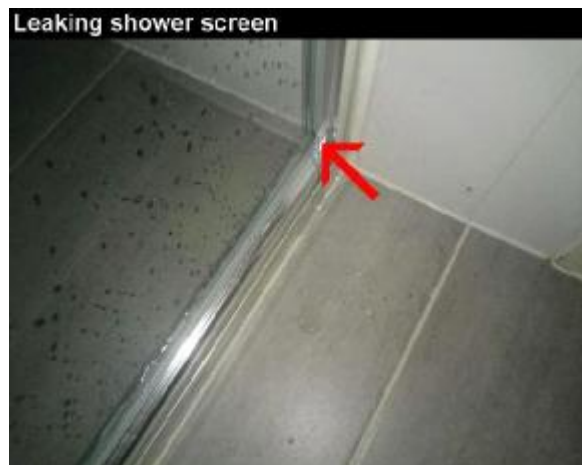
Location: The item identified is located in Bathroom one

LEAKING SCREEN

Repair priority: Within one year

Should be resealed to prevent deterioration of other elements. To be fixed in the near future.

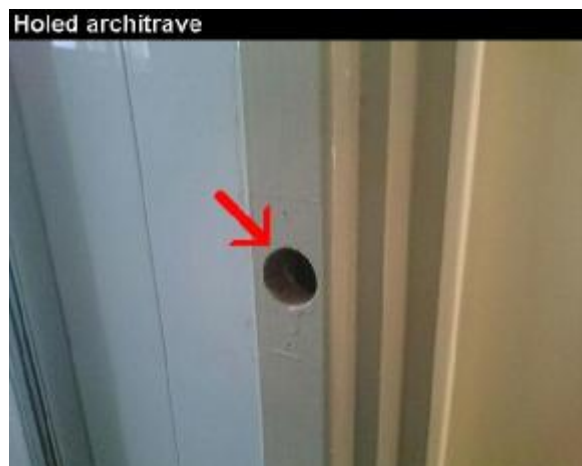
Location: The item identified is located in Bathroom one

Repair priority: During routine maintenance

Should be repaired or new architrave installed. Repairs can be carried out during routine maintenance.

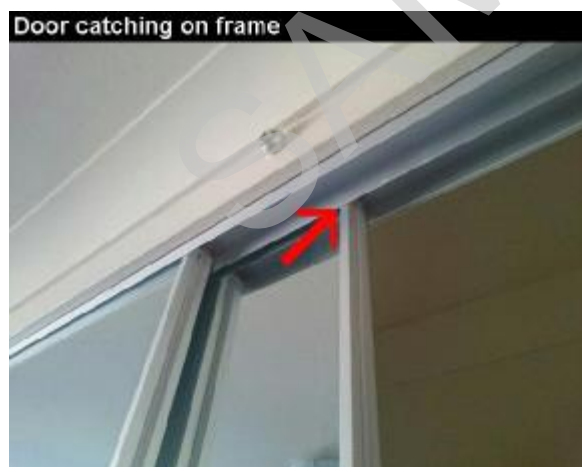
Location: The item identified is located in Bedroom three

CATCHING ON FRAME

Repair priority: During routine maintenance

Should be trimmed or adjusted to allow for correct operation. Repairs can be carried out during routine maintenance.

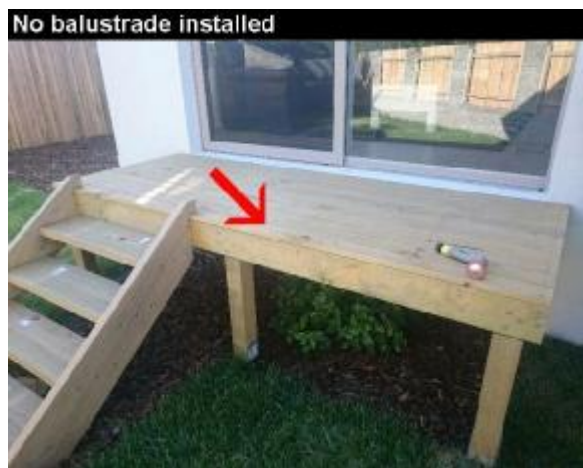
Location: The item identified is located in the Western elevation.

MISSING BALUSTRADE

Repair priority: Within one year

The installation of a balustrade is recommended.

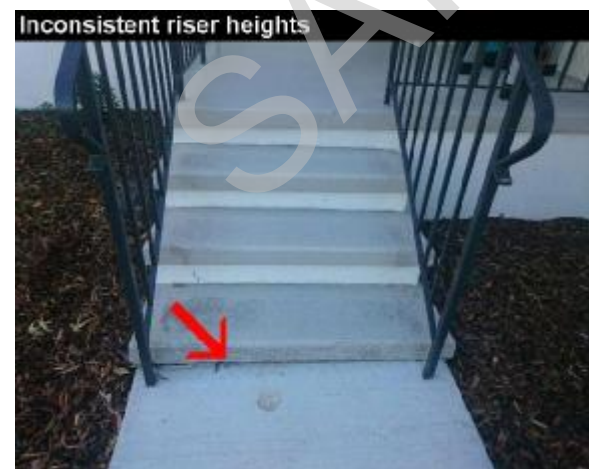
Location: The item identified is located in the Northern elevation and Southern elevation

SIGNIFICANTLY INCONSISTENT RISER HEIGHT

The stairs have not been constructed in accordance with the correct standards and may pose a trip hazard. A licensed builder should be engaged to provide advice on the repairs required. Must be fixed without delay.

Repair priority: Immediate

The stairs have not been constructed in accordance with the correct standards. A Licensed Builder should be consulted regarding modification or replacement of the stairs.

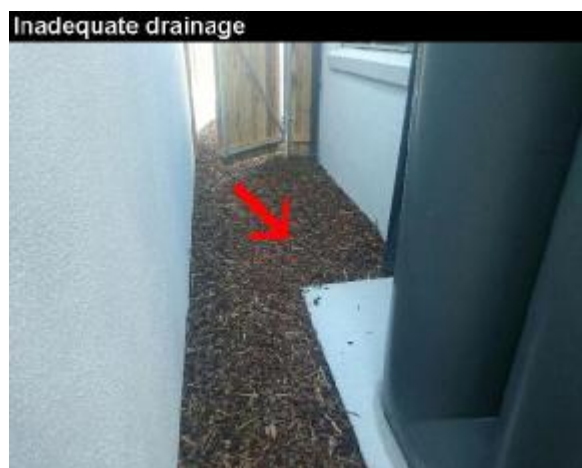
Location: The item identified is located in the Eastern elevation

INADEQUATE DRAINAGE INSTALLED

Repair priority: Within one year

Further inspection or advice required from specialist: Yes, by a licensed builder or plumber

Should be improved to ensure surface water tracks away from this area correctly and to prevent deterioration of other elements and/or loss of utility. To be fixed in the near future.

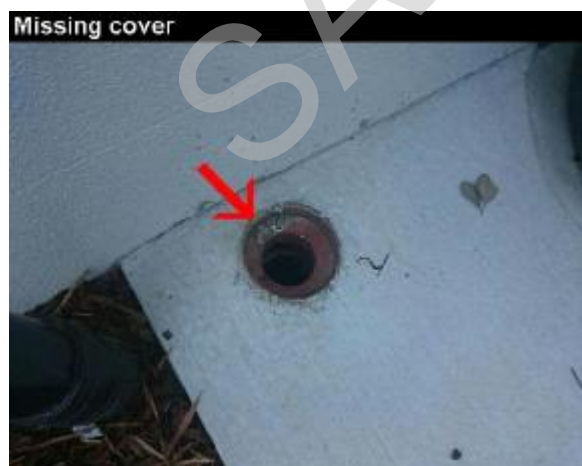
Location: The item identified is located in the Eastern elevation

MISSING COVER TO INSPECTION OUTLET

Repair priority: Within one year

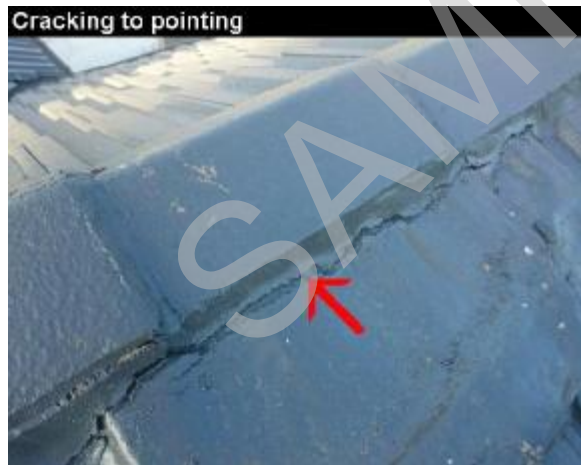
Location: The item identified is located in the Main dwelling and Northern section

CRACKED AND LOOSE RIDGE POINTING AND BEDDING

Repair priority: Unable to determine

Further inspection or advice required from specialist: Yes, by a qualified roof tiler

Must be repaired or replaced to prevent further deterioration and/or loss of utility. Must be fixed without delay.

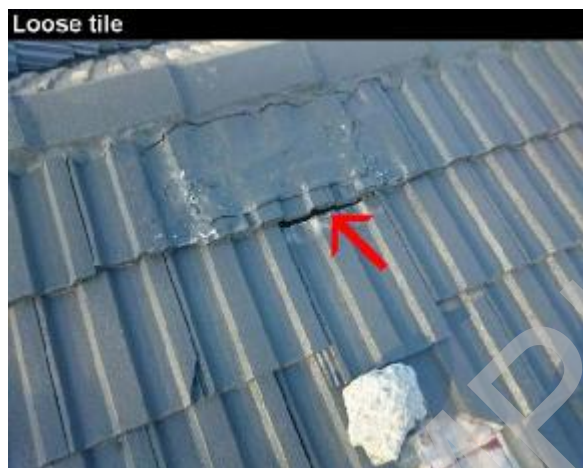
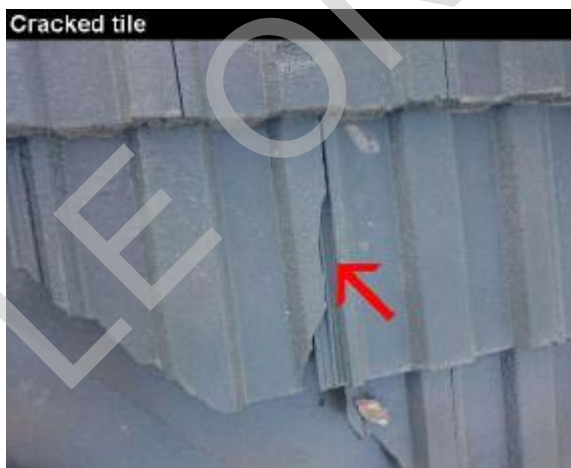
Location: The item identified is located in the Main dwelling and Northern section

CRACKED TILES

Repair priority: Within one year

LOOSE TILES

Repair priority: Immediate

Should be repaired or replaced to prevent further deterioration and/or loss of utility. To be fixed in the near future.

Should be repaired or replaced in the near future.

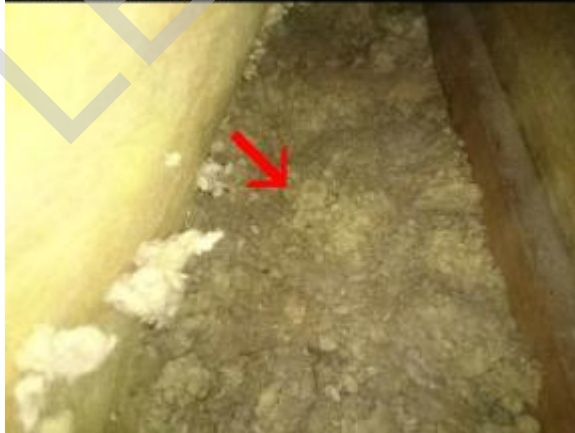
LOOSE FILL INSULATION INSTALLED

Loose fill insulation is installed to this ceiling area.

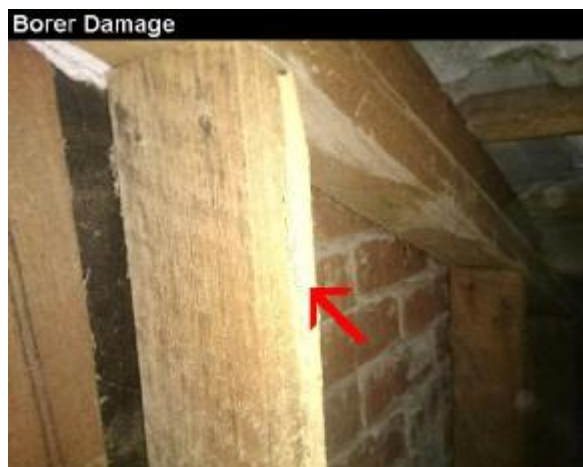
Bedroom two.

Evidence of Lyctus borer was found. Lyctus borer is not considered to be a significant pest of timber and as the damage is confined to the sapwood content of hardwood timbers, no treatment is required in respect of this borer. Lyctus borer damage was noted to the following timber(s)/area(s). IMPORTANT: SEE NOTE ON BORERS.

Visible wall frame timbers.

Visible timber damage appears minor. Please refer to the definitions section of this report on Timber Damage.

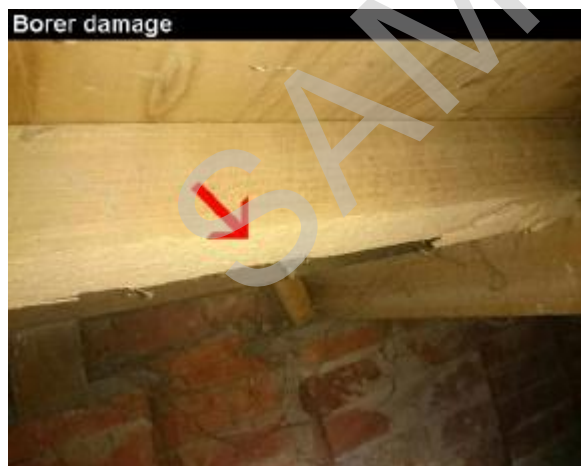
Evidence of Lyctus borer was found. Lyctus borer is not considered to be a significant pest of timber and as the damage is confined to the sapwood content of hardwood timbers, no treatment is required in respect of this borer. Lyctus borer damage was noted to the following timber(s)/area(s). IMPORTANT: SEE NOTE ON BORERS.

Affected subfloor timbers

Floor joist/s.

Visible timber damage appears minor. Please refer to the definitions section of this report on Timber Damage.
