## New Construction Final Handover Report

4 Smith Street  
Smithtown NSW/ACT

11/01/2016.

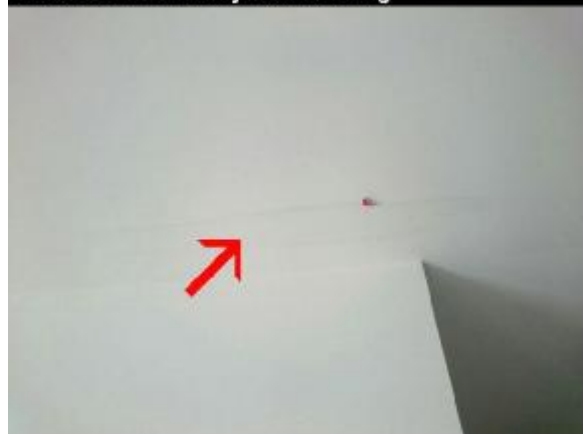
**WATER DAMAGED CEILING LINING DUE TO CURRENT ROOF LEAKS**  
Should be repaired after leak issue has been corrected. To be fixed in the near future.

Water stain to family room ceiling

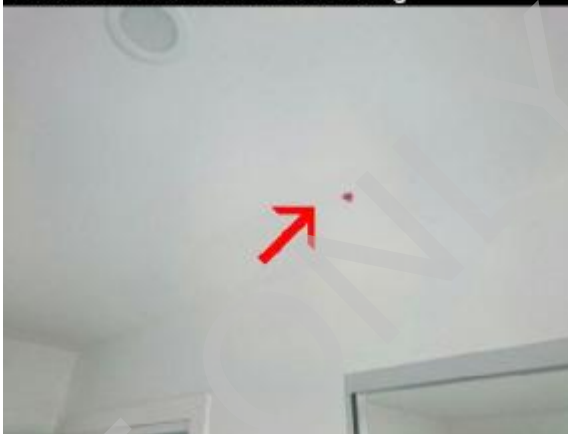
Water stain to bedroom four ceiling

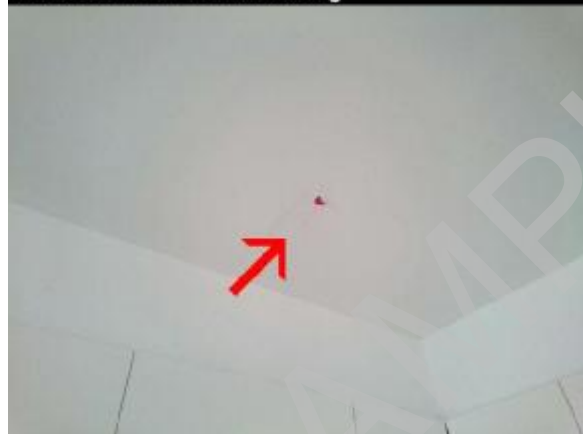
Water stain to kitchen ceiling

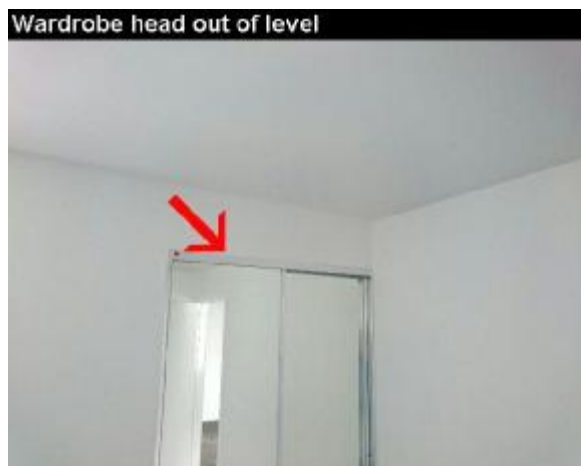
**Location:** The item identified is located in Bedroom two

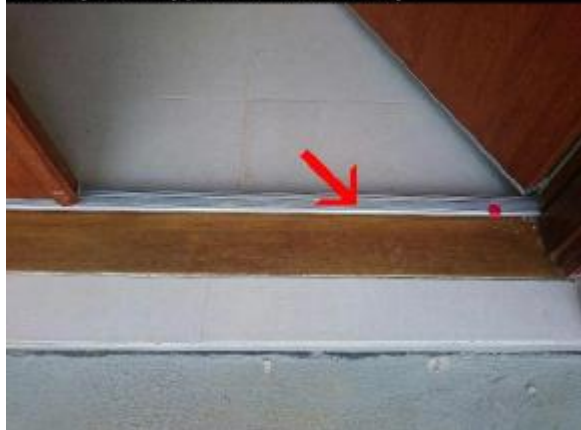
**INADEQUATE SUPPORT TO WEATHERSTRIP**  
Should be repaired or replaced. To be fixed in the near future.

Inadequate support to weatherstrip

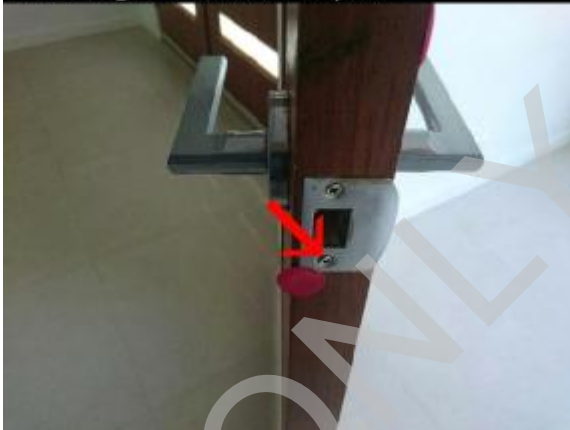
**SCREWS POORLY INSTALLED TO STRIKER PLATE**  
Should be replaced. To be fixed in the near future.

Protruding screws to striker plate

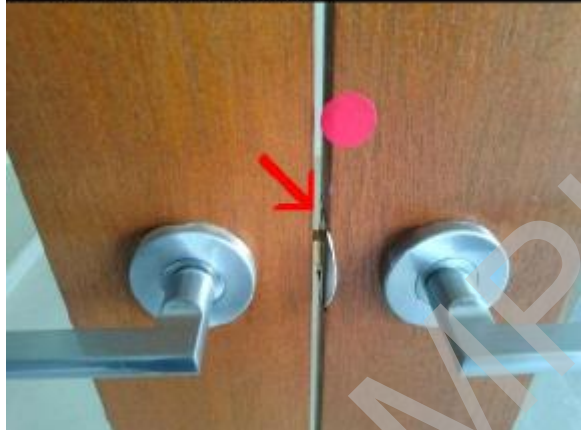
**OVERSIZE MARGINS TO DOOR**  
Should be repaired or replaced. To be fixed in the near future.

Oversize gaps lounge doors

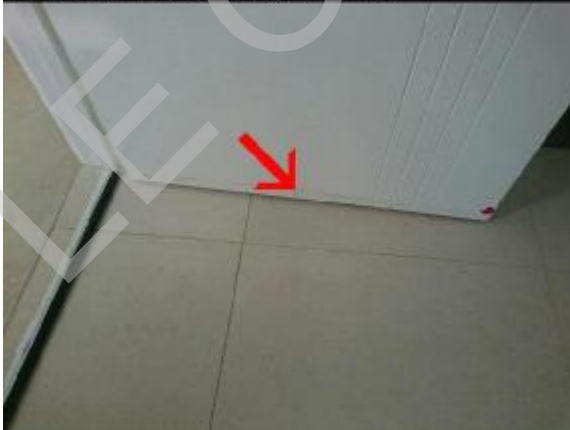
Detached weatherstrip garage door

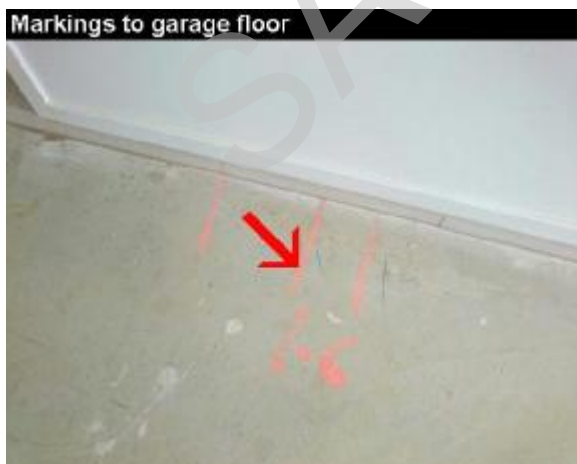
**RESIDUE AND STAINS TO FLOOR**

**Location:** The item identified is located in Garage

Should be repaired or replaced to prevent further deterioration and/or loss of utility. To be fixed in the near future.

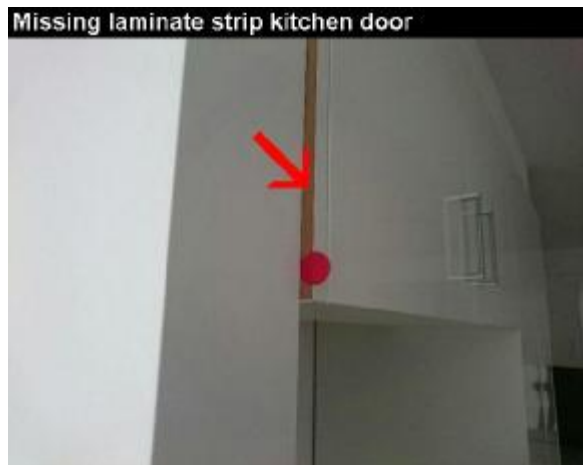
**MISSING EDGE STRIP**

Missing laminate strip kitchen door

Should be replaced. To be fixed in the near future.

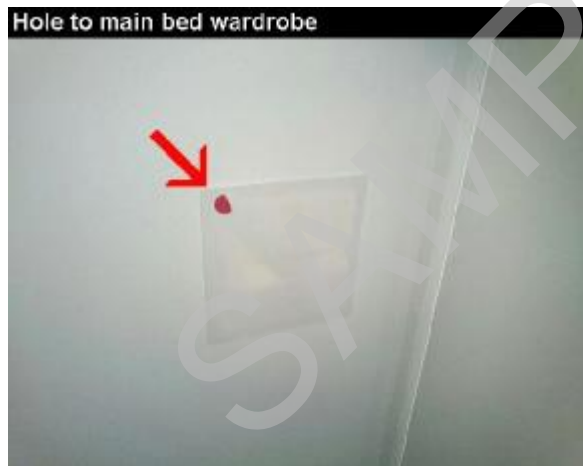
#### HOLED LINING

Hole to main bed wardrobe

Should be repaired. To be fixed in the near future.

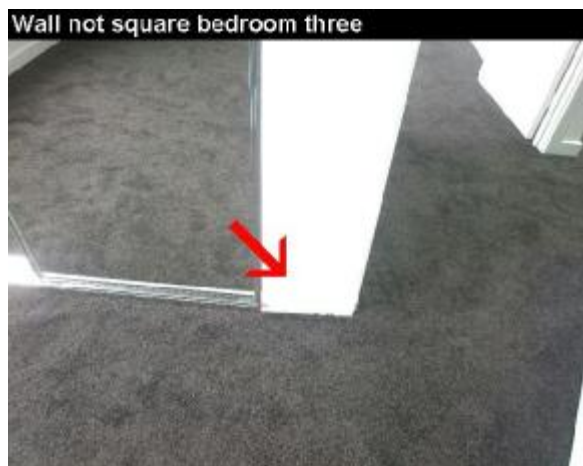
#### WALL FRAME OUT OF SQUARE

**Location:** The item identified is located in Bedroom three

Should be repaired or replaced. To be fixed in the near future.

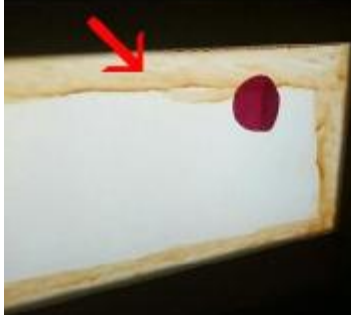
Residue onto glass and door furniture of doors to entry and entry door sill not stained.

Stain to entry door glass

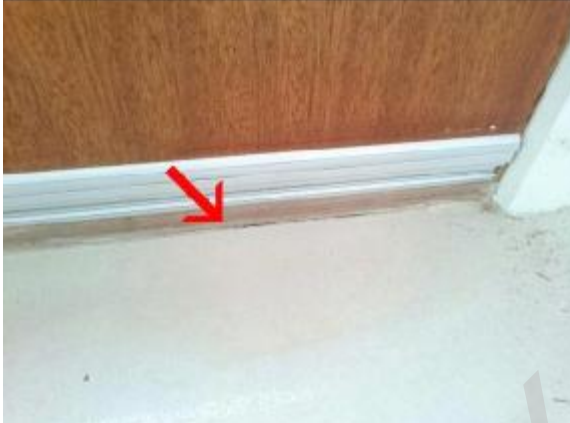
Entry door sill missing stain

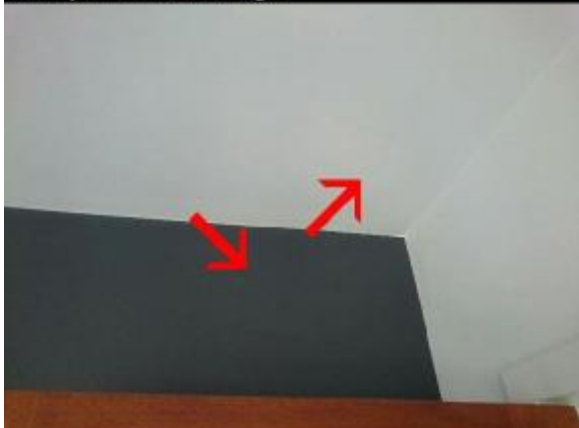
Poor paint finish lounge

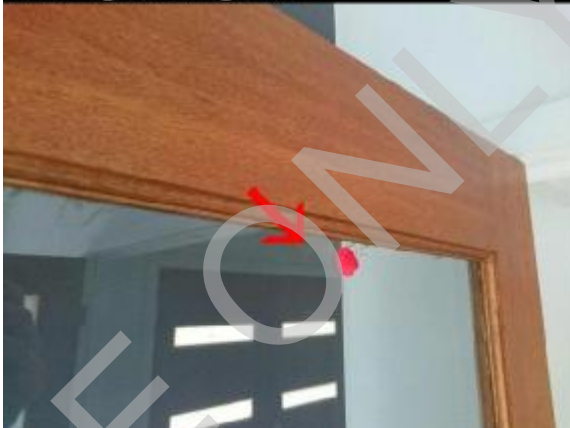
Stain to glass lounge door

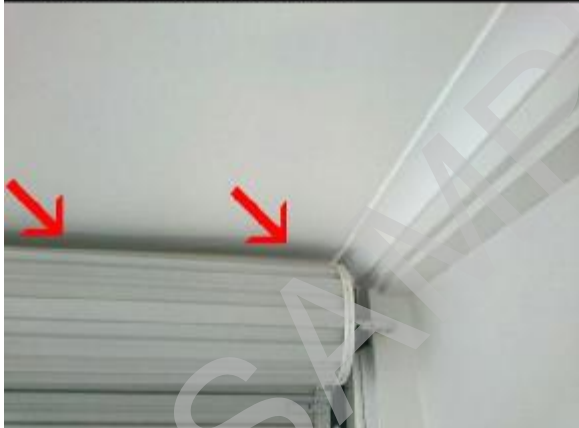
Missing paint to garage ceiling

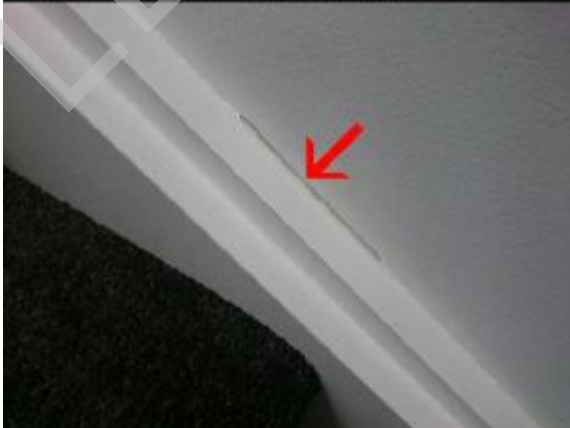
Cracking at join of stair stringer and wall lining.

Gap at join of stairs and wall lining

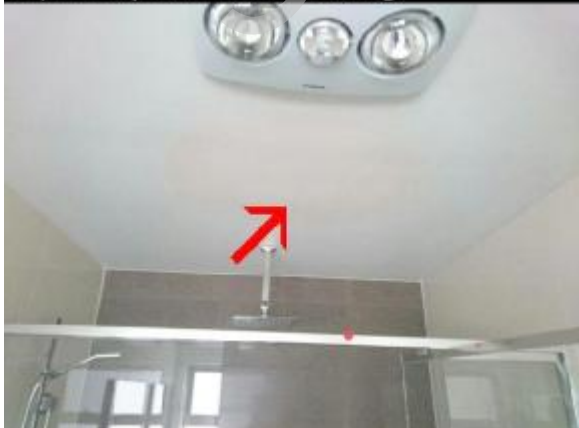
Unpainted patch to ensuite ceiling

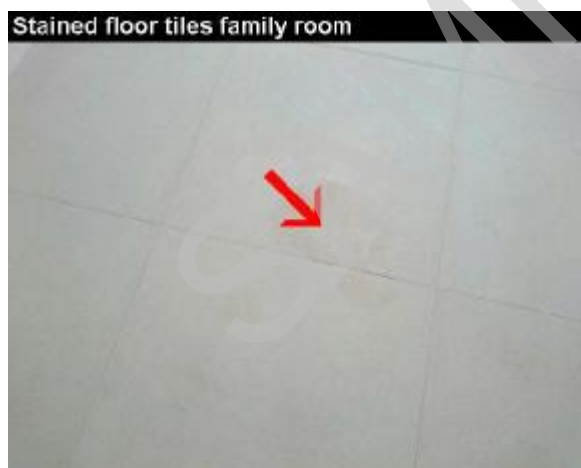
#### STAINED TILES

**Location:** The item identified is located in Family room

The affected tiles require replacement.

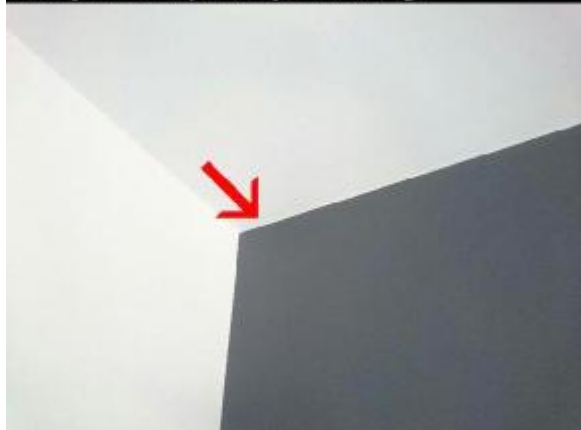
Poorly finished plaster join to lounge

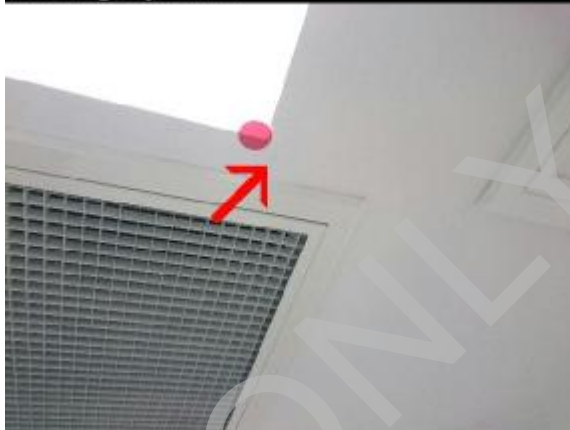
**CRACKING TO PLASTER JOINS**

Cracking to join hall

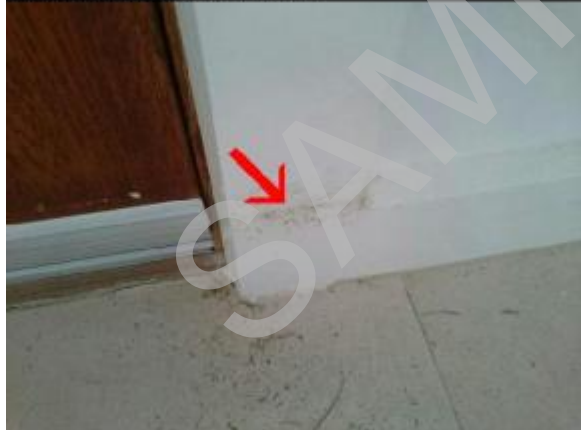
**INADEQUATE BUILDERS CLEAN**

Staining to entry architrave

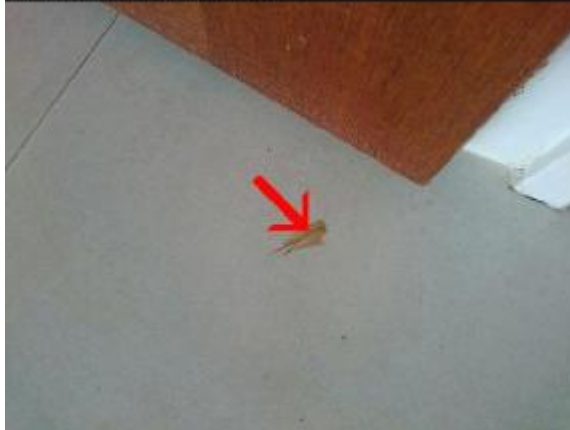
Staining to floor of lounge

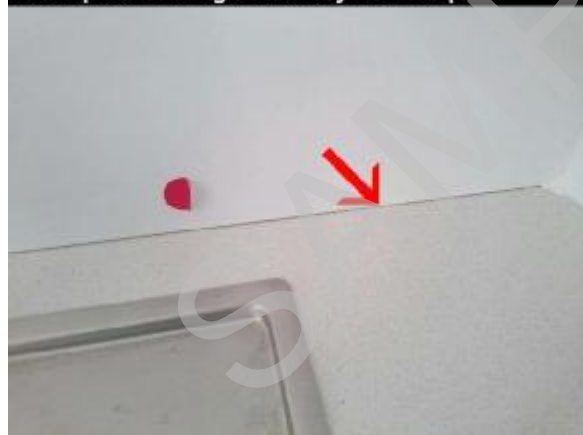
#### INADEQUATELY SEALED BENCHTOP

Inadequate sealing to laundry benchtop

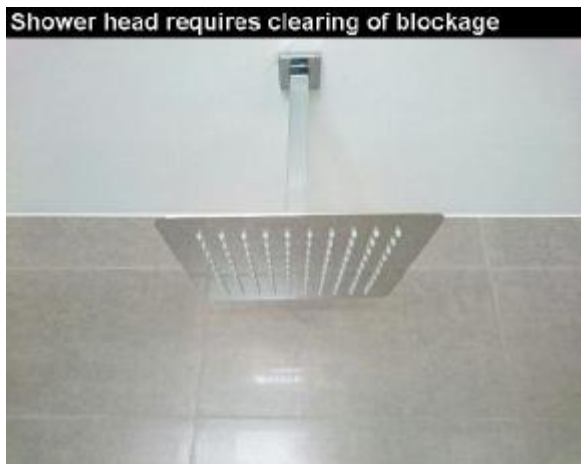
#### SHOWER HEAD BLOCKED

**Location:** The item identified is located in Main ensuite

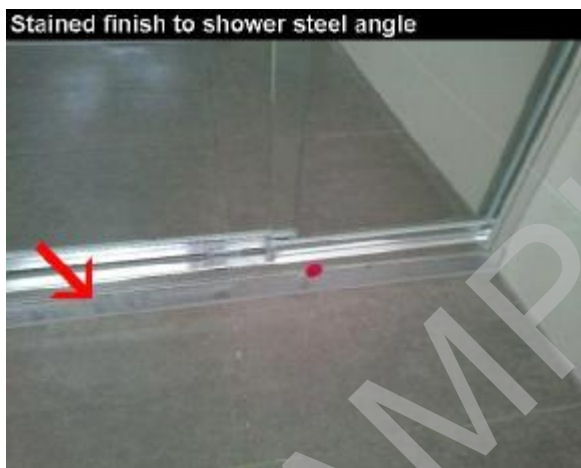
**STAINING TO ALUMINIUM STRIP**  
Thorough cleaning is required.

**Location:** The item identified is located in Bathroom one and Main ensuite

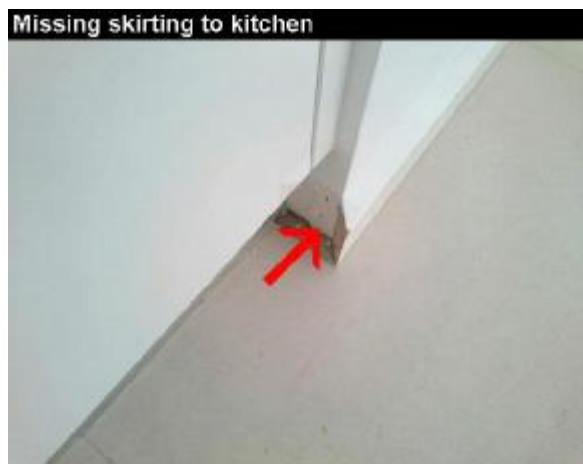
**MISSING SKIRTING**

**Location:** The item identified is located in Kitchen one

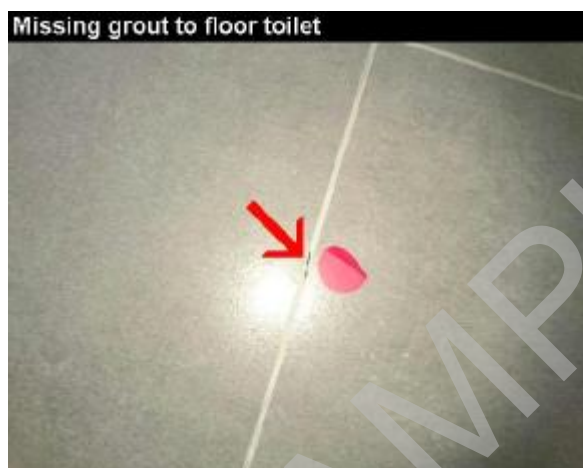
**DAMAGED OR MISSING GROUT**  
Should be re-grouted.

**Location:** The item identified is located in Toilet

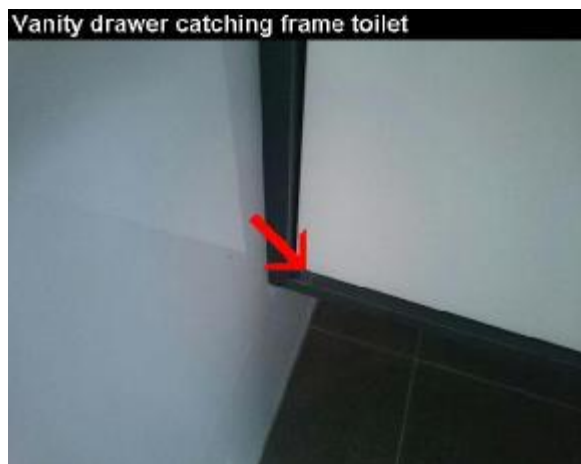
**INCORRECTLY OPERATING DRAWER**  
Should be adjusted to allow for correct operation.

**Location:** The item identified is located in Bathroom one and Toilet

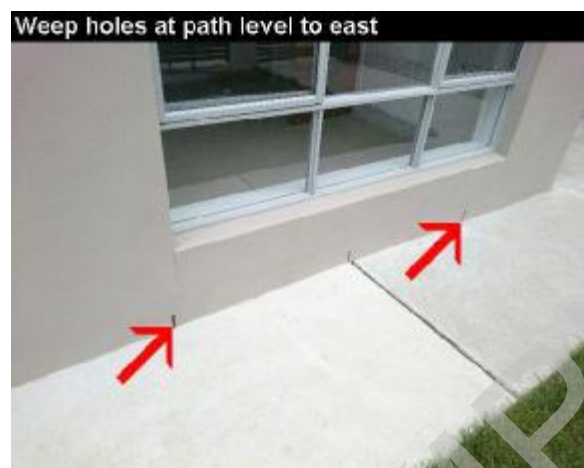
Must lower surface level because it is higher than the dampcourse or internal floor level, to prevent the possibility of water entering the internal area of the building and to prevent deterioration of other elements and/or loss of utility. Must be repaired without delay.

**Location:** The item identified is located in the Eastern elevation

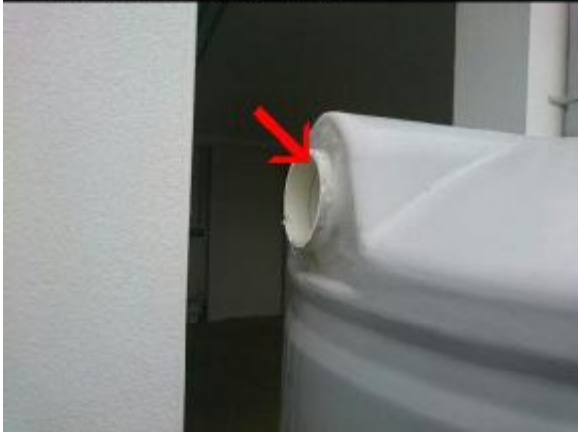
#### OVERFLOW PIPE DISCONNECTED

Missing overflow pipe to tank

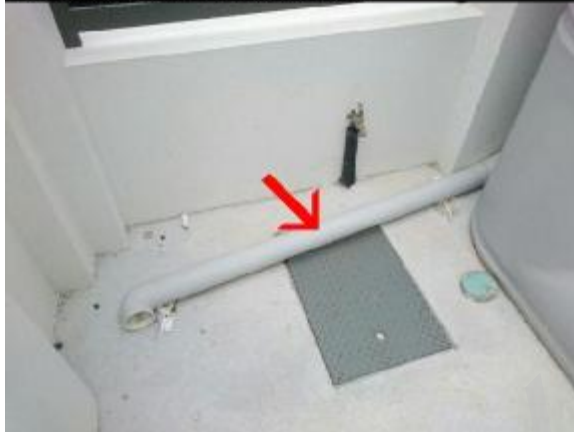
Removed overflow pipe to tank

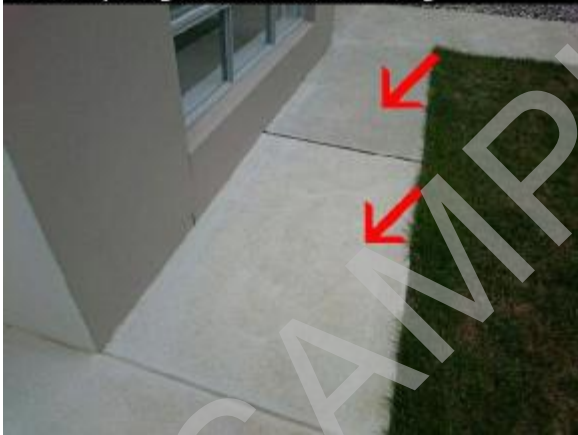
Eastern path graded towards building

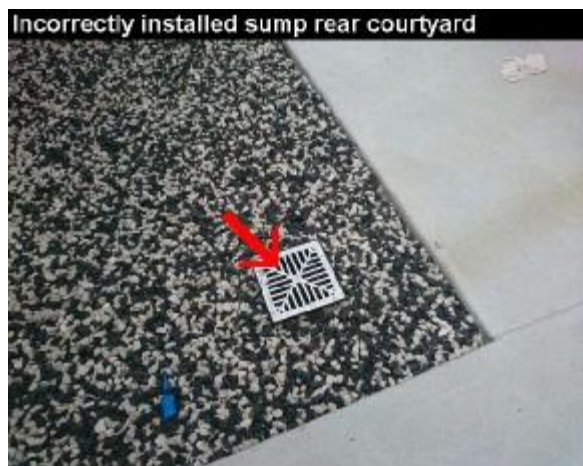
#### INADEQUATE DRAINAGE INSTALLED

**Location:** The item identified is located in the Western elevation

Should be improved to ensure surface water tracks away from this area correctly and to prevent deterioration of other elements and/or loss of utility. To be fixed in the near future.

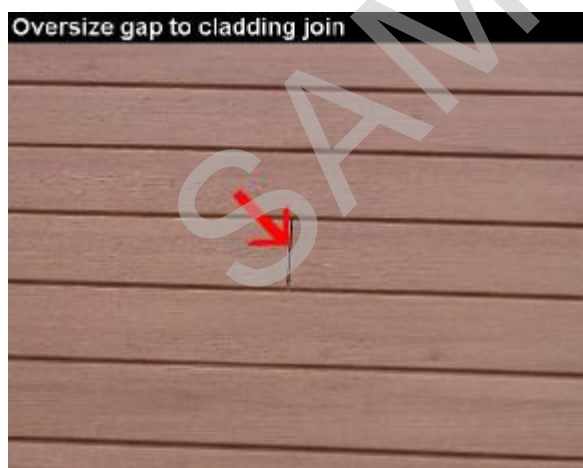
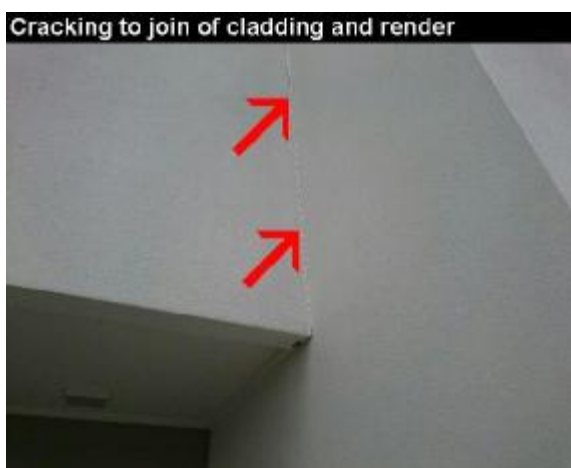
#### CRACKING TO JOINS

Should be repaired to prevent further deterioration. This type of cracking is common with this type of external cladding.

Should be repaired or replaced to prevent deterioration of other elements and/or loss of utility. To be fixed in the near future.

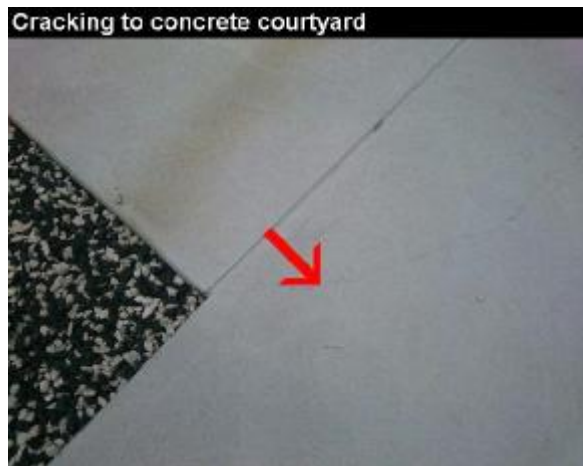
#### MINOR CRACKING TO CONCRETE

**Location:** The item identified is located in the Western elevation

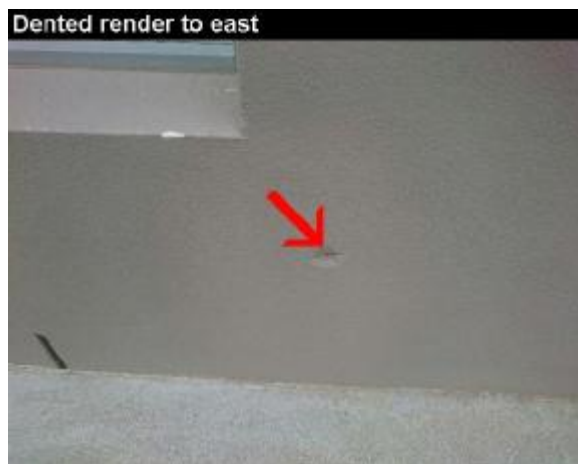
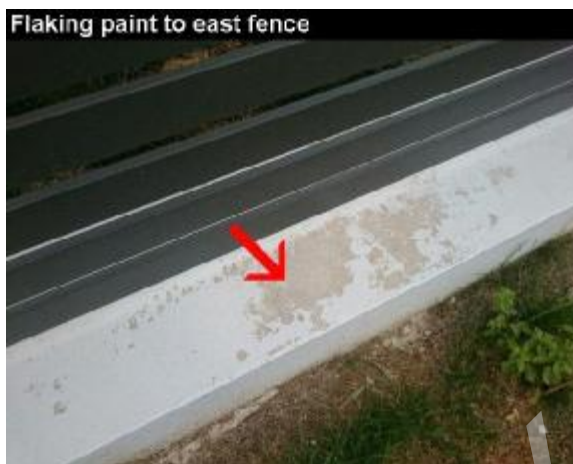
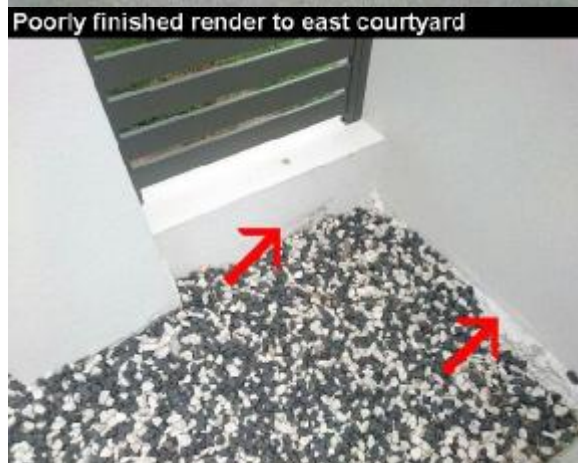
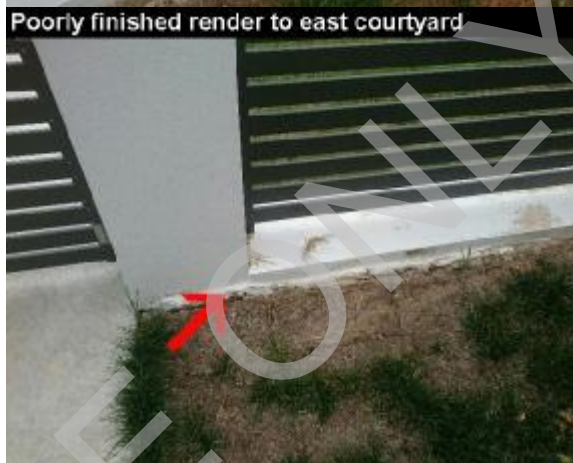
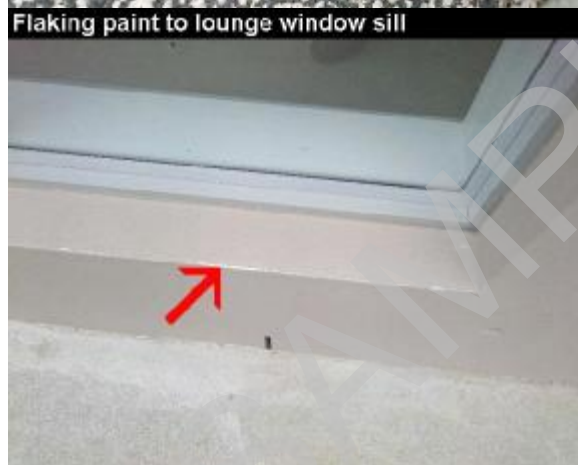
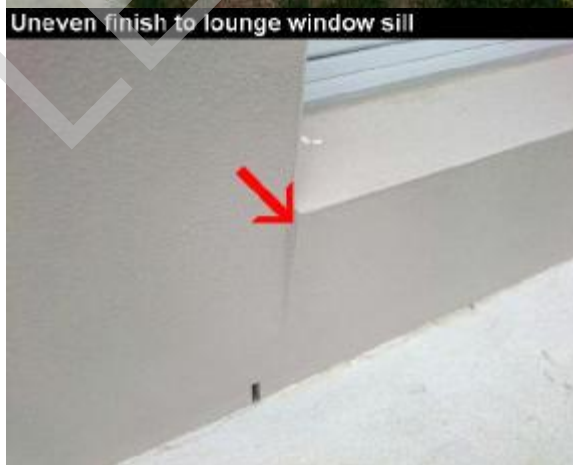
#### DENTED RENDER AND FLAKING PAINT FINISH TO WINDOW SILL AND FENCE

Repair and re-painting of the affected areas is required.

Filling of the joint is recommended.

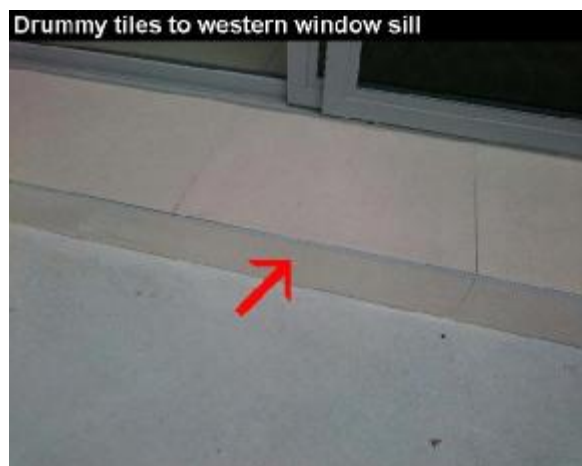
### SLIGHTLY DRUMMY TILES

**Location:** The item identified is located in the Western elevation

Repairs may be required over time.

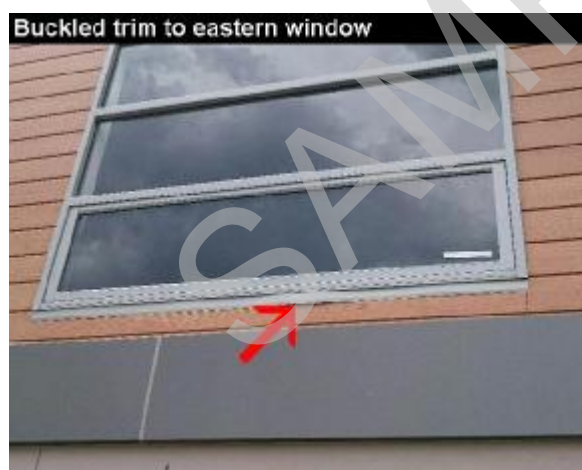
### BUCKLED TRIM

**Location:** The item identified is located in the Eastern elevation

Repair or replacement of the trim is required.

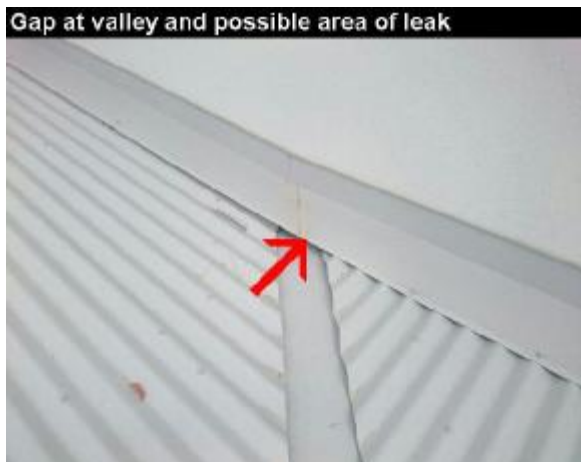
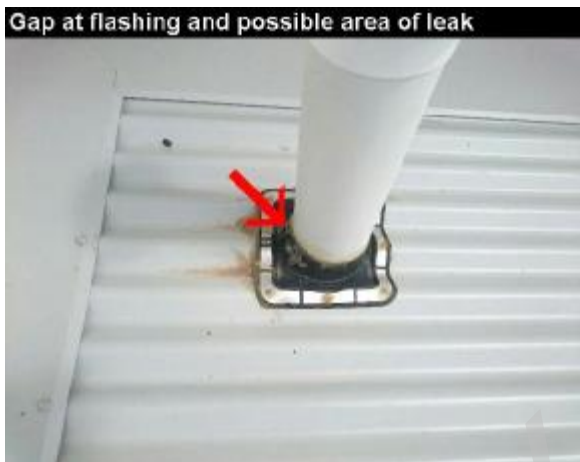
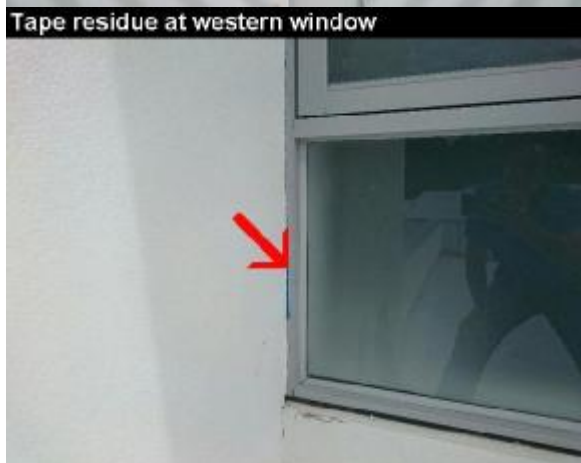
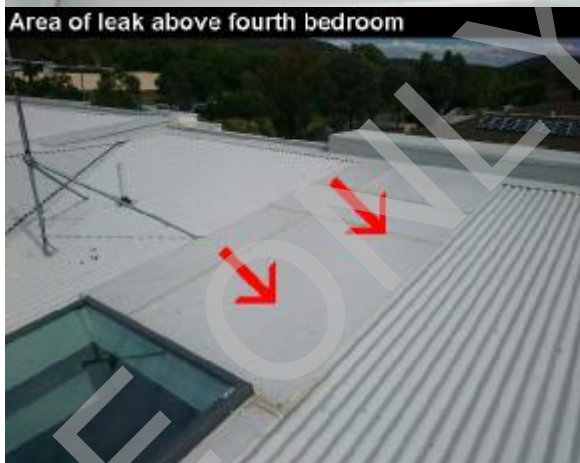
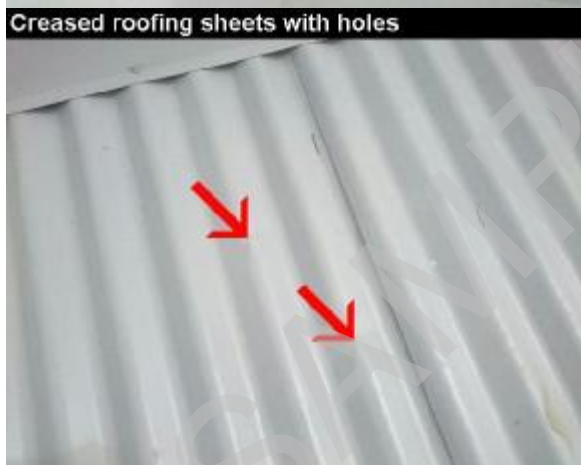
**Location:** The item identified is located in the Main dwelling and Western section

Must seal or replace sheeting to help prevent water entry into the roof void and to prevent further deterioration and/or loss of utility. Must be fixed without delay.

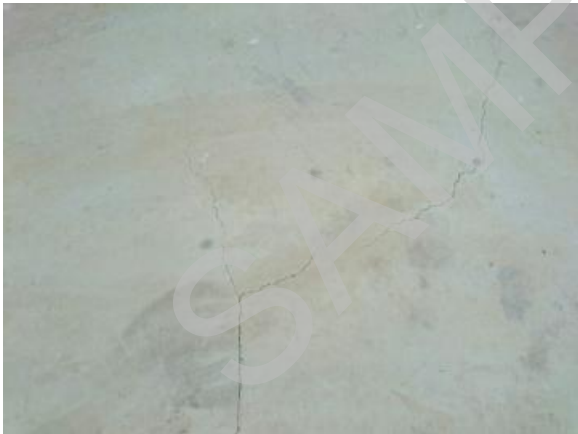
#### Floor

Garage, 1-3mm cracking visible, Serviceability flaw

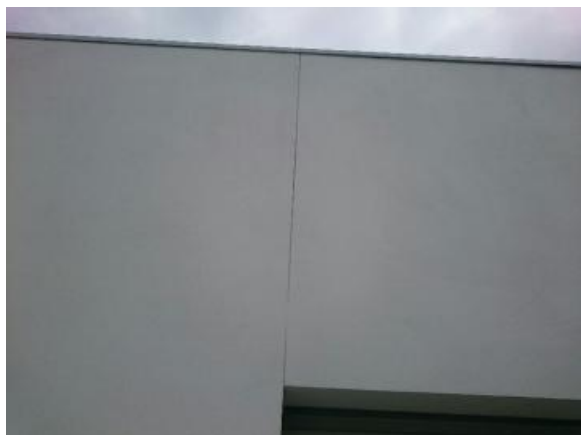
#### Render

Western elevation, 1-3mm cracking visible, Appearance flaw
