Peace of Mind Building, Timber Pest & Compliance Report

4 Smith Place
Smithtown NSW/ACT

4 Smith Street, Smithtown

13/02/2016.

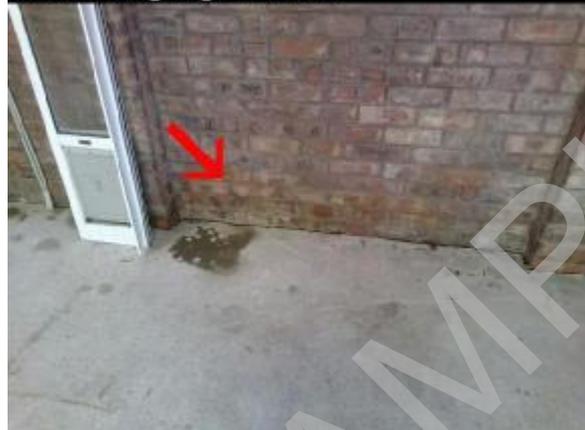
MOISTURE TO EXTERNAL WALL

Moisture to garage wall east

Repair priority: Immediate

Further inspection or advice required from specialist: Yes, by a licensed builder

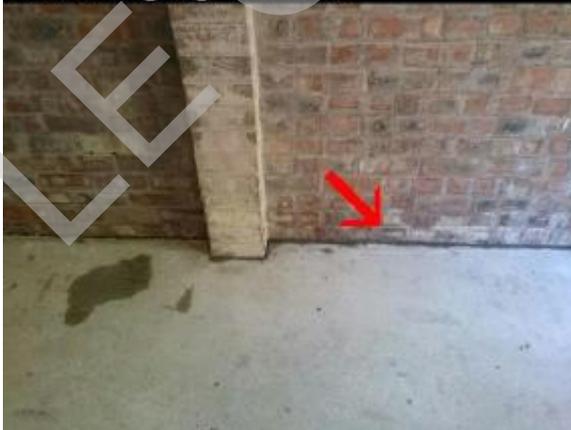
Moisture to garage wall south

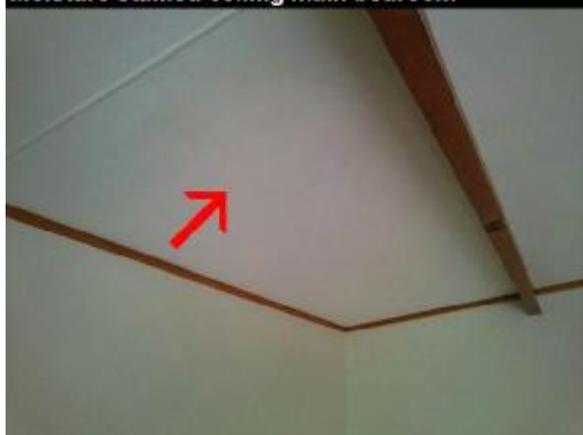
WATER STAINED CEILING LINING DUE TO ROOF LEAKS

Moisture stained ceiling main bedroom

Should be further assessed to determine if there are any current issues with leaks. To be fixed in the near future.

Repair priority: Within one year

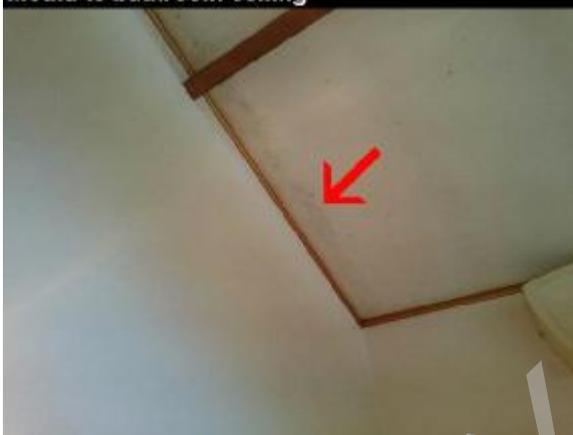
MODERATE MOULD TO CEILING

May be linked to a leak into the roof void area or due to a lack of ventilation during use of the shower. Poses a health risk. To be fixed in the near future.

Mould to bathroom ceiling

Repair priority: Within one year

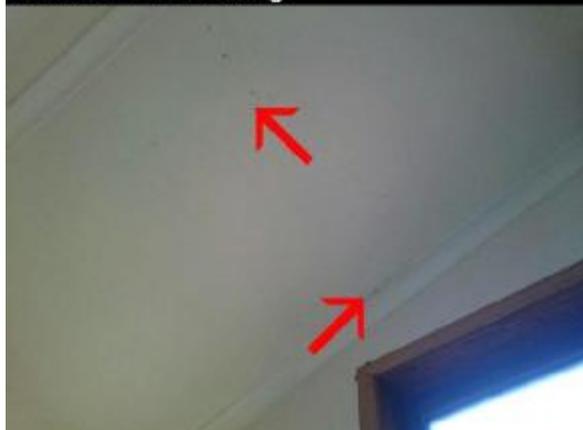
Mould to ensuite ceiling

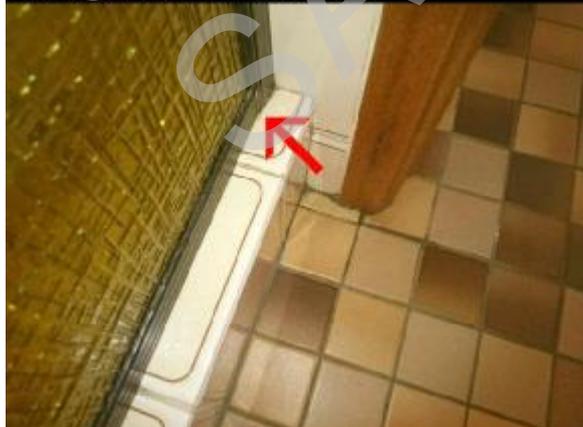
LEAKING SCREEN

Leaking screen main bathroom

Should be resealed to prevent deterioration of other elements. To be fixed in the near future.

Repair priority: Within one year

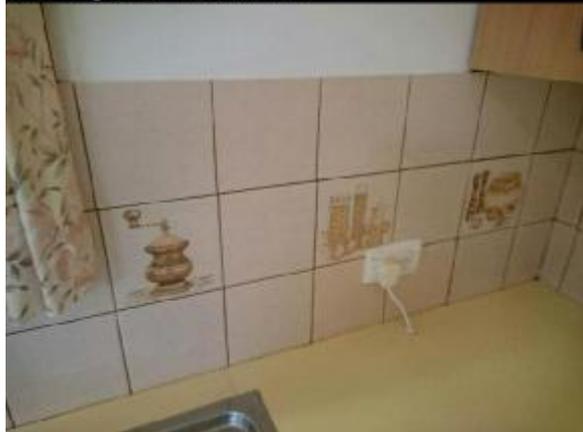
SIGNIFICANTLY DRUMMY TILES

Drummy wall tiles kitchen

Should be replaced to prevent further deterioration and/or loss of utility. To be fixed in the near future.

Repair priority: Within one year

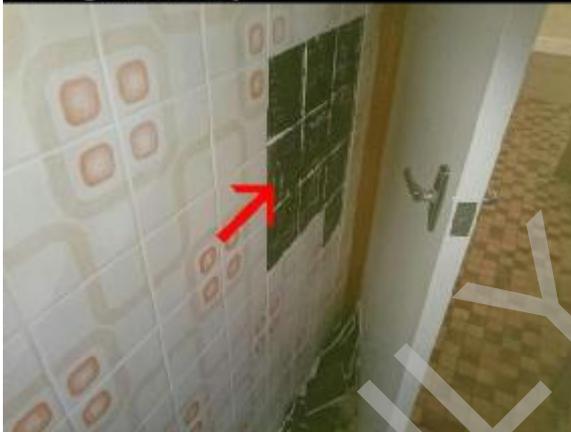
MISSING AND DETACHED TILES

Missing tiles laundry

Should be replaced. To be fixed in the near future.

Repair priority: Within one year
Location: The item identified is located in Laundry one
Further inspection or advice required from specialist: No

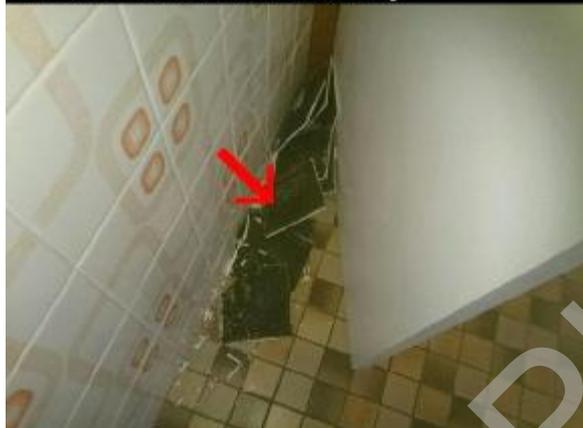
Detached and broken tiles laundry

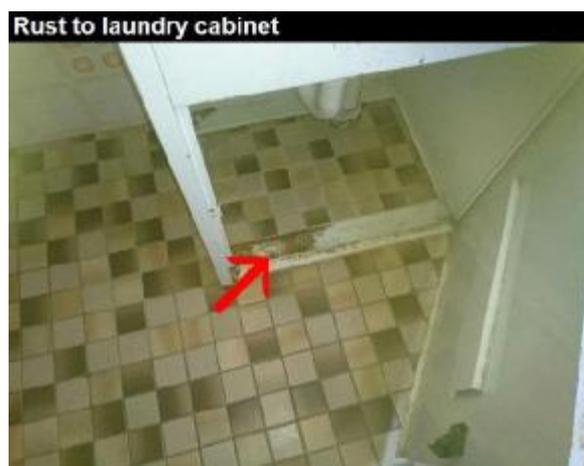
MINOR RUST TO CABINET

Should be treated to help prevent any further deterioration. Repairs can be carried out during routine maintenance.

Repair priority: During routine maintenance

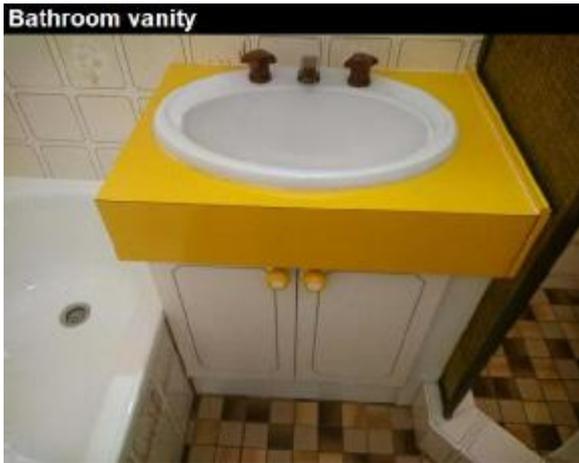
MINOR WATER DAMAGE TO CUPBOARDS

Should be repaired. Repairs can be carried out during routine maintenance.

Repair priority: During routine maintenance

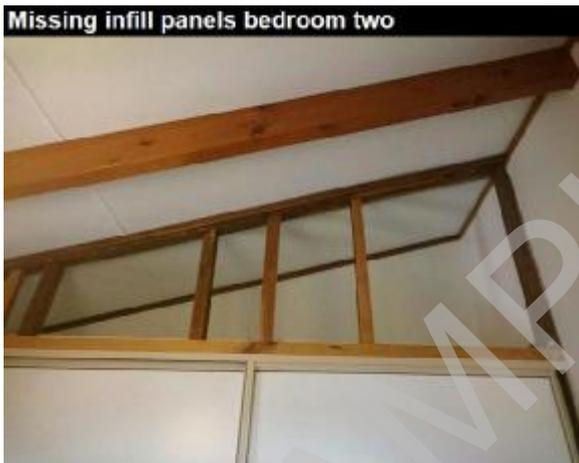
MISSING INFILL PANELS

Should be repaired or replaced. Repairs can be carried out during routine maintenance.

Repair priority: During routine maintenance

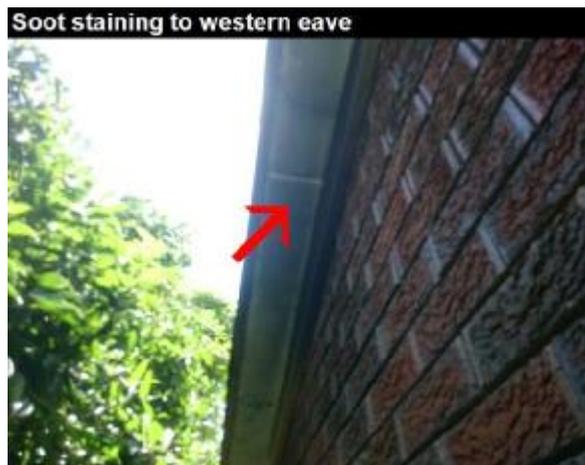
NOTABLE SOOT STAINING TO EAVE

Notes: The soot is located above the flue for the gas heater.

Soot staining to western eave

Assessment by qualified technician is recommended. Repairs can be carried out during routine maintenance.

Repair priority: Low

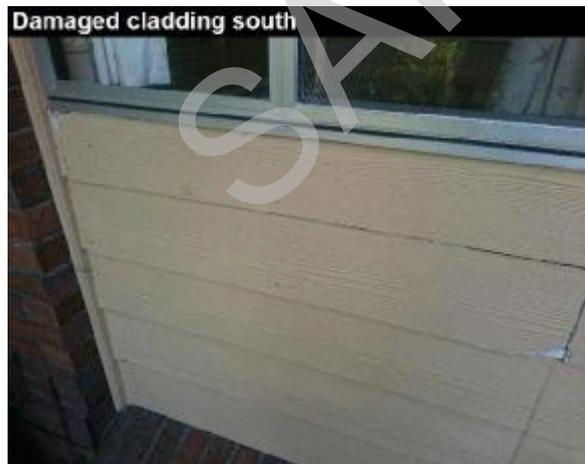
MODERATELY DAMAGED CLADDING

Damaged cladding south

Should be repaired or replaced to prevent deterioration of other elements and/or loss of utility. To be fixed in the near future.

Repair priority: Within one year

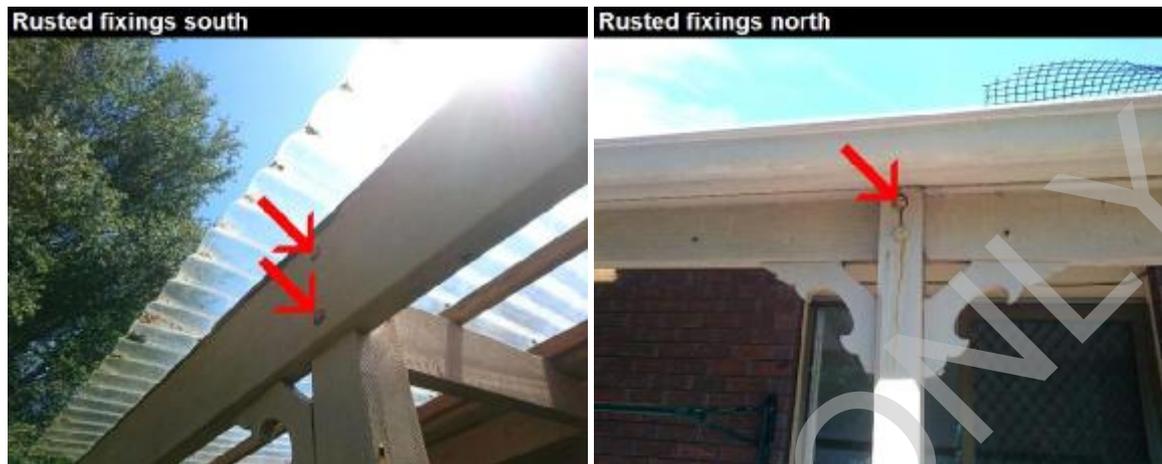
MINOR RUSTED METAL FIXINGS

Should be treated to help prevent further deterioration and/or loss of utility. To be fixed in the near future.

Repair priority: Within one year

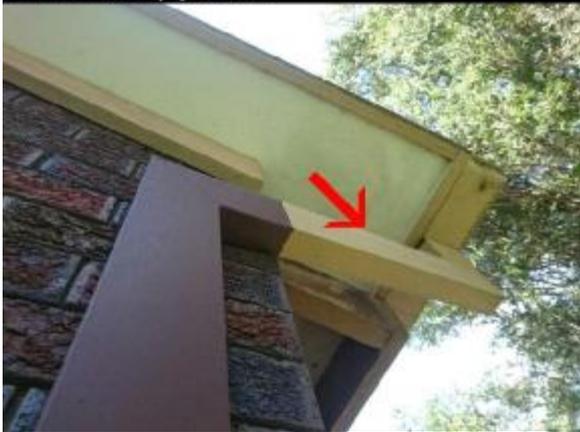
MODERATELY RUSTED METAL

Rusted downpipe west

Should be treated to help prevent further deterioration and/or loss of utility. To be fixed in the near future.

Repair priority: Within one year

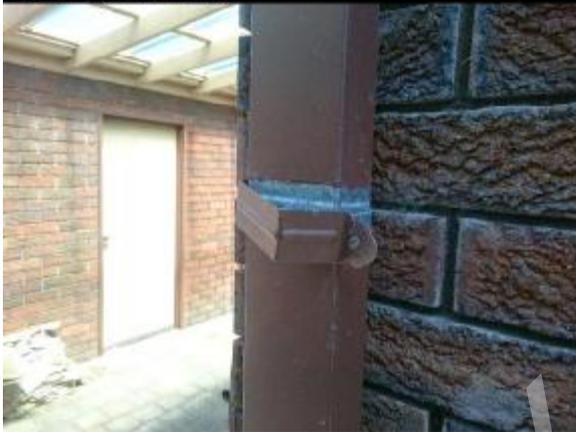
LOOSE BRACKETS

Loose bracket east

Should be secured to ensure the downpipe is held in place correctly. Repairs can be carried out during routine maintenance.

Repair priority: During routine maintenance

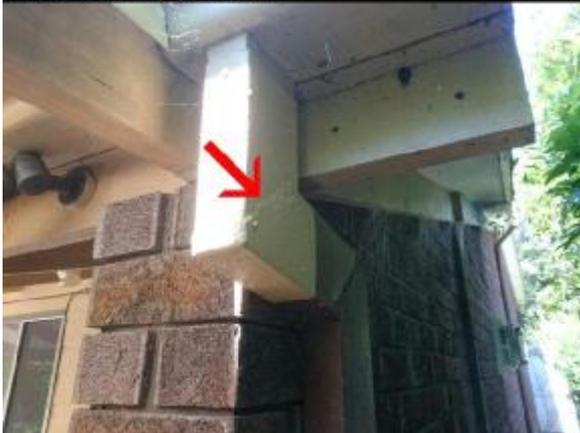
Rusted downpipe west

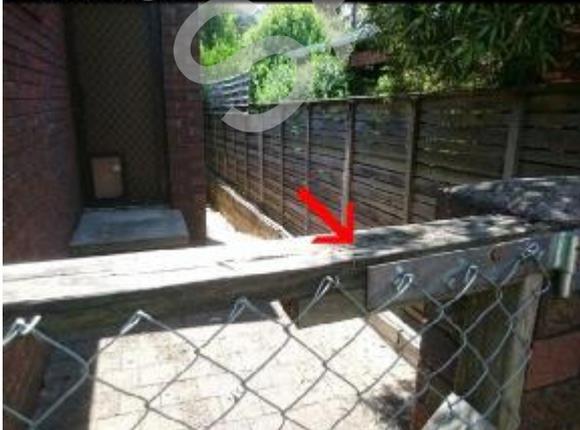
MODERATE WOODROT TO GATE

Woodrot to gate east

Should be repaired or replaced to prevent further deterioration and/or loss of utility. To be fixed in the near future.

Repair priority: Within one year

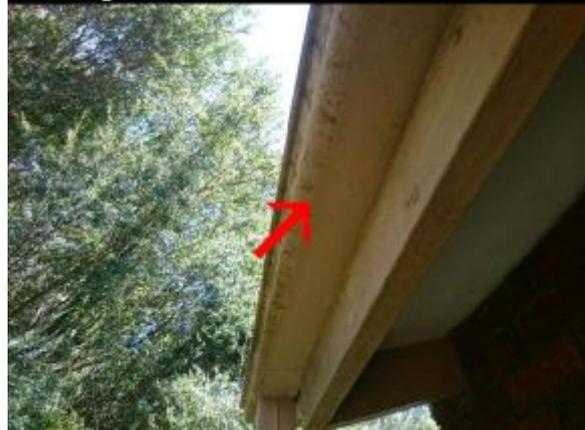
MODERATELY RUSTED GUTTER

Rusted gutter south

Should be repaired or replaced to prevent further deterioration and/or loss of utility. To be fixed in the near future.

Repair priority: Within one year

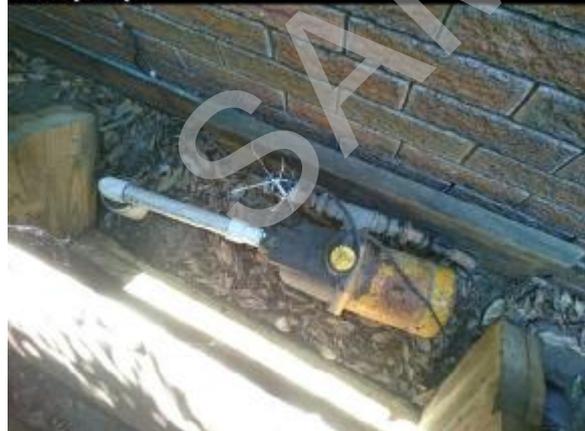
The pump was switched on and was found to be operating; however it is unknown whether or not water is being drawn to the surface and if so where it is connected to. It is recommended a suitably experienced plumber is engaged to assess the operation of the bore.

Bore pump

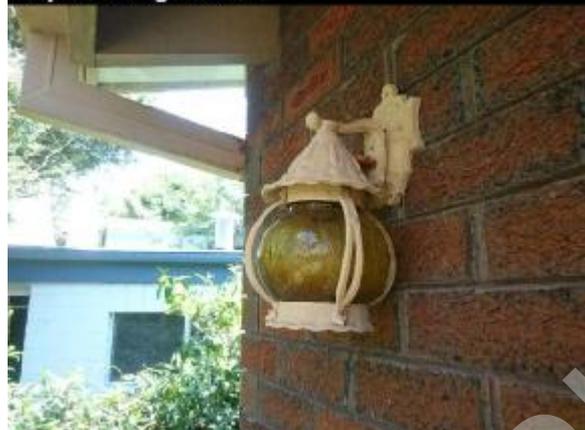
LIGHT IS NOT OPERATING

Inoperable light south

Replace the globe and retest operation of light.

Repair priority: Within one year

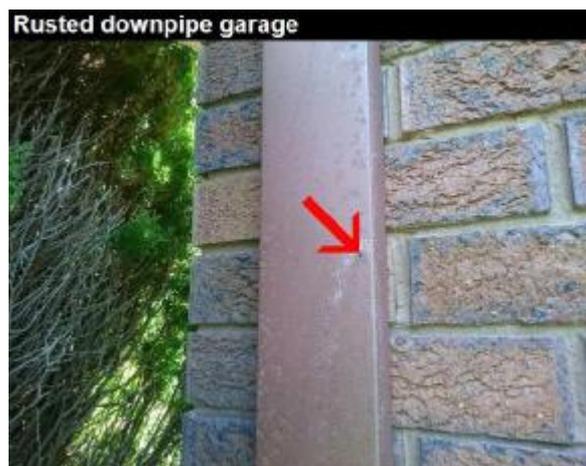
SIGNIFICANTLY RUSTED METAL

Must be replaced to help prevent loss of utility. Must be replaced without delay.

Repair priority: Immediate

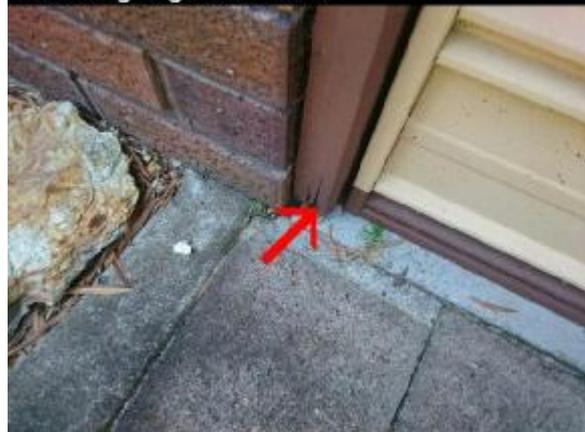
Woodrot garage door frame

Should be repaired to prevent deterioration of other elements and/or loss of utility. To be fixed in the near future.

Repair priority: Within one year

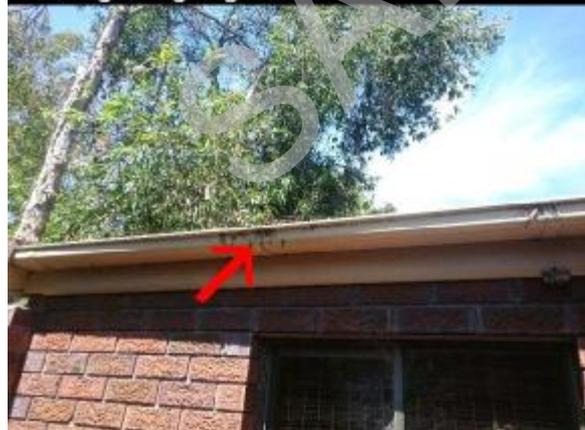
BOWED GUTTER

Bowed gutter garage north

Should be repaired or replaced since gutter is likely to hold water. Necessary to ensure water is tracking towards the downpipes and prevent deterioration of other elements and/or loss of utility. To be fixed in the near future.

Repair priority: Within one year

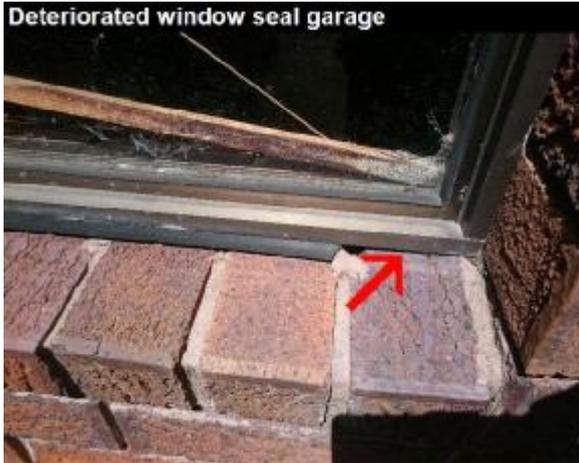
DETERIORATED WINDOW SEALS

Should replace seals or sealing. To be fixed in the near future.

Repair priority: Within one year

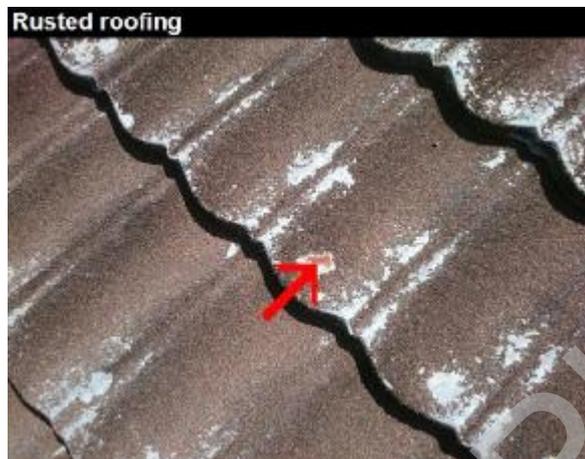
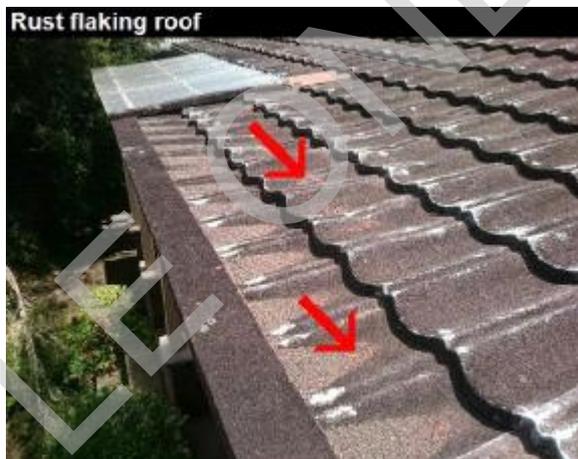
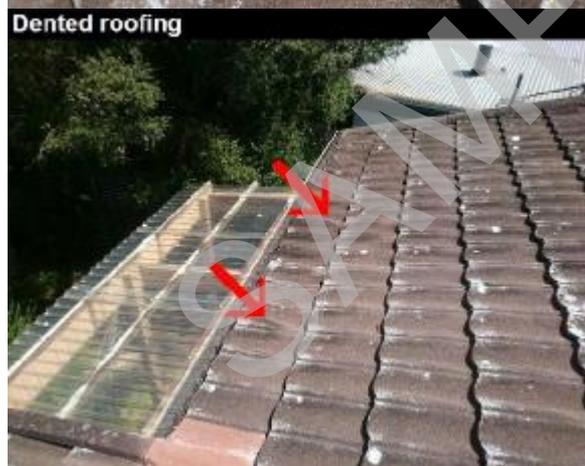
MODERATELY RUSTED ROOF SHEETING

Should be repaired or replaced to prevent further deterioration and/or loss of utility. To be fixed in the near future.

Repair priority: Within one year

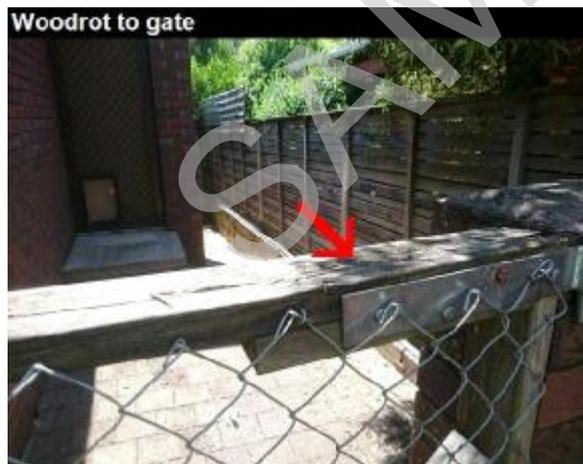
Visible timber damage appears moderate. Please refer to the definitions section of this report on Timber Damage.

Lyctus borer damage

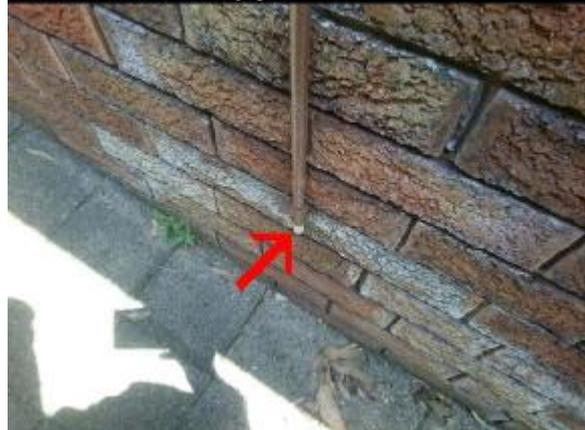
The hot water system overflow is discharging moisture adjacent to the structure. We recommend the overflow be situated over a drain; Logs to garden should be removed;

Hot water overflow pipe

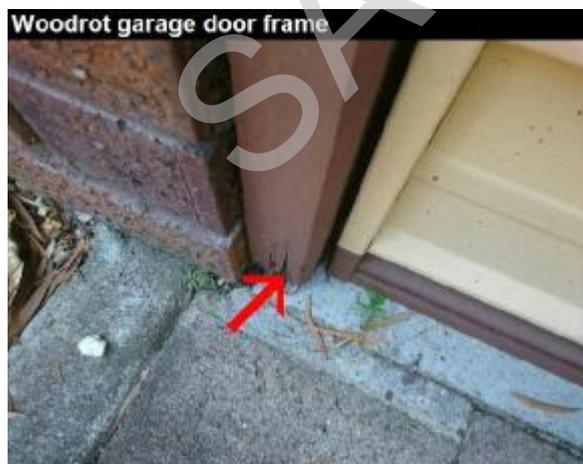
Visible timber damage appears minor. Please refer to the definitions section of this report on Timber Damage.

Lyctus borer damage
