## Timber Pest Report

4 Smith Street  
Smithtown NSW/ACT

## VISUAL TIMBER PEST INSPECTION & REPORT IN ACCORDANCE WITH AS4349.3-2010

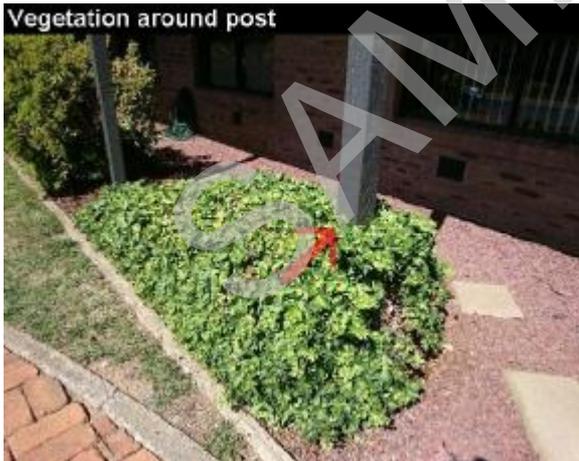
Inspection to sections of the exterior was restricted due to the growth of foliage. Inspection was limited in the following locations and or areas: Eastern elevation.

Vegetation around post

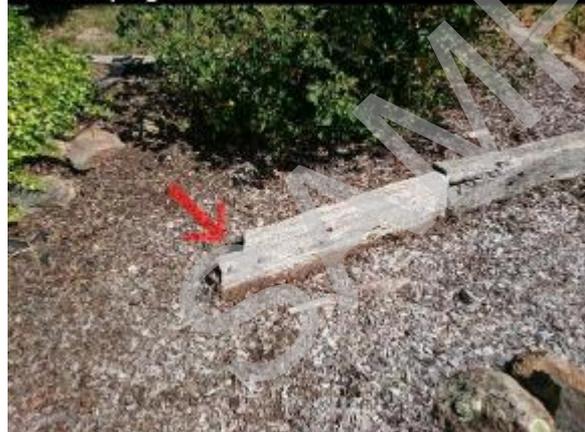
Landscaping timbers

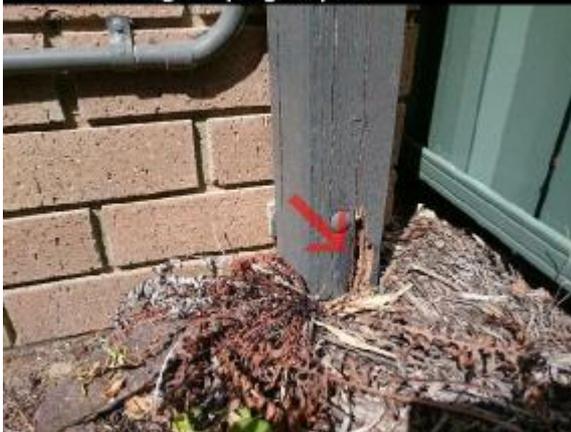
Termite damage to pergola post

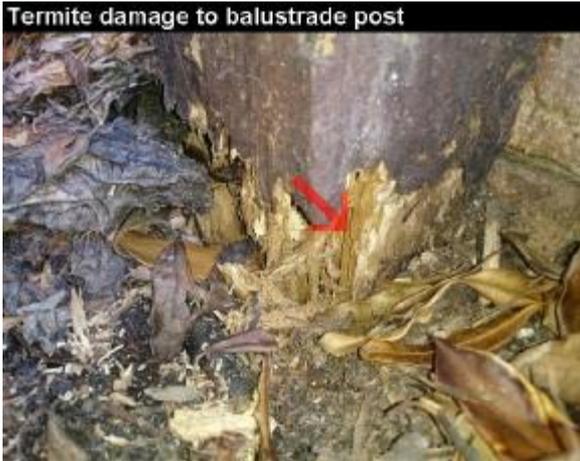
Balcony timbers: Pergola timbers: Sleepers or timber landscaping materials:

Northern elevation. Eastern elevation. Western elevation.

Visible timber damage appears moderate. Please refer to the definitions section of this report on Timber Damage.

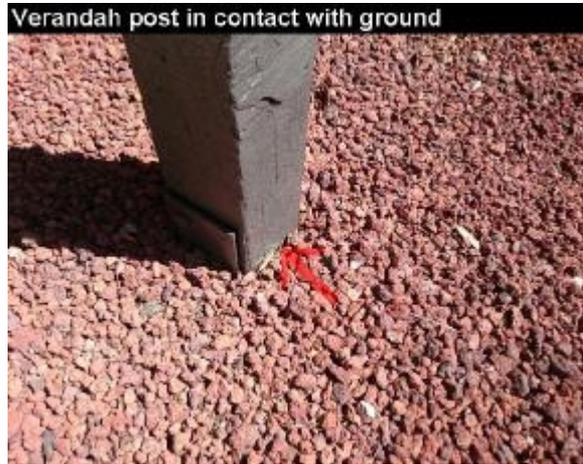
Some external timbers are in contact with soil. These should be modified so that timber to soil contact does not occur; Influence of nearby areas: Trees; Tree stumps;
