1.0	Instructing party	(Sample Report)
2.0	Client reference	(Sample Report)
3.0	Our reference	(Sample Report)
4.0	Instructions	We have been instructed to inspect the existing works at which include construction to concrete slab level and partly constructed wall framing. We have been asked to provide a report detailing any concerns that may exist at this stage of construction in particular in relation to issues with the set out and dimensions of the slab. Concerns have also been raised in relation to the location of a plumbing waste pipe for the vanity to the main bathroom.

5.0	Purpose of report	The purpose of this report is to advise the client of any issues with the construction to date and advise of any discrepancies with the approved plans.

13.0 Subject building

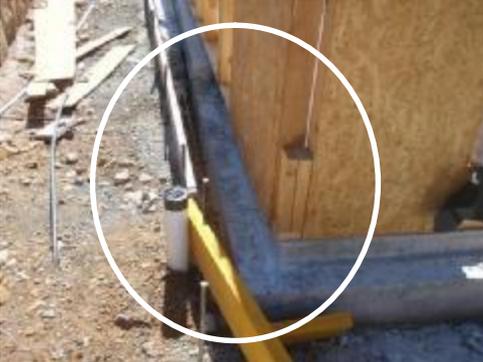
Misaligned Slab to Northwest Corner

1. The concrete floor slab has been constructed out of alignment at the northwest (front left) corner of the dwelling.

There is formwork and steel in place to add to this slab. It is recommended a Structural Engineer be engaged to assess this work prior to pouring the concrete. It is important to ensure there is adequate support being provided for the brickwork and that the new concrete is correctly tied to the existing floor slab.

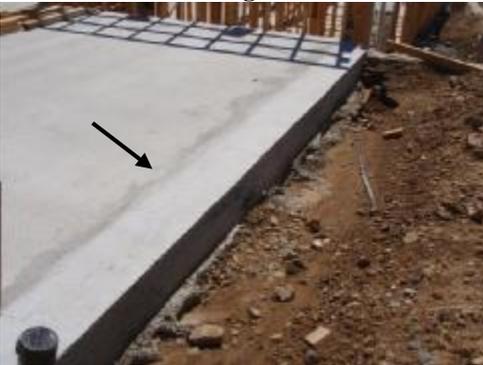
In filled Slab to Garage Area

2. The concrete slab for the garage at the southern side has been patched as it appears a rebate was mistakenly created as opposed to a level slab for installation of a single skin brick wall.

There is potential for cracking where the new concrete infill to the rebate adjoins the original floor slab. It is recommended that a control joint be created at this joint to allow for any movement that may occur. It is recommended a Structural Engineer be engaged to assess this work. It is important to ensure there is adequate support being provided for the brickwork and that the new concrete is correctly tied to the existing floor slab.

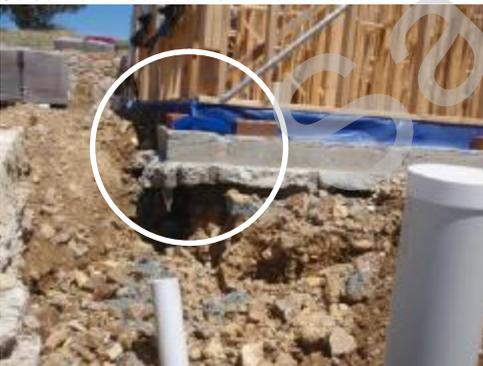
Subsided Foundation Material

3. There has been subsidence of the foundation material beneath the concrete slab to the southeast corner of the dwelling.

This subsidence has the potential to result in settlement of the concrete floor slab in this area. It is recommended advice be sought from a Structural Engineer on the correct method of providing permanent support for this corner of the slab.

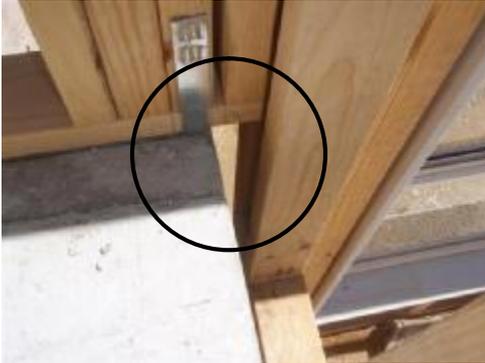
Ensuite Floor & Wall Frame to East

1. The ensuite and walk in robe areas are likely to be undersize as the eastern walls will require battening to bring the alignment of the wall lining beyond the floor slab edge at the step down to the lower level.

I am concerned a batten may be installed to the edge of the slab to maintain the room dimensions in these rooms. This would result in a small section of the floor tiles being laid on timber rather than entirely on concrete. This in turn can result in differential movement where the concrete and timber meets and may ultimately result in cracking to the tiles in this area in the future. It is important to ensure that this area is constructed in a manner that ensures there is no movement in the floor tiles.

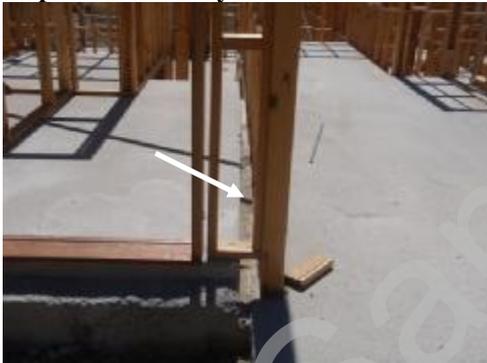
Step Down at Entry

3. The step down in the floor slab to the entry and hall area is incorrectly positioned and will require repairs.

This area will need to be infilled with concrete.

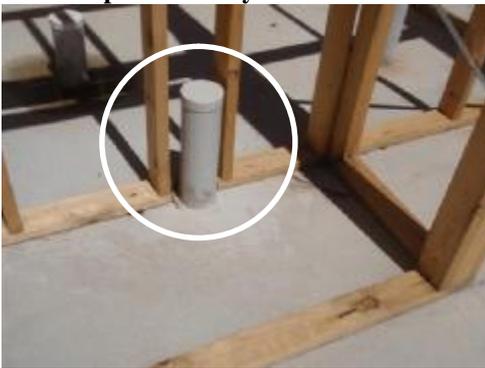
Waste Pipe for Vanity

6. The waste pipe for the bathroom vanity is partly protruding into the wardrobe area for bedroom 4.

The existing waste pipe should be able to be cut off at the floor slab level and still allow access to the pipe within the wall frame to connect the vanity waste pipe. This will need to be checked with the plumber.
