Dilapidation Report XYZ Project

1 Smith Street
Smithtown NSW

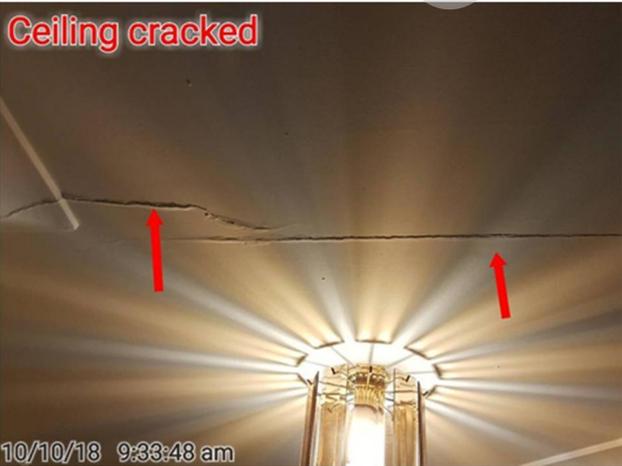
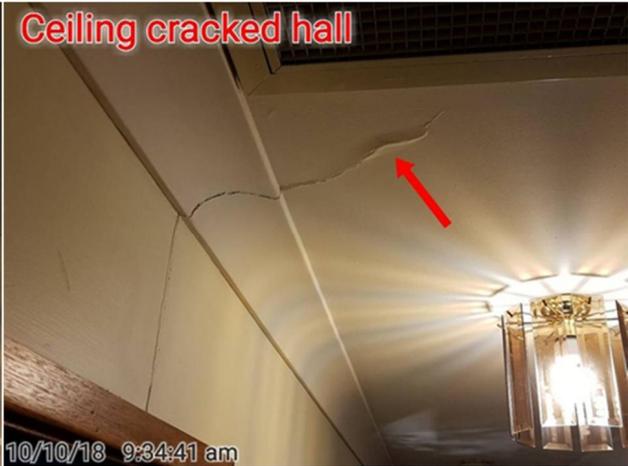
Defects	
Defect 1	
Defect description:	Ceiling - cracked
Additional notes:	Nil
Defect location:	Multiple locations throughout
Defect image:

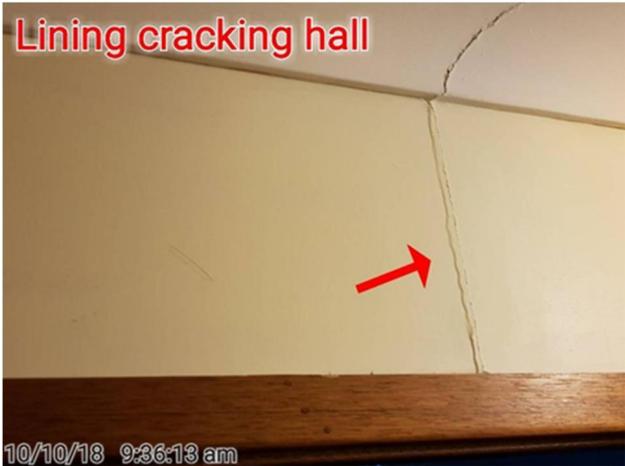
Defect 2	
Defect description:	Lining (Plasterboard) - cracking
Additional notes:	Nil
Defect location:	Eastern area of room - to central section
Defect image:

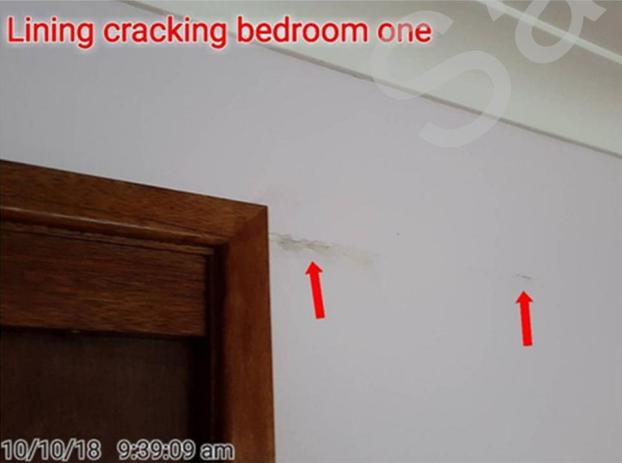
<p>Bedroom one</p> <p>10/10/18 9:37:08 am</p>	
Defects	
Defect 1	
Defect description:	Lining (Plasterboard) - cracking
Additional notes:	Nil
Defect location:	Western area of room - to central section
Defect image:

<p>Lining cracking bedroom one</p> <p>10/10/18 9:39:09 am</p>

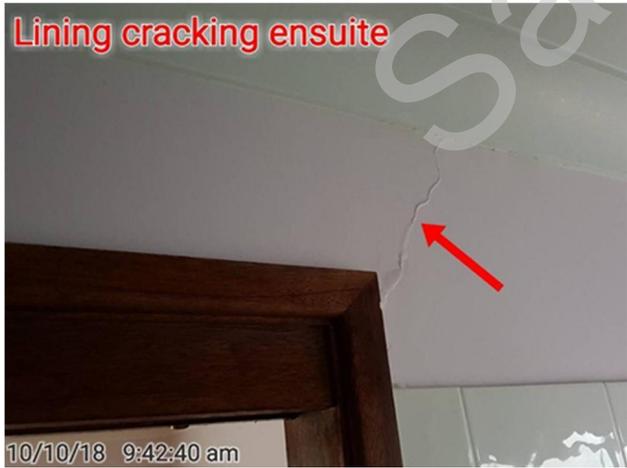
<p>Main ensuite</p> <p>10/10/18 9:40:19 am</p>	
Defects	
Defect 1	
Defect description:	Lining (Plasterboard) - cracking
Additional notes:	Nil
Defect location:	Eastern area of room - to central section
Defect image:

<p>Lining cracking ensuite</p> <p>10/10/18 9:42:40 am</p>

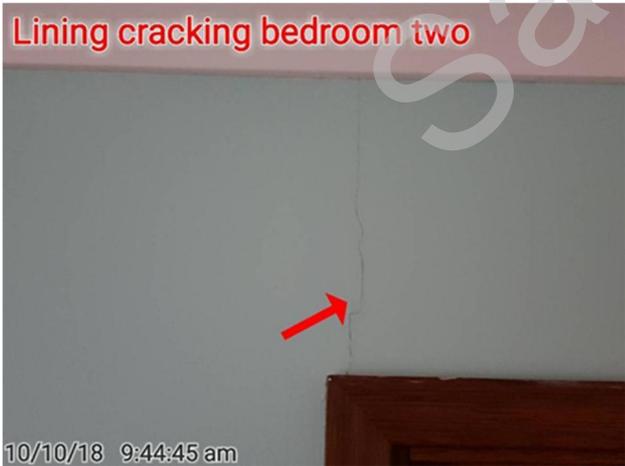
<p>Bedroom two</p> <p>10/10/18 9:43:22 am</p>	
Defects	
Defect 1	
Defect description:	Lining (Plasterboard) - cracking
Additional notes:	Nil
Defect location:	Western area of room - to central section
Defect image:

<p>Lining cracking bedroom two</p> <p>10/10/18 9:44:45 am</p>

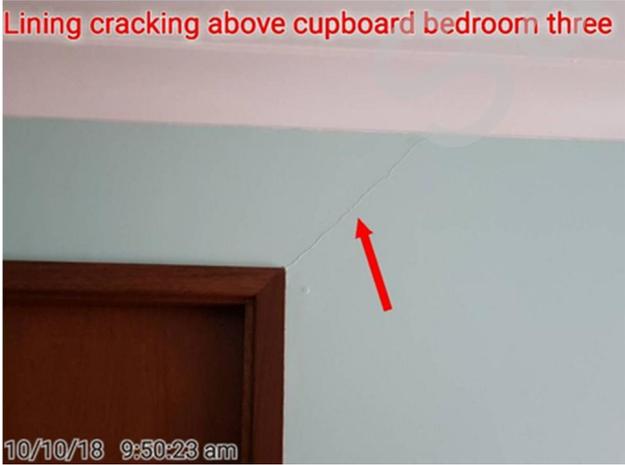
<p>Bedroom three</p> <p>10/10/18 9:48:31 am</p>	
Defects	
Defect 1	
Defect description:	Lining (Plasterboard) - cracking
Additional notes:	Nil
Defect location:	Multiple locations throughout
Defect image:

<p>Lining cracking above cupboard bedroom three</p> <p>10/10/18 9:50:23 am</p>

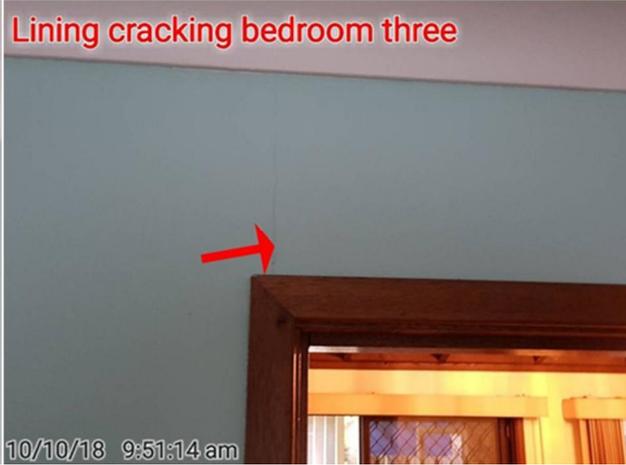
<p>Lining cracking bedroom three</p> <p>10/10/18 9:51:14 am</p>

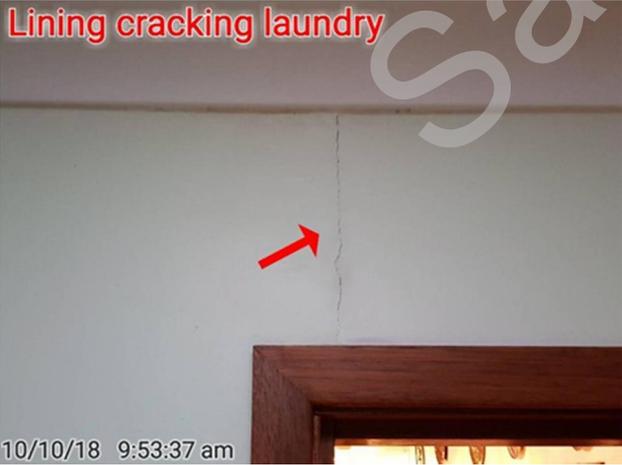
Defects	
Defect 1	
Defect description:	Lining (Plasterboard) - cracking
Additional notes:	Nil
Defect location:	Eastern area of room - to central section
Defect image:

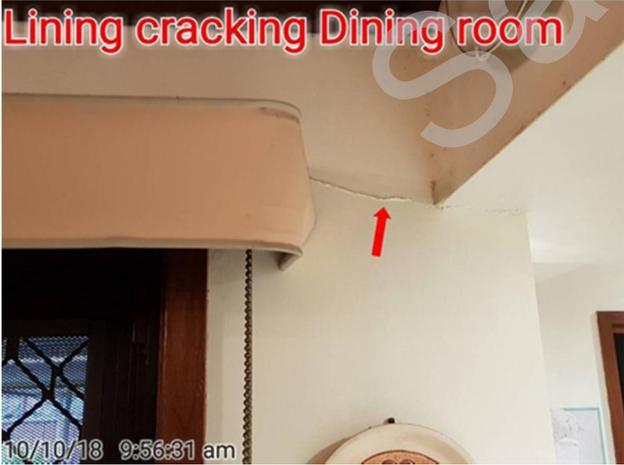
<p>Dining room</p> <p>10/10/18 9:54:50 am</p>	
Defects	
Defect 1	
Defect description:	Lining (Plasterboard) - cracking
Additional notes:	Nil
Defect location:	Multiple locations throughout
Defect image:

<p>Lining cracking Dining room</p> <p>10/10/18 9:56:31 am</p>

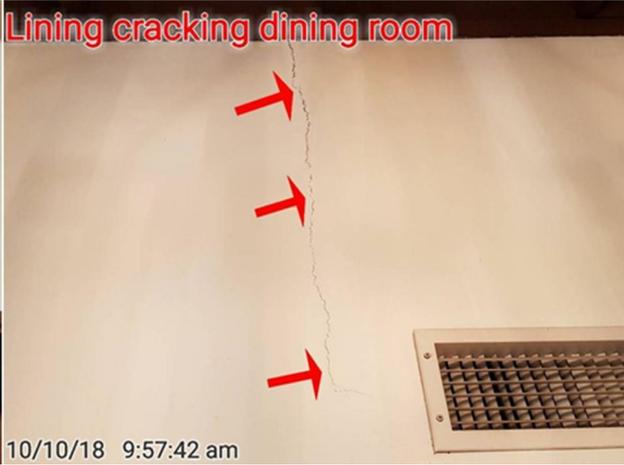
<p>Lining cracking dining room</p> <p>10/10/18 9:57:42 am</p>

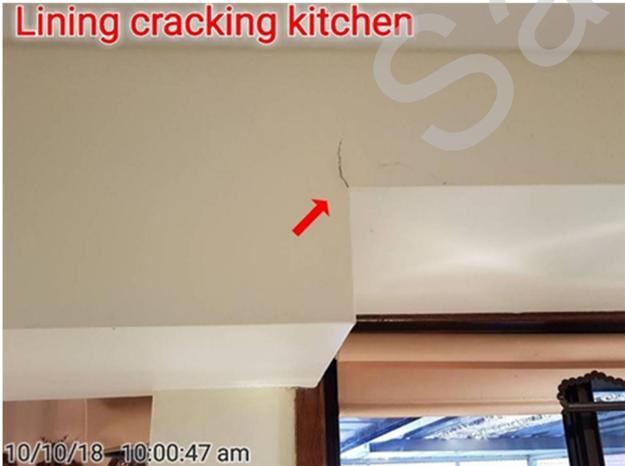
<p>Kitchen</p> <p>10/10/18 9:59:20 am</p>	
Defects	
Defect 1	
Defect description:	Lining (Plasterboard) - cracking
Additional notes:	Nil
Defect location:	Western area of room - to northern section
Defect image:

<p>Lining cracking kitchen</p> <p>10/10/18 10:00:47 am</p>

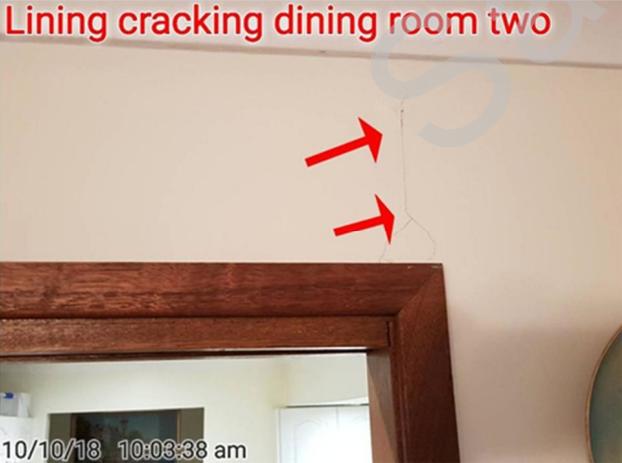
<p>Dining room two</p> <p>10/10/18 10:02:18 am</p>	
Defects	
Defect 1	
Defect description:	Lining (Plasterboard) - cracking
Additional notes:	Nil
Defect location:	Multiple locations throughout
Defect image:

<p>Lining cracking dining room two</p> <p>10/10/18 10:03:38 am</p>

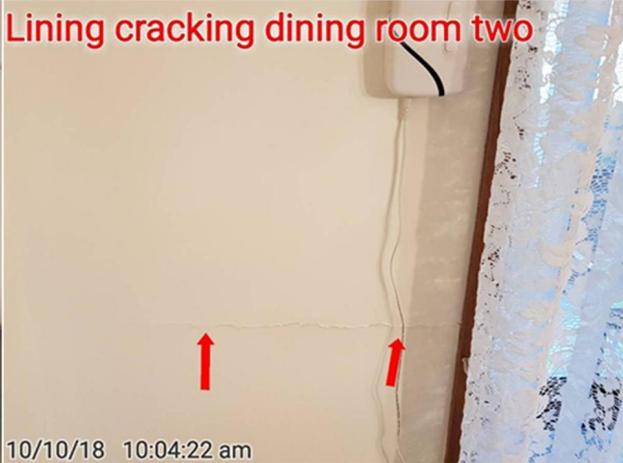
<p>Lining cracking dining room two</p> <p>10/10/18 10:04:22 am</p>

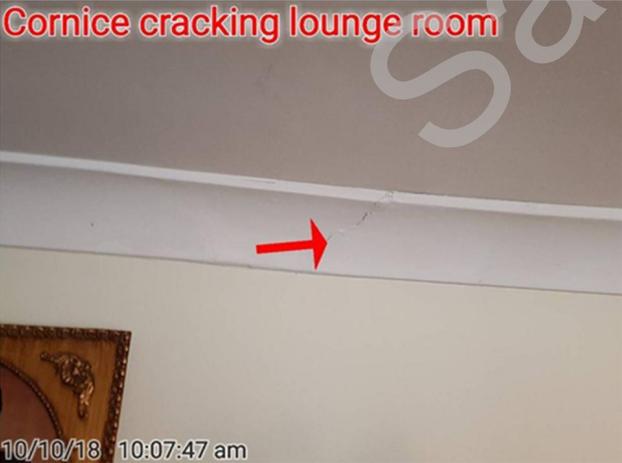
<p>Lounge room</p>	
Defects	
Defect 1	
Defect description:	Cornice - cracked
Additional notes:	Nil
Defect location:	Western area of room - to central section
Defect image:

<p>Cornice cracking lounge room</p>

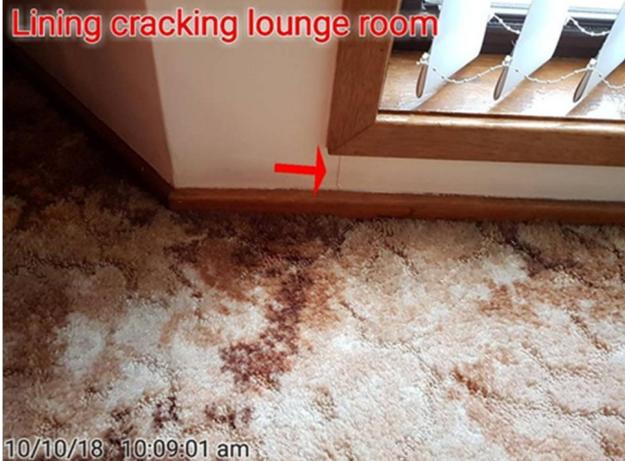
Defect 2	
Defect description:	Lining (Plasterboard) - cracking
Additional notes:	Nil
Defect location:	Eastern area of room - to northern section
Defect image:

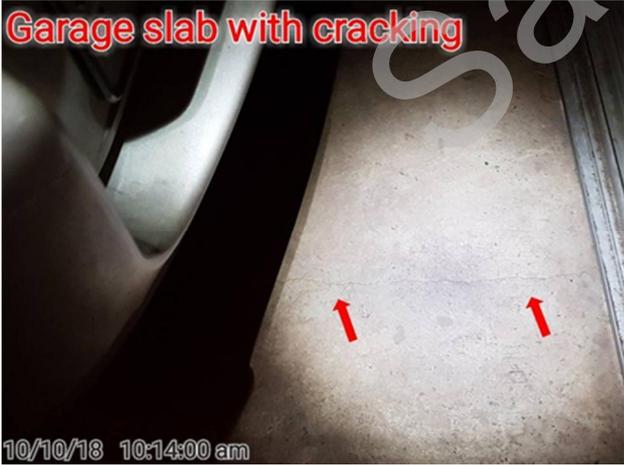
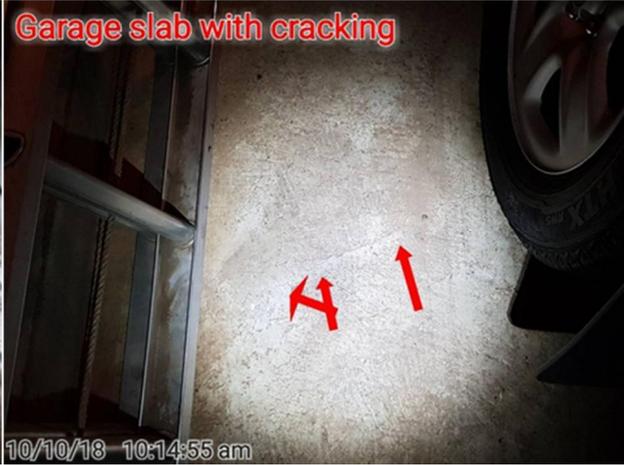
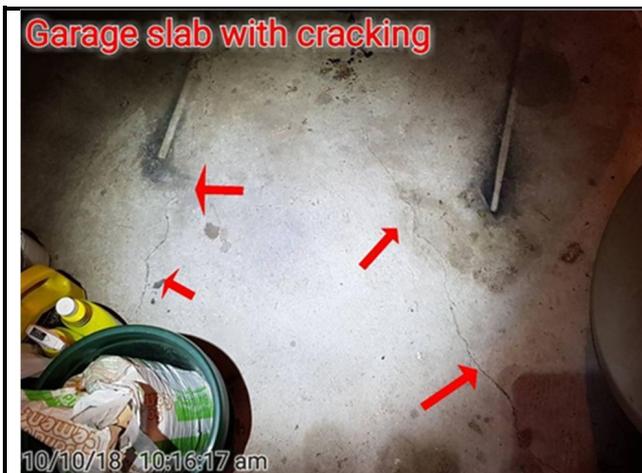
Defects	
Defect 1	
Defect description:	Floor (Concrete) - cracked
Additional notes:	Nil
Defect location:	Multiple locations throughout
Defect image:

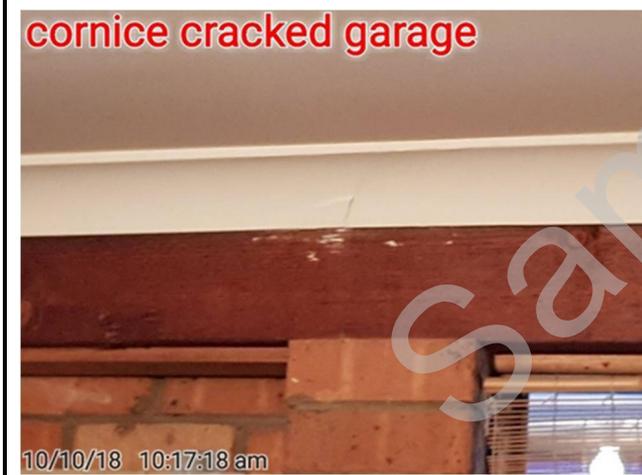
Defect 2

Defect description:	Cornice - cracked
Additional notes:	Nil
Defect location:	Northern area of room - to central section

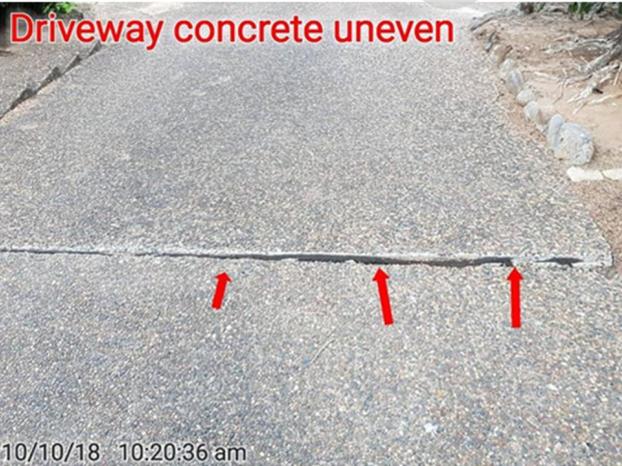
Defects	
Defect 1	
Defect description:	Driveway - uneven
Additional notes:	Nil
Defect location:	Northern area
Defect image:

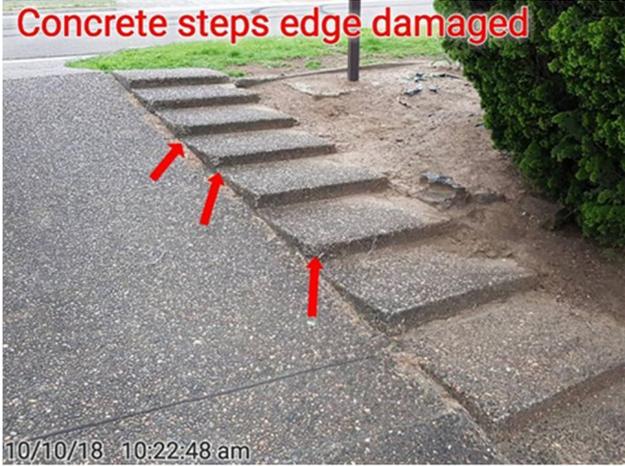
Defect 2	
Defect description:	Concrete steps - damaged
Additional notes:	Nil
Defect location:	Central area
Defect image:

<p>Concrete steps edge damaged</p> <p>10/10/18 10:22:48 am</p>	
Defect 3	
Defect description:	Driveway - cracking
Additional notes:	Nil
Defect location:	Northern area
Defect image:

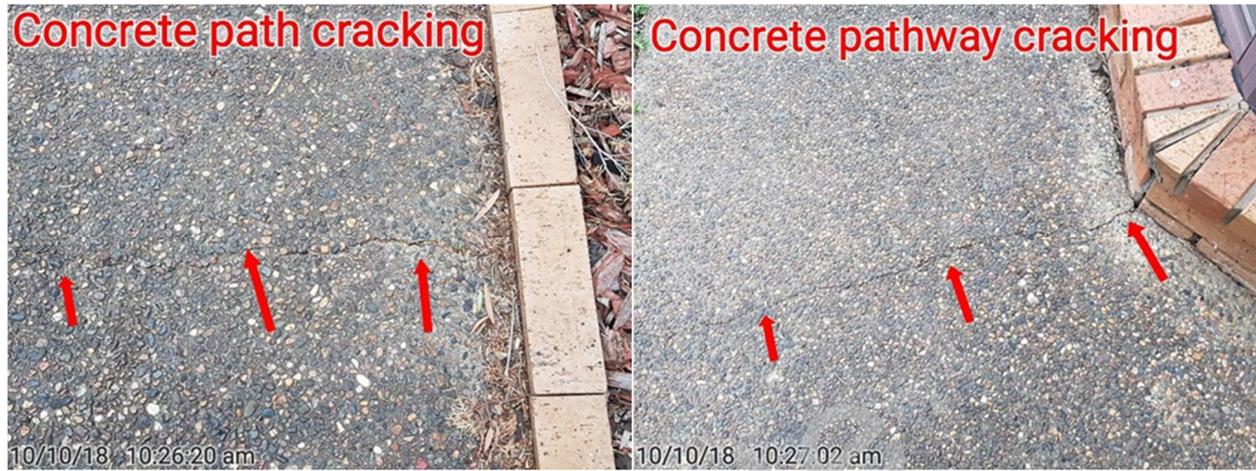
Defect 4	
Defect description:	Paths - cracked
Additional notes:	Nil
Defect location:	Multiple locations

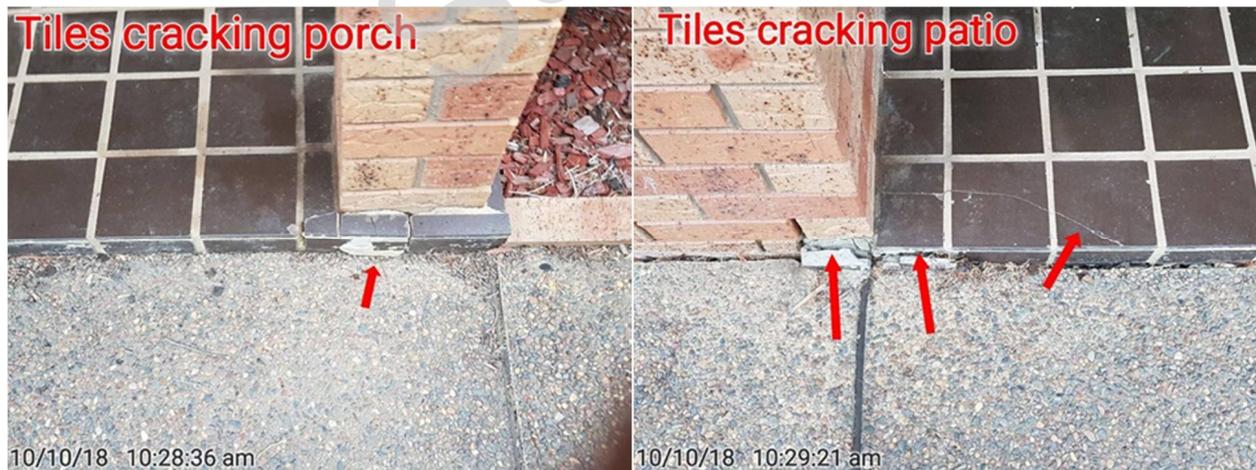
Defect 5	
Defect description:	Tiles - cracked
Additional notes:	Nil
Defect location:	Central area

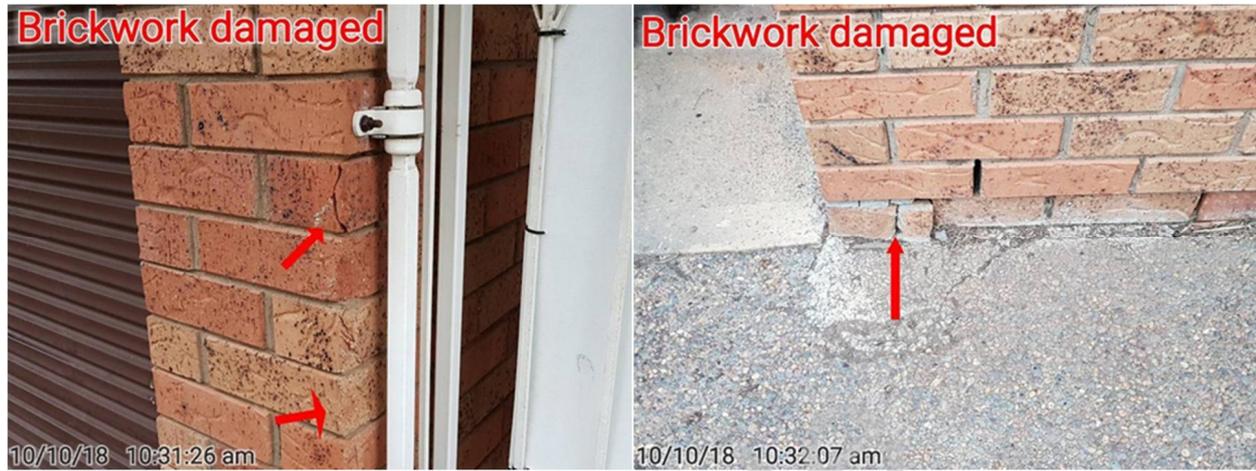
Defect 6	
Defect description:	Brickwork - damaged
Additional notes:	Nil
Defect location:	Multiple locations

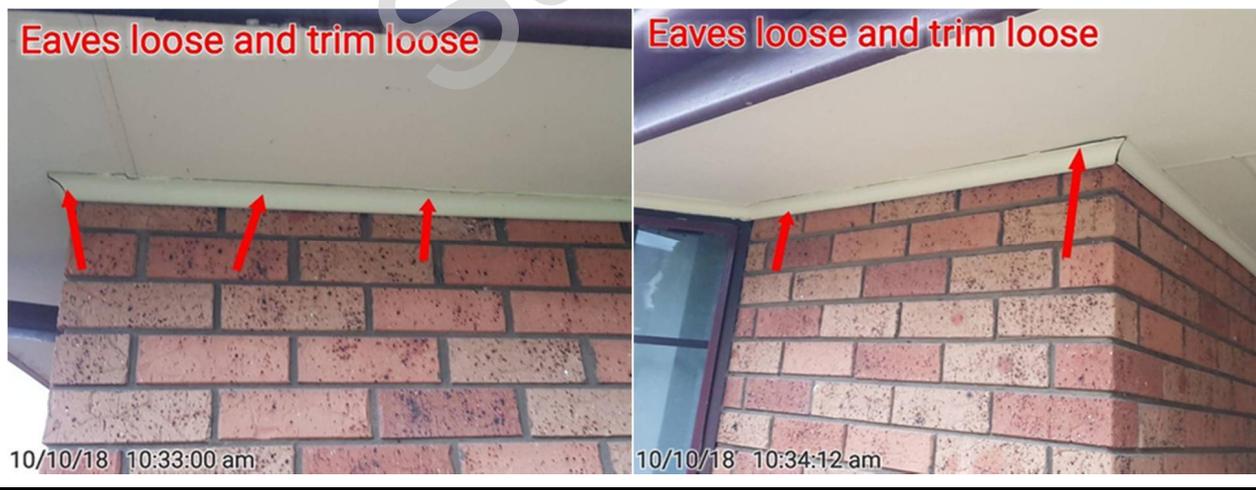
Defect 7	
Defect description:	Eaves - loose trim
Additional notes:	Nil
Defect location:	Multiple locations

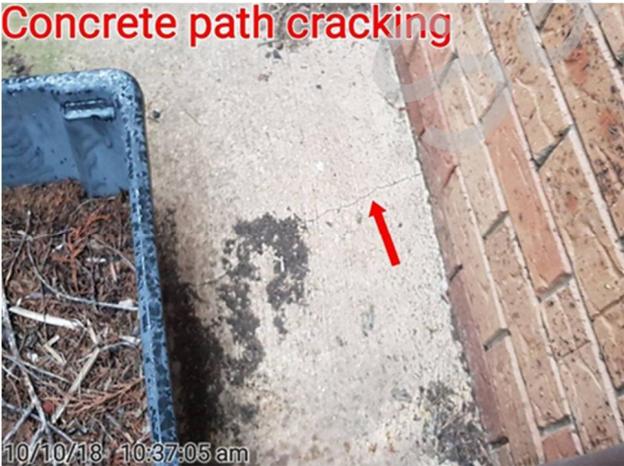
Defects	
Defect 1	
Defect description:	Paths - cracked
Additional notes:	Nil
Defect location:	Multiple locations
Defect image: Concrete path cracking

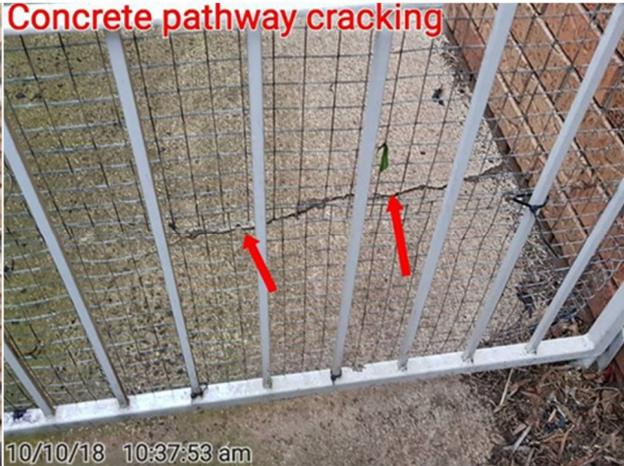
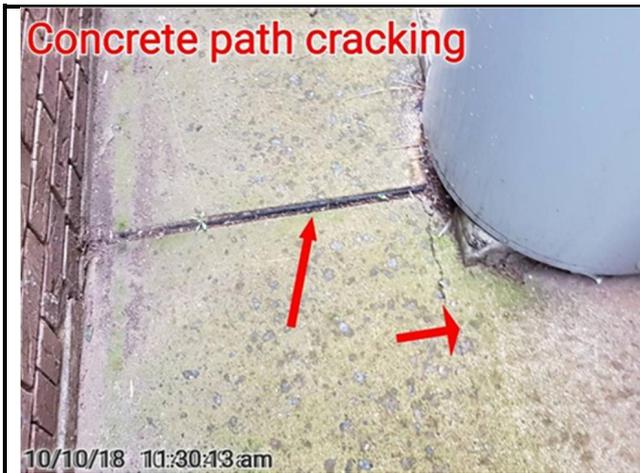
Concrete pathway cracking

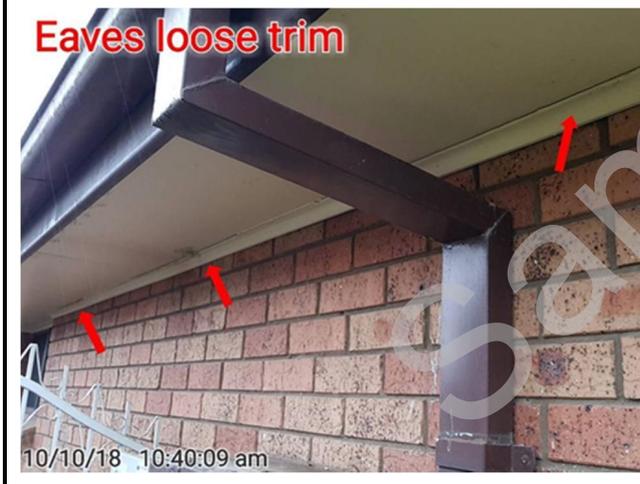
Defect 2

Defect description:	Eaves - loose trim
Additional notes:	Nil
Defect location:	Eastern area

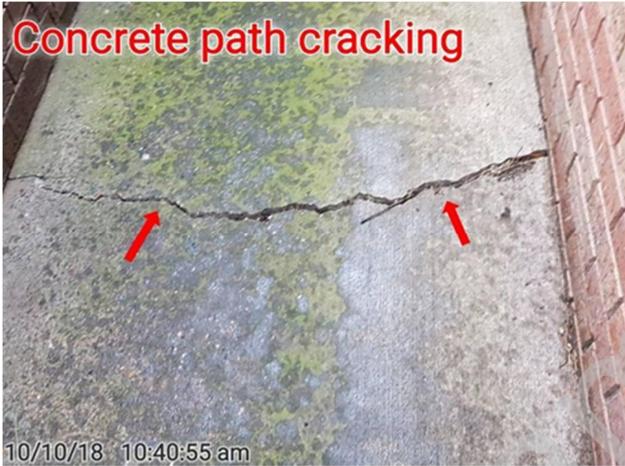
Elevation/Area 3	
Elevation Description:	Western elevation
Image: No image obtained for this elevation.	
Defects	
Defect 1	
Defect description:	Paths - cracked
Additional notes:	Nil
Defect location:	Central area
Defect image:

<p>Concrete path cracking</p> <p>10/10/18 10:40:55 am</p>

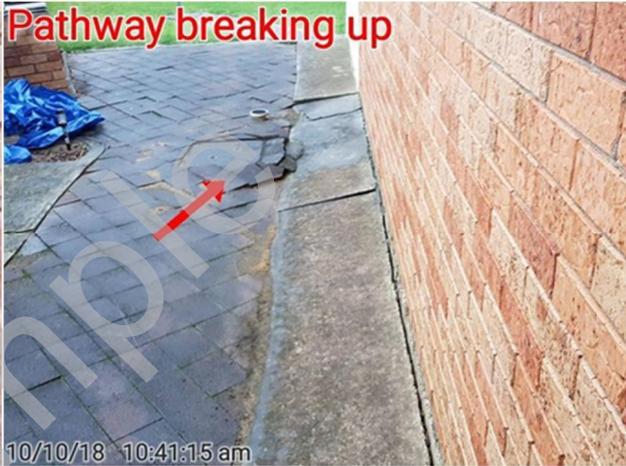
<p>Pathway breaking up</p> <p>10/10/18 10:41:15 am</p>

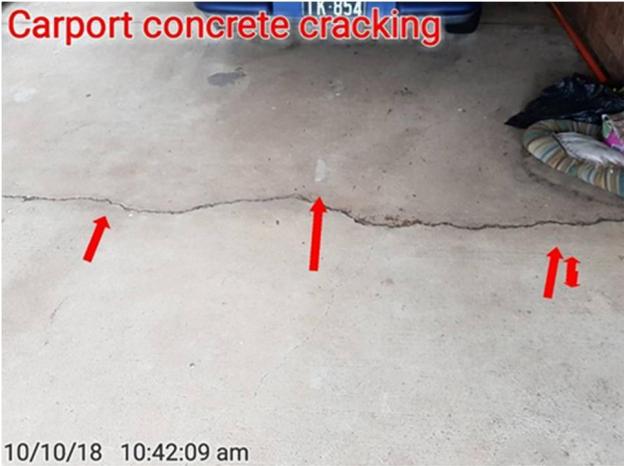
Elevation/Area 4	
Elevation Description:	Northern elevation
Image: No image obtained for this elevation.	
Defects	
Defect 1	
Defect description:	Driveway - cracking
Additional notes:	Nil
Defect location:	Central area, Multiple locations
Defect image:

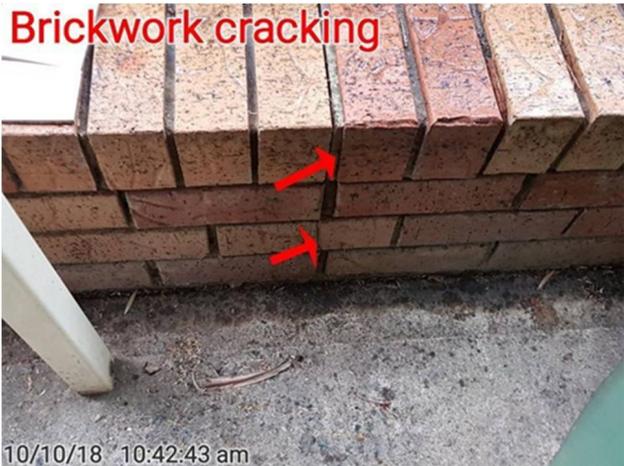
Defect 2	
Defect description:	Brickwork - cracked
Additional notes:	Nil
Defect location:	Central area
Defect image:
