## Footing & Slab Report

SAMPLE

Report Details	
Job Address:	SAMPLE
Clients Email Address:	<a href="#">SAMPLE</a>
Clients Name:	SAMPLE
Clients Phone Number:	SAMPLE
Conducted on:	22 Apr 2022 14:00 AEST
Assessor Name:	Grant Johnston
Assessor's Contact Number:	SAMPLE
Assessor's Accreditation:	Grant Johnston: I am a Licensed Builder and a Trade Qualified Carpenter. I have been involved in the construction and inspection of both commercial and residential buildings, which have included construction such as that existing at the above address.
Our Job Number:	5991
Builders details:	
Builders name:	SAMPLE
Builders supervisor name:	SAMPLE
Contact number:	SAMPLE
Builders email address:	<a href="#">SAMPLE</a>

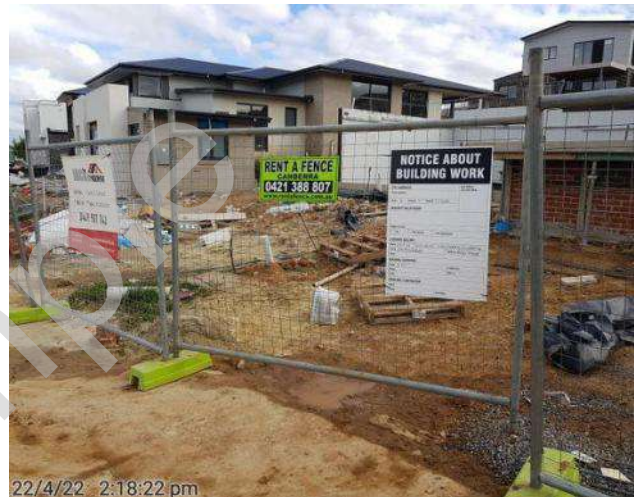
Photo 4

Inadequate

Site fencing has large gaps which would easily allow unauthorized entry to the property.

Various areas

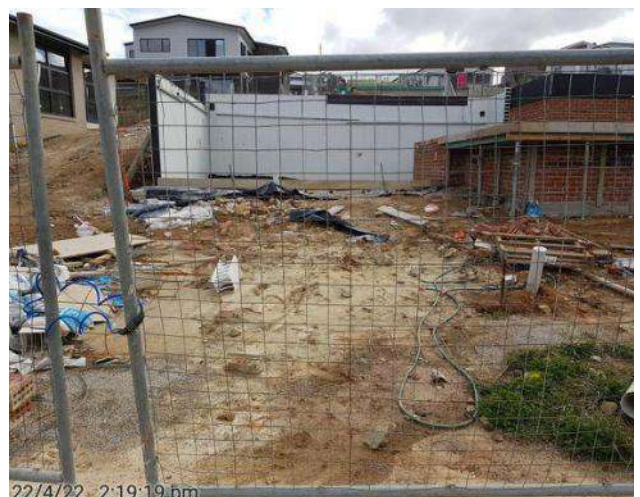
Photo 6

Inadequate

No sediment control has been installed to the property.

Front section

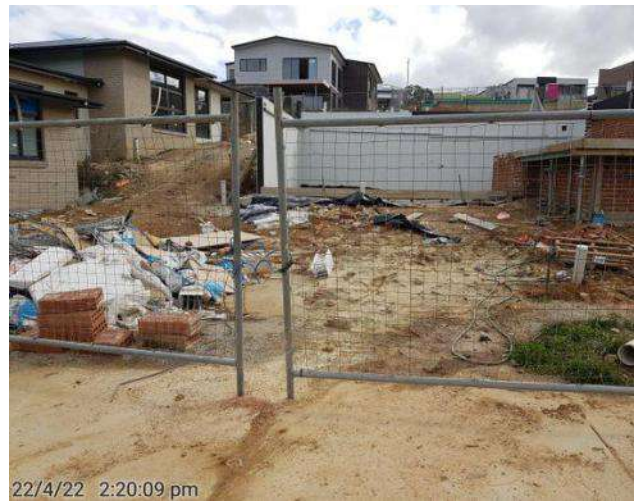
Photo 8

Inadequate

Unable to find relevant site pegs required for the construction of the dwelling.

Various areas

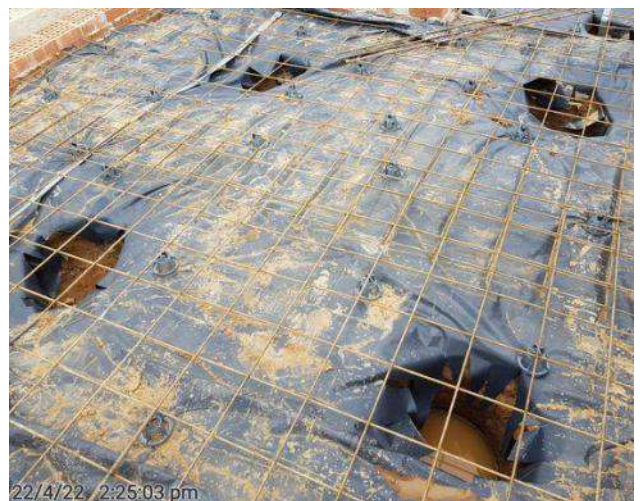
Photo 12

No

Loose soil and debris is in the pier footings and needs to be removed. As per the NCC 2019 National Construction Code of Australia - Volume Two. PART 3.2.2 FOOTINGS AND SLABS PREPARATION. 3.2.2.1 Excavation for footings. (c) Footing excavations must be free of loose earth, tree roots, mud or debris immediately before pouring concrete.

Pier/s have water in the base which needs to be removed before pouring. As per the NCC 2019 National Construction Code of Australia - Volume Two. PART 3.2.2 FOOTINGS AND SLABS PREPARATION. 3.2.2.1 Excavation for footings. (c) Footing excavations must be free of loose earth, tree roots, mud or debris immediately before pouring concrete.

Eastern area of slab - to central section

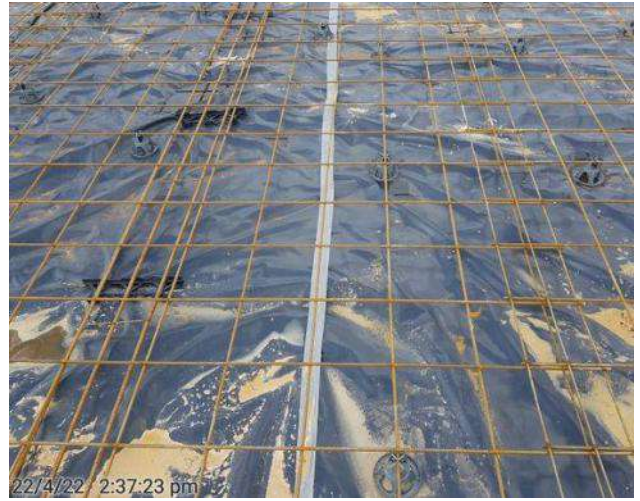
Photo 20

No

ACT. The vapour barrier does not extend to the outer edges of the slab area. As per the NCC 2019 National Construction Code of Australia - Volume Two - 3.2.2.6 Vapour barriers - A vapour barrier must be installed under slab-on-ground construction for all Class 1 buildings and for Class 10 buildings where the slab is continuous with the slab of a Class 1 building as follows— (c) The vapour barrier must be placed beneath the slab so that the bottom surface of the slab is entirely underlaid and extends under edge beams to finish at ground level.

Multiple locations throughout

Builder informed me that the certifier has failed him for this as well. Requested photos of the vapour barrier installed correctly.

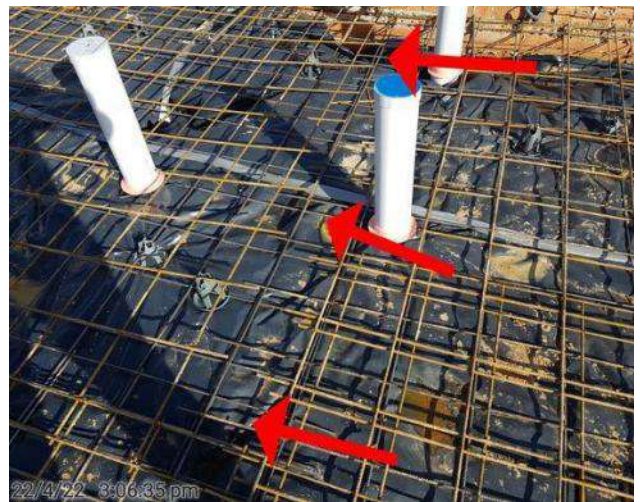
Photo 36

No

The top steel lap is not lapped correctly. As per the NCC 2019 National Construction Code - 3.2.3.2 Steel reinforcement-(c) Minimum laps for reinforcement as shown in Table 3.2.3.1 and Figure 3.2.3.1 must be provided where reinforcing is used - Square and Rectangular Mesh - The two outermost transverse wires of one sheet must overlap the two outer most transverse wires of the other.

Some sections of the top steel are not installed correctly when compared with the approved plans.

Multiple locations throughout

The top layer of steel is not installed to the correct height and is bowing down in the garage and middle level area which will weaken the slab. This must be installed correctly for the correct strength of the slab.

There is a gap where the top steel is not lapped. Builder advised that he is installing a new sheet across the area and it will be rectified before the pour.

Also photos to be provided before the pour of the rectified steel areas.

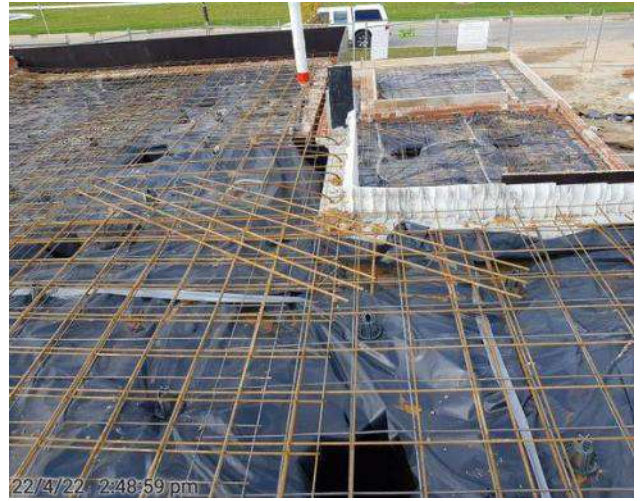
Photo 38

No

The minimum gap to external exposure is 40mm. As per the NCC 2019 National Construction Code - 3.2.3.2 Steel reinforcement - (d) Footings and slabs-on-ground must have concrete cover between the outermost edge of the reinforcement (including ligatures, tie wire etc.) and the surface of the concrete of not less than the following: (iv) 40 mm to external exposure.

- Western area of slab - to southern section
- Western area of slab - to northern section
- Western area of slab - to central section

Builder informed me that he will cut this back correctly and install cavity boards before the pour. Have requested photos before the pour.
