# Frame & Brickwork Report

### INSPECTION SCOPE AND INSPECTION REPORT

**Report Purpose:**

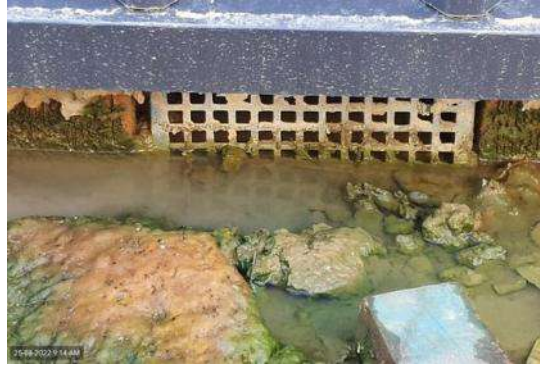
Photo 20

Adequate sub-floor ventilation has not been installed to allow for the correct amount of air-flow to the sub-floor area.

There is not enough clearance between the floor joists and the soil internally.

The limited vents are below ground level and will be covered by the paths. Builder agreed that a mechanical vent system will be installed.

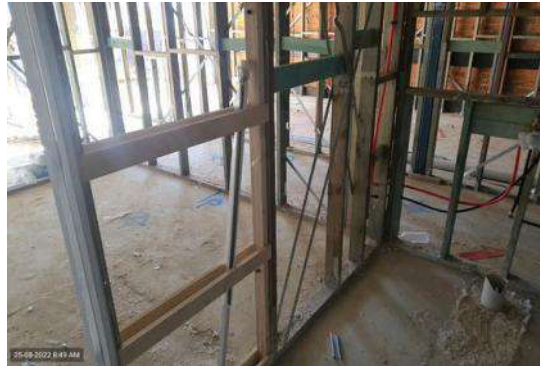
Photo 60

No blocking has been installed for the towel rail holder.

No blocking has been installed for the toilet roll holder.

No blocking has been installed for the vanity.

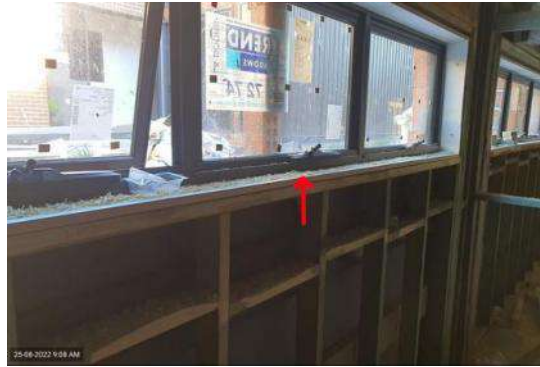
Photo 68

The window has not been installed plumb and level.

The bottom reveals are bowed in the middle and require fixing.

Bedroom one slab not fully installed to support the window correctly and requires additional concreting to support the window base correctly without allowing external moisture to enter the bedroom.

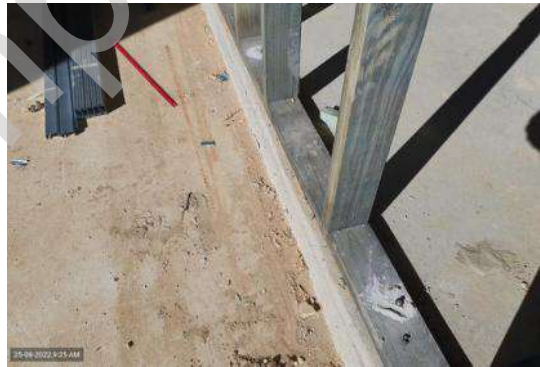
Photo 72

1. Concrete slab is protruding into the garage area. Advised that they are going to add more gyprock to fill the wall out. This will make the garage smaller.
2. The electrical pipes are protruding into bedroom one wall area. This will affect the internal wall lining and the correct method of repair is required.
3. The entry door frame is hanging over the slab/ brickwork due to the slab not being in the correct position. This needs to be repaired correctly otherwise there will be cracking in the floor coverings.
4. The window in main bedroom is overhanging the slab and this needs to be filled correctly to prevent moisture entering the slab area.

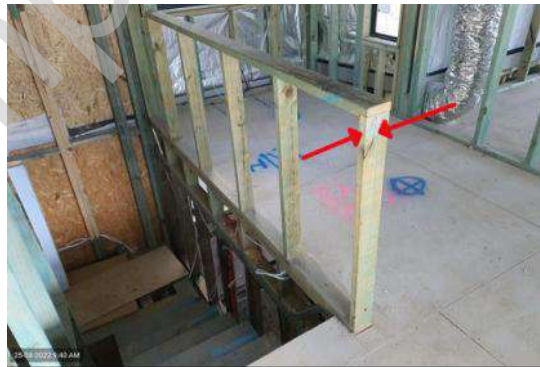
Photo 80

Stairwell frame not secured correctly and is loose.
