New Construction Sample Report

The purpose of the assessment is to provide detail on the quality and adequacy of the completed structure and finishes for a newly constructed building or addition to a building.

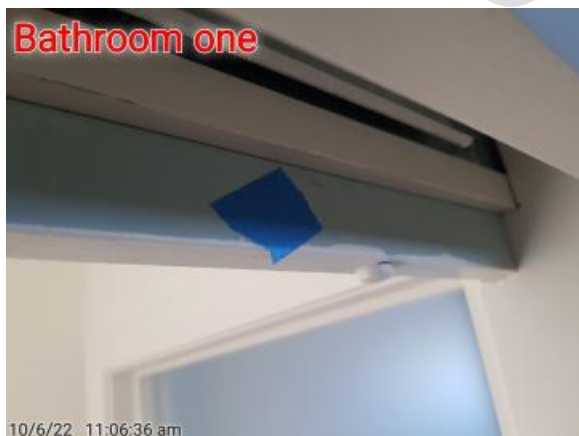
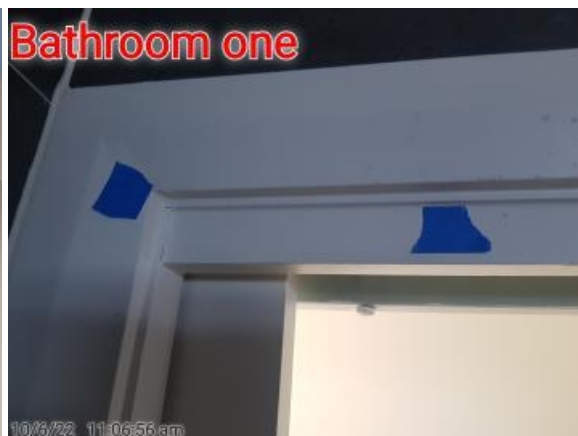
Door Frame

PAINT FINISH TO DOOR FRAME NOT TO AN ACCEPTABLE STANDARD
Must be repaired and repainted correctly. Repairs required immediately.

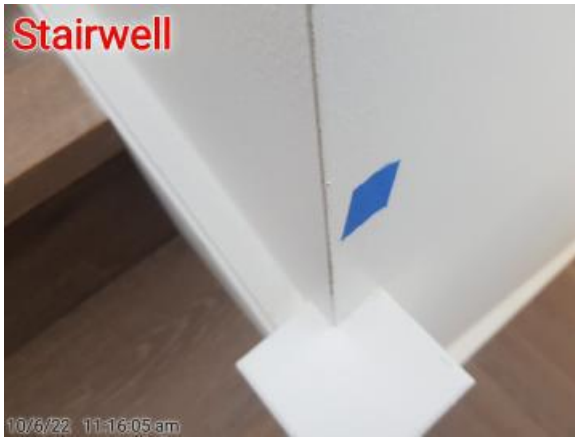
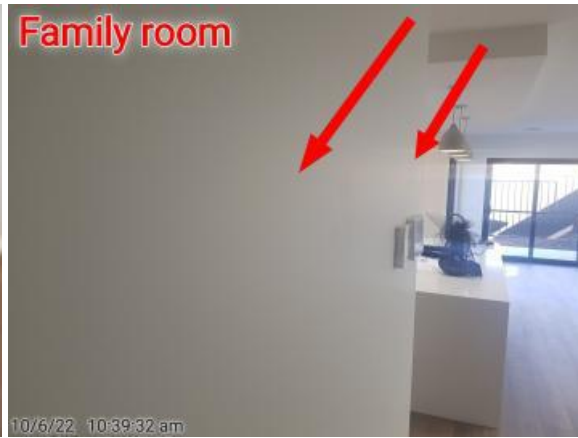
Skirting

PAINT FINISH TO SKIRTING NOT TO AN ACCEPTABLE STANDARD

Must be repaired and repainted correctly. Repairs required immediately.

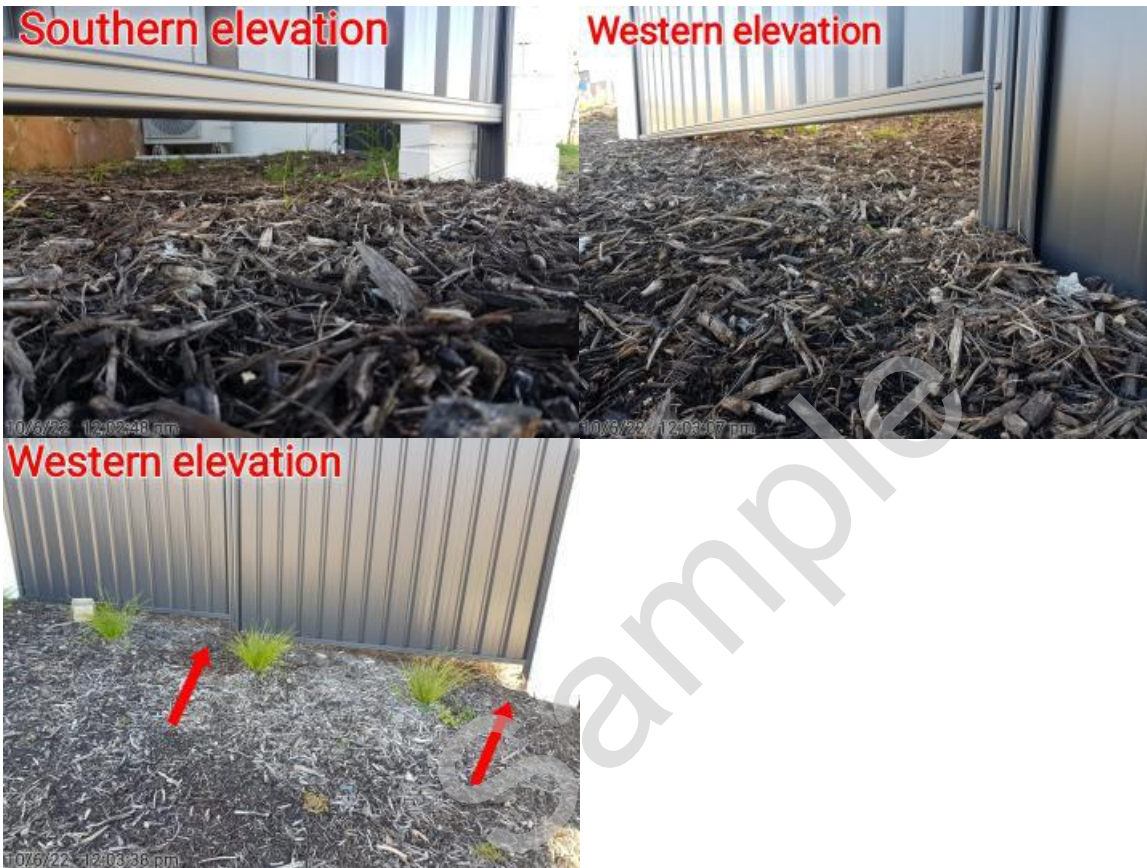
Fences (Colorbond)

RESIDUE TO FINISH

The cement mortar from the retaining wall below has been smeared over the fence along the entire length. Must be removed without damaging the surface beneath. Repairs required immediately.

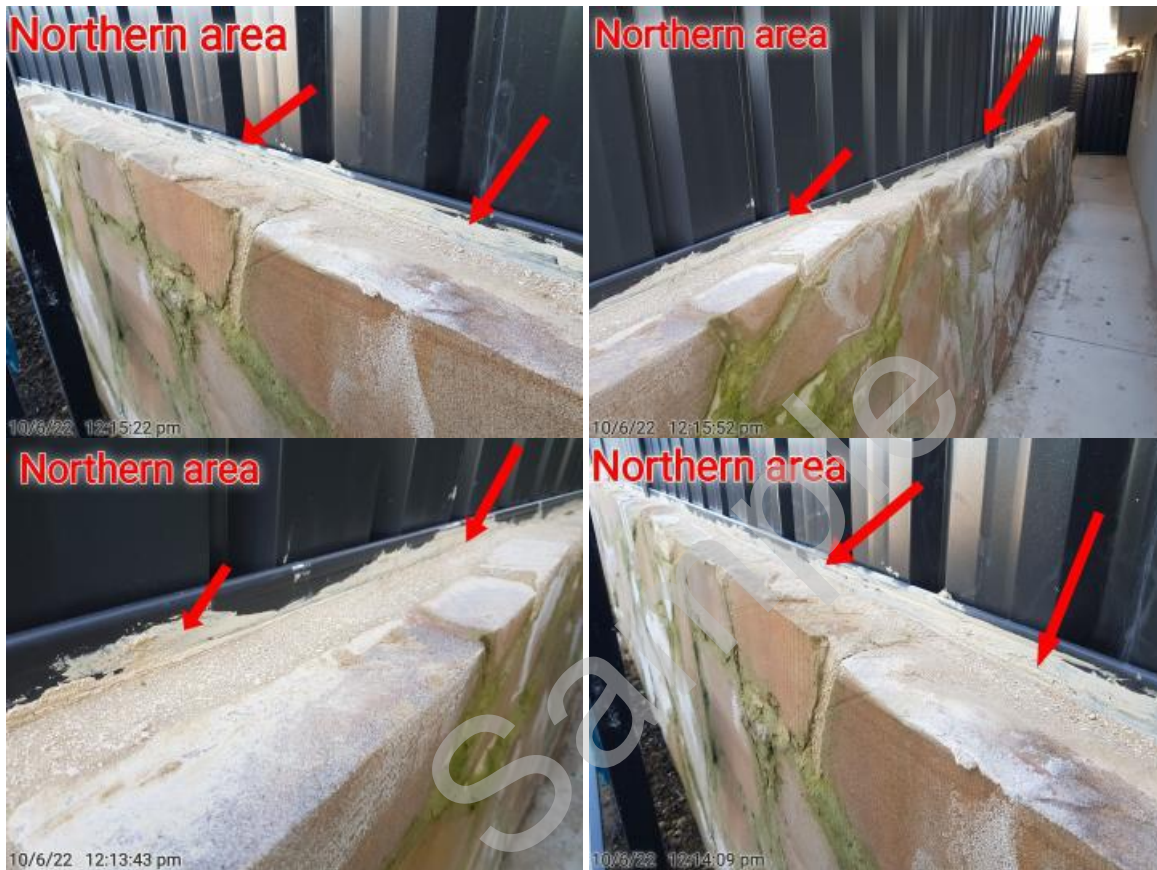
Render

CHIPPED RENDER

Must repair. To be fixed without delay.

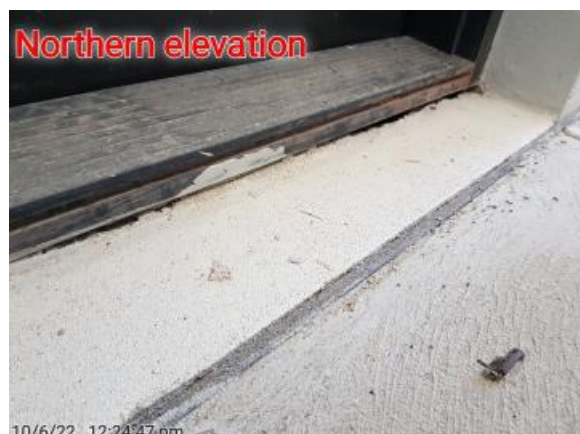
Render

FINISH TO RENDER NOT TO AN ACCEPTABLE STANDARD

Must be repaired and repainted correctly. Repairs required immediately.

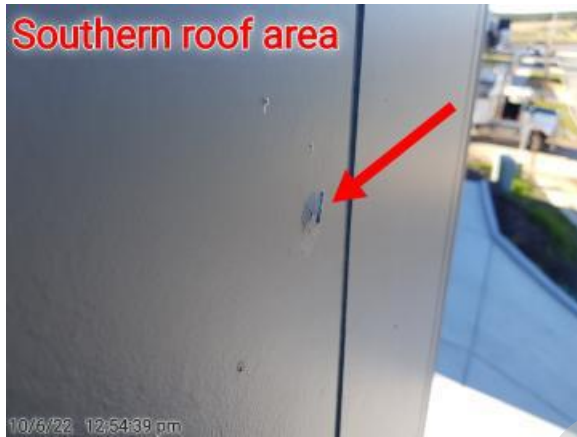
Roof (Metal)

DAMAGED BARGE CAPPING

Must be repaired correctly or replaced. Must be fixed without delay.

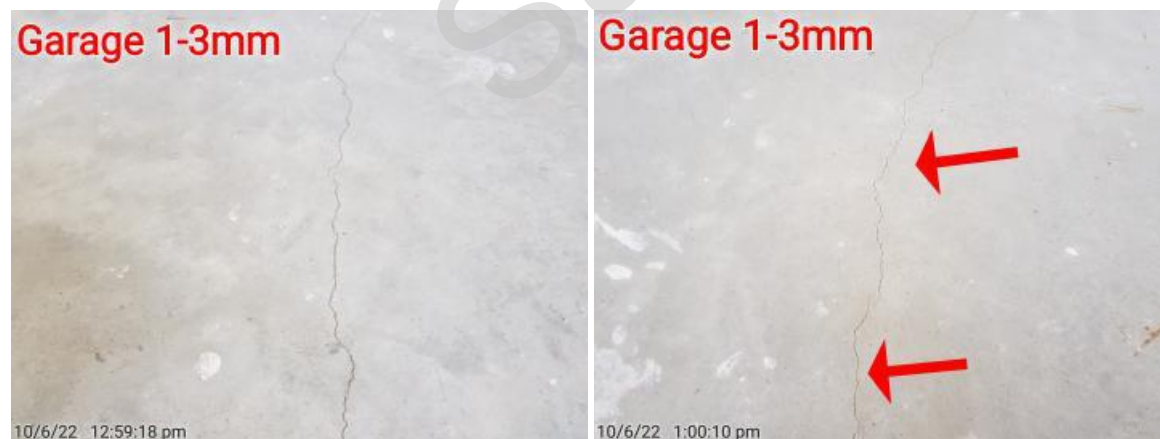
Garage

1-3mm cracking visible, Serviceability flaw

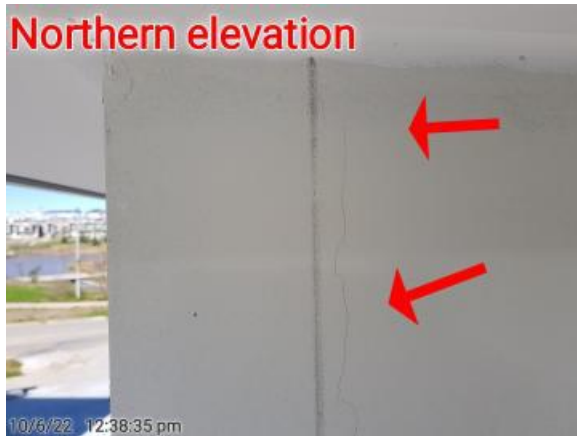
Render

Hairline cracking visible, Serviceability flaw
