## Platinum Building Report

10 Smith Street  
Smithtown ACT

# BUILDING REPORT

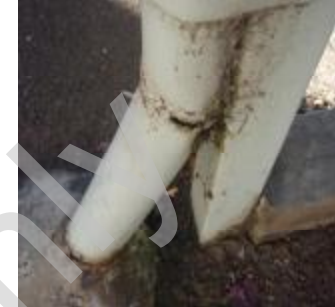
Leaks to Joins

**LEAKS TO JOINS**

Defect Type - D

Repair Priority - Low

The joins require sealing to prevent leaks.

Relevant Specialist - Licensed Roof Plumber/Handyman

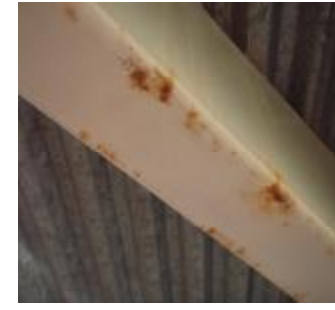
Surface Rust to Beam

**SURFACE RUST**

Defect Type - D

Repair Priority - Medium

Treatment of the rust and painting of the beam is required to help prevent any further deterioration.

Relevant Specialist - Qualified Painter/Handyman

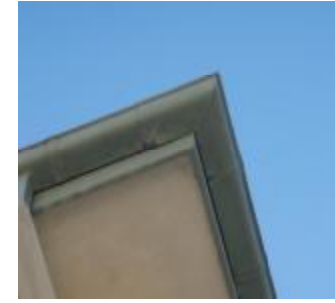
Leaks to Gutter

LEAKS AT JOINS

Defect Type - E

Repair Priority - Low

Relevant Specialist - Licensed Plumber/Handyman

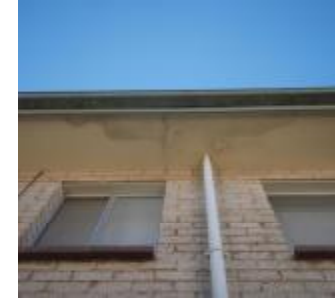
Staining to Eaves

MOISTURE STAINS VISIBLE

The cause of the moisture staining was not visible at the time of the inspection; however is most likely due to overflowing or blocked gutters. A further inspection by a Licensed Builder is required to ascertain the cause of the leak.

Defect Type - C

Repair Priority - Medium, FI

Relevant Specialist - Licensed Builder

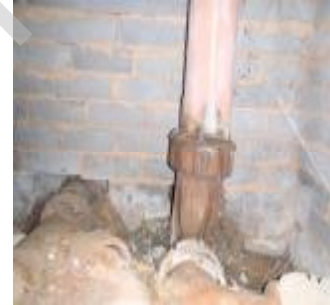
Overflowing Pipe

Defect Type - E

Repair Priority - High, SH

Relevant Specialist - Licensed Plumber

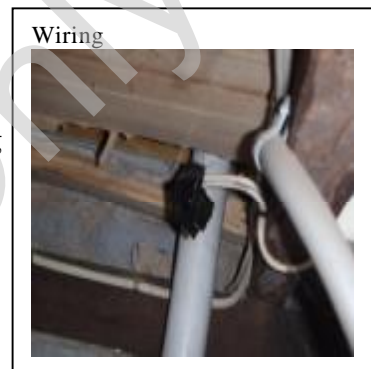
Defect Type - F

Repair Priority - High, SH

Location - S

A Licensed Electrician should be engaged to check the wiring and provide advice on the correct method of repair. This may pose a safety risk and should be checked without delay.

Relevant Specialist - Licensed Electrician

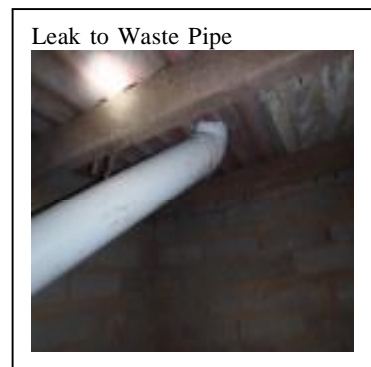
#### LEAKS TO SHOWER WASTE PIPE

Defect Type - E

Repair Priority - High, SH

Location - S

Repair is required by a Licensed Plumber.

Relevant Specialist - Licensed Plumber

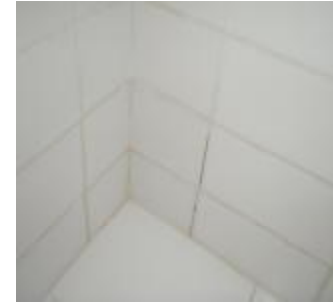
Shower Recess

Defect Type - A

Relevant Specialist - Qualified Tiler/Handyman
