## Special Purpose Building Report

10 Smith Street, Smith Town

# **BUILDING REPORT**

Date: *1<sup>st</sup> June 2009*

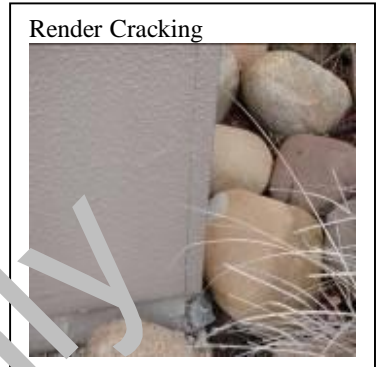
#### 1-3MM CRACKING VISIBLE

The existing cracking is not significant and does not usually pose a structural concern; however movement or settlement of hidden items such as footings or foundation material can be linked to this cracking. For your peace of mind the opinion of a Structural Engineer can be sought in regards to the significance of this cracking.

Defect Type - A

Repair Priority - Medium

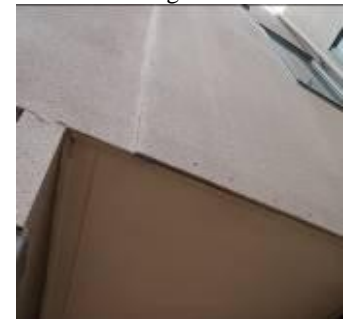
Loose Cladding

#### LOOSE CLADDING BOARDS

The loose cladding boards require resecuring to the wall frame.

Defect Type - A

Repair Priority - Medium

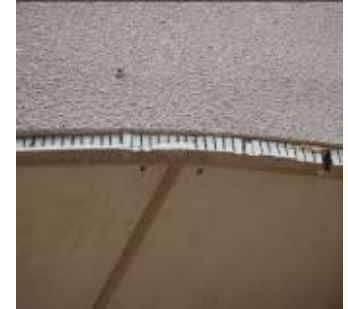
Loose Trim

#### LOOSE TRIM

Defect Type - B

Repair Priority - Low

Relevant Specialist - Qualified Carpenter/Handyman

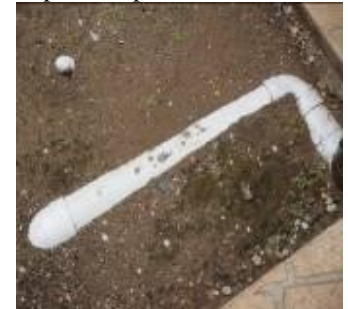
Exposed Pipe

The pipe is exposed above ground level and should be buried to help prevent the possibility of damage.

Defect Type - F

Repair Priority - Medium

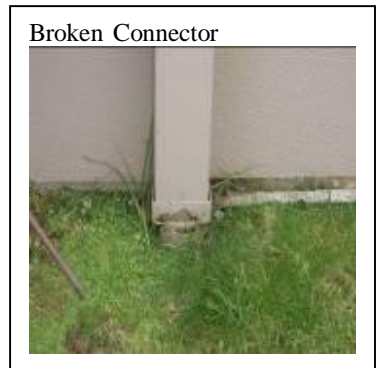
BROKEN CONNECTOR FITTING

The connector to the stormwater pipe is broken and requires repair or replacement.

Defect Type - D

Repair Priority - Medium

Relevant Specialist - Licensed Plumber

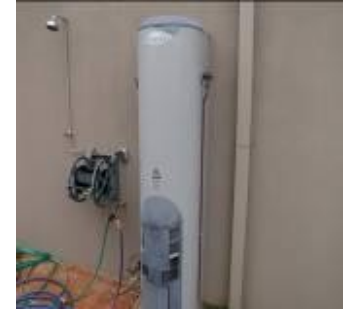
Hot Water Unit

The unit requires inspection by a Licensed Plumber who can provide further advice on any repairs required.

Defect Type - E

Repair Priority - High, FI

Overall Condition: Poor

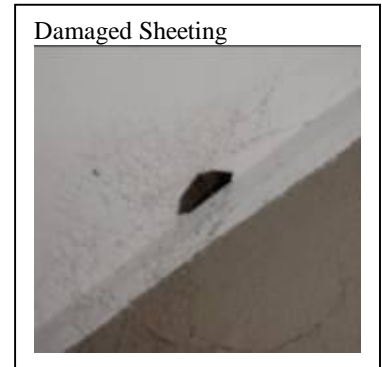
DAMAGED SHEETING

The affected sheeting requires repair or replacement.

Defect Type - A

Repair Priority - Medium

Relevant Specialist - Qualified Carpenter/Handyman

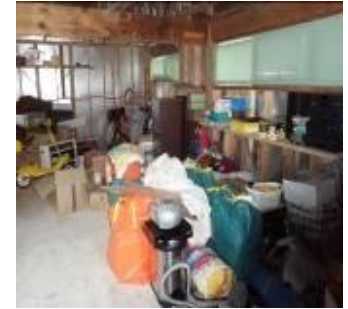
Stored Goods

Overall Condition: Unable to fully assess

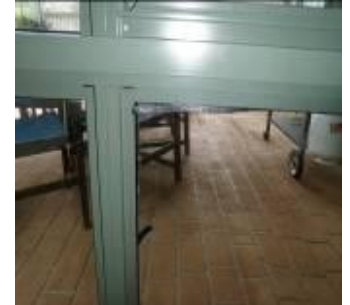
Glazing Bead

Overall Condition: Fair
