Issue 15 of 2019 – 30 July

SAFework NSW – POSITION PAPER CLADDING OVER ASBESTOS CONTAINING MATERIALS

Position paper: over cladding asbestos containing materials

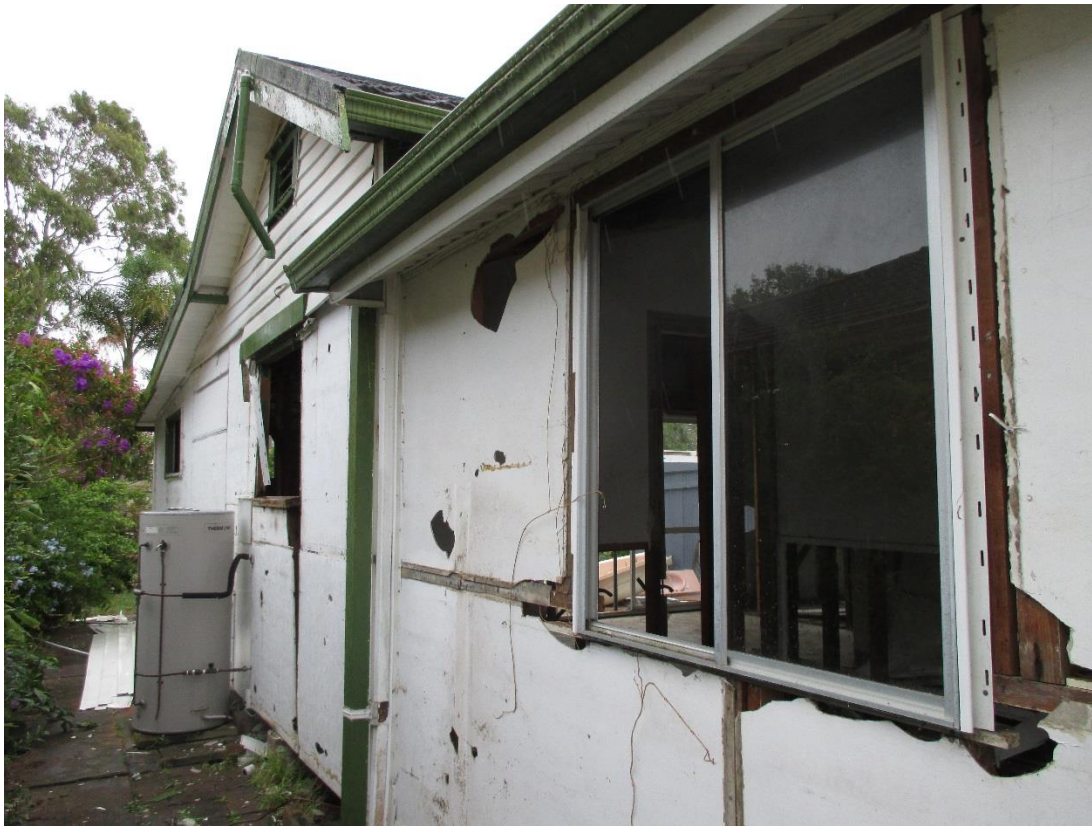
SafeWork NSW Inspectors have observed that only the asbestos cover strips are being removed from the external asbestos wall sheeting of houses to provide a flat surface to install the new cladding material. The removal of these strips using pinch bars or similar tools and nailing new non-asbestos cladding into the existing asbestos containing material causes breakage and contamination of the ground and wall cavities where work is being undertaken.

Figure 1: *Damage caused to asbestos sheeting when removing connecting strips*

To control risks from ACM, it is the SafeWork NSW position, that whether you are a homeowner or a person conducting a business or undertaking (PCBU), where asbestos is present, a licensed asbestos removalist should be engaged to remove the ACM prior to cladding.

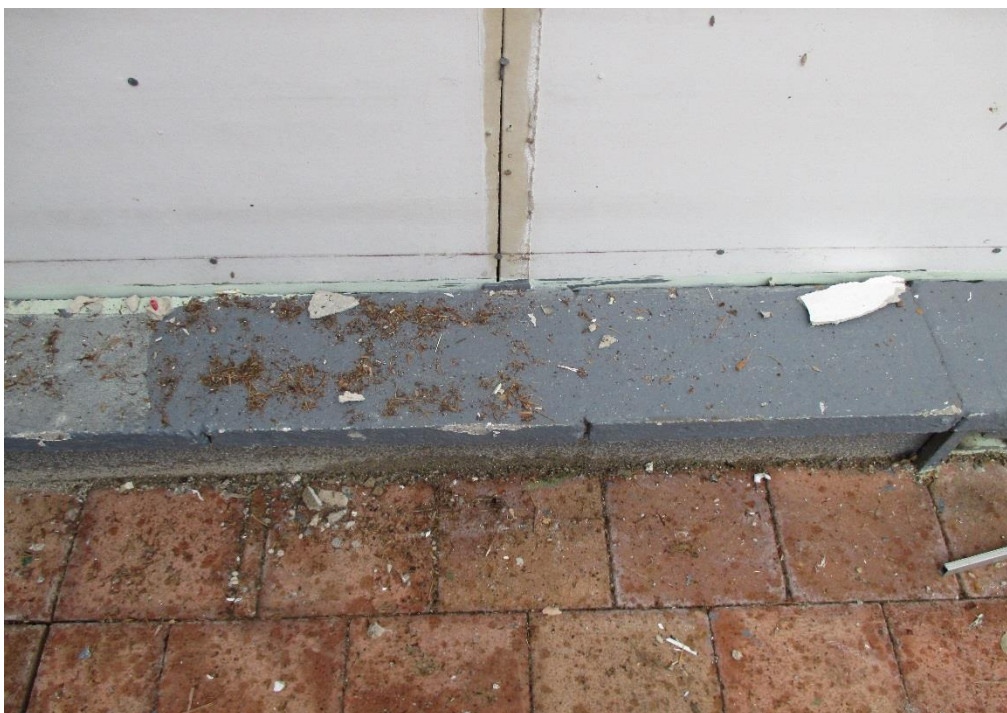
Figure 2: *Asbestos contamination on the ground*

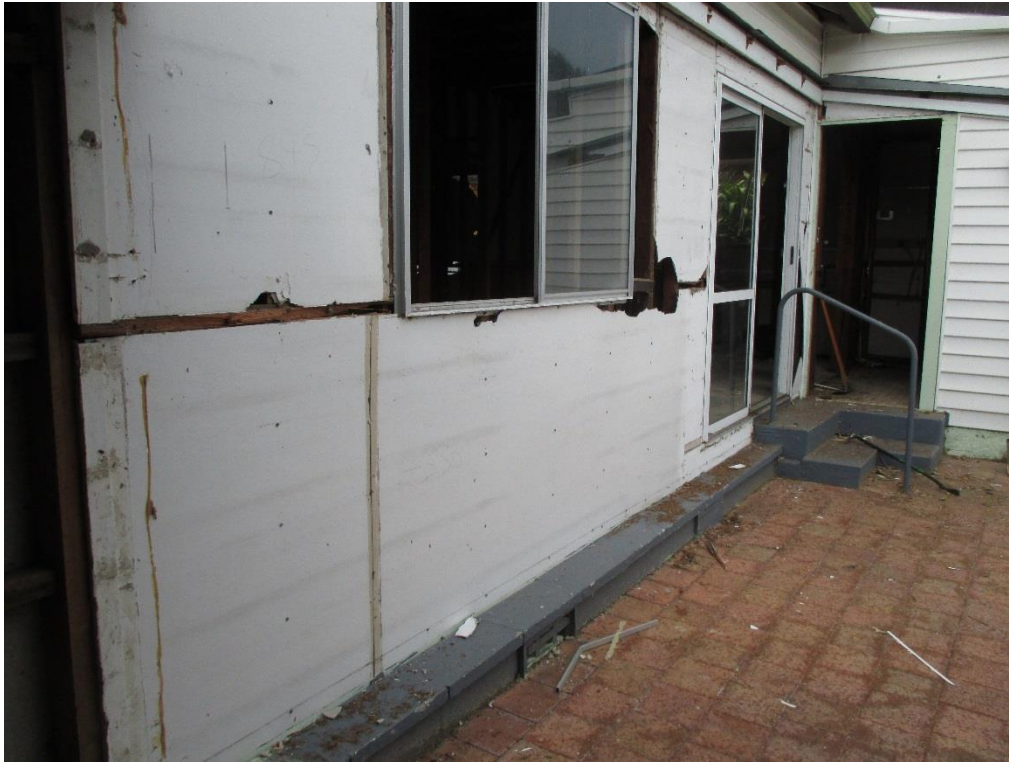
Figure 3: Damage to ACM sheeting in preparation for cladding
