Property Evaluation Reports

5 Smith Street, Amaroo, ACT

Property & Inspection Details

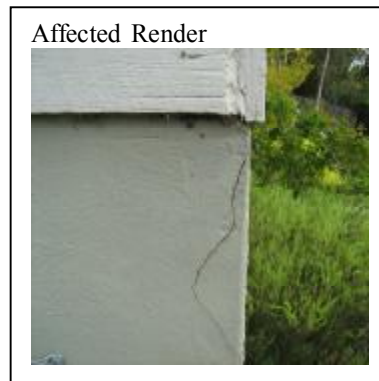
Location - E

HAIRLINE CRACKING VISIBLE

The existing cracking is not significant and does not usually pose a structural concern.

Relevant Specialist - Licensed Builder/Qualified Renderer

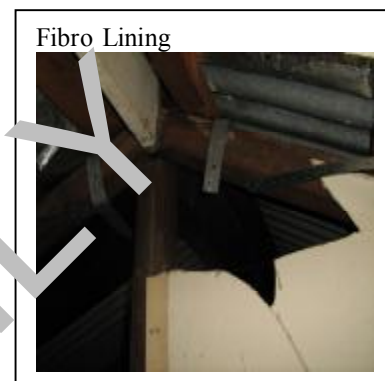
Overall Condition: Fair

Relevant Specialist - Licensed Builder
