Building Report

5 Smith Street, Moruya, NSW

BUILDING REPORT

Date: 26th May 2009

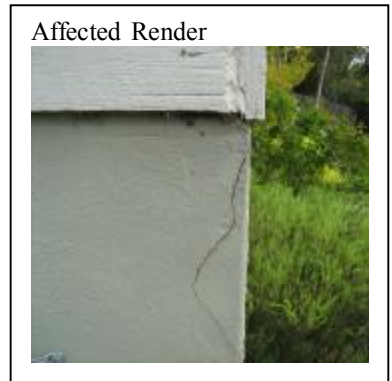
Location - E

HAIRLINE CRACKING VISIBLE

The existing cracking is not significant and does not usually pose a structural concern.

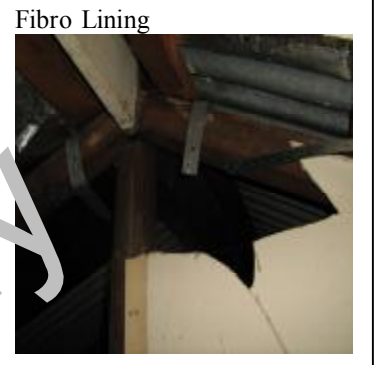
Overall Condition: Fair
