Dilapidation Report XYZ Project

1 Smith Street
Smithtown NSW

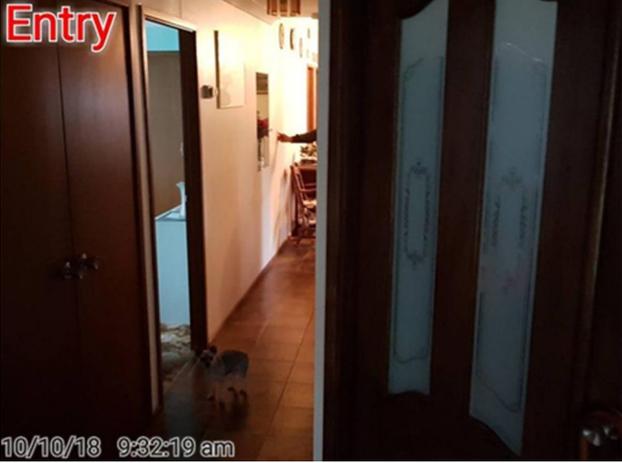
INTERNAL	
Room/Area Assessed	
Room 1	
Room Description:	Entry
Image

Defects	
Defect 1	
Defect description:	Ceiling - cracked
Additional notes:	Nil
Defect location:	Multiple locations throughout
Defect image:

Defect 2	
Defect description:	Lining (Plasterboard) - cracking
Additional notes:	Nil
Defect location:	Eastern area of room - to central section
Defect image:

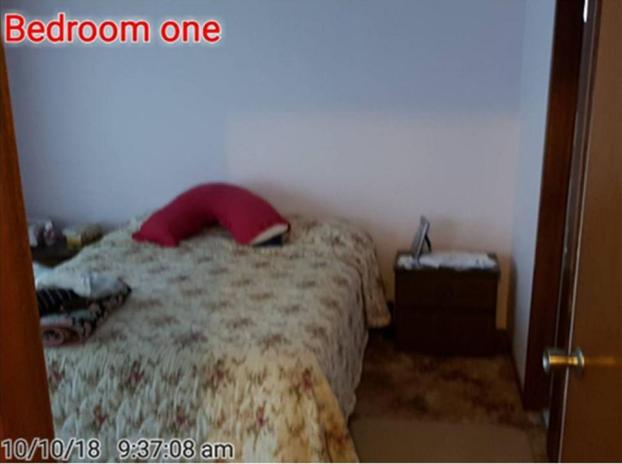
Room 2	
Room Description:	Bedroom one
Image

<p>Bedroom one</p> <p>10/10/18 9:37:08 am</p>	
Defects	
Defect 1	
Defect description:	Lining (Plasterboard) - cracking
Additional notes:	Nil
Defect location:	Western area of room - to central section
Defect image:

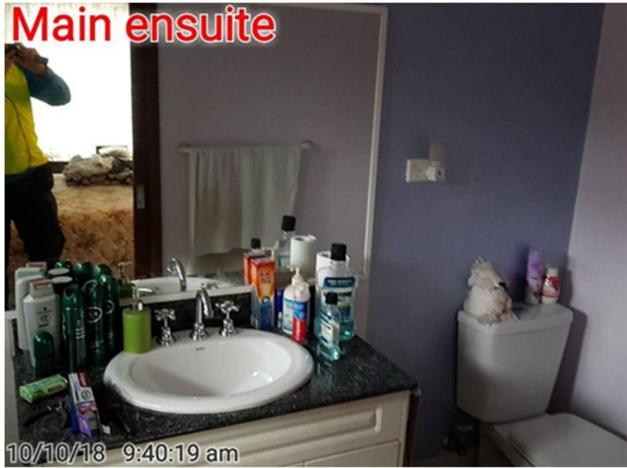
Room 3	
Room Description:	Main ensuite
Image

<p>Main ensuite</p> <p>10/10/18 9:40:19 am</p>	
Defects	
Defect 1	
Defect description:	Lining (Plasterboard) - cracking
Additional notes:	Nil
Defect location:	Eastern area of room - to central section
Defect image:

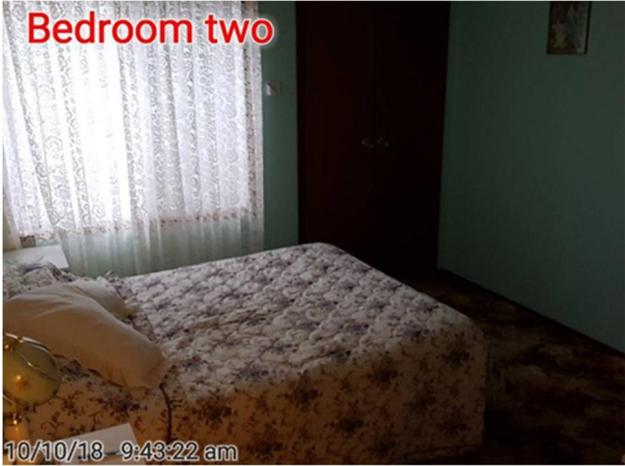
Room 4	
Room Description:	Bedroom two
Image

<p>Bedroom two</p> <p>10/10/18 9:43:22 am</p>	
Defects	
Defect 1	
Defect description:	Lining (Plasterboard) - cracking
Additional notes:	Nil
Defect location:	Western area of room - to central section
Defect image:

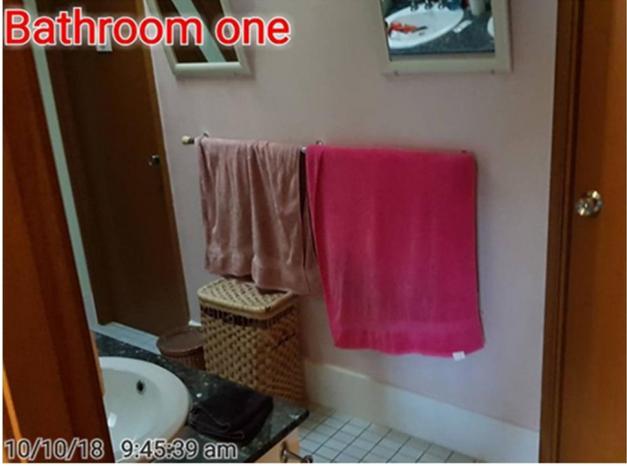
Room 5	
Room Description:	Bathroom one
Image

Defects	
Defect 1	
Defect description:	No defects identified
Additional notes:	Nil

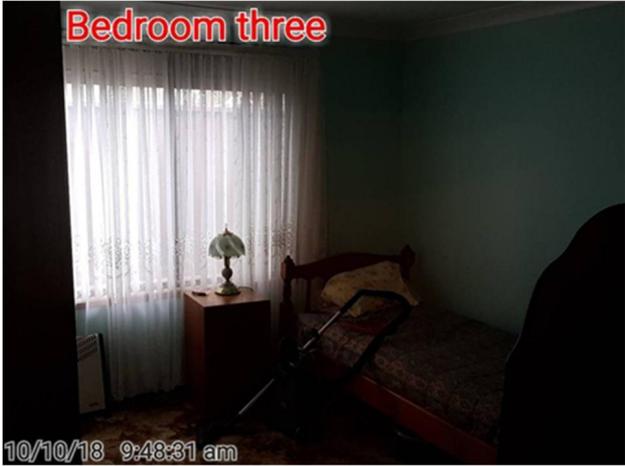
Room 6	
Room Description:	Bedroom three
Image

<p>Bedroom three</p> <p>10/10/18 9:48:31 am</p>	
Defects	
Defect 1	
Defect description:	Lining (Plasterboard) - cracking
Additional notes:	Nil
Defect location:	Multiple locations throughout
Defect image:

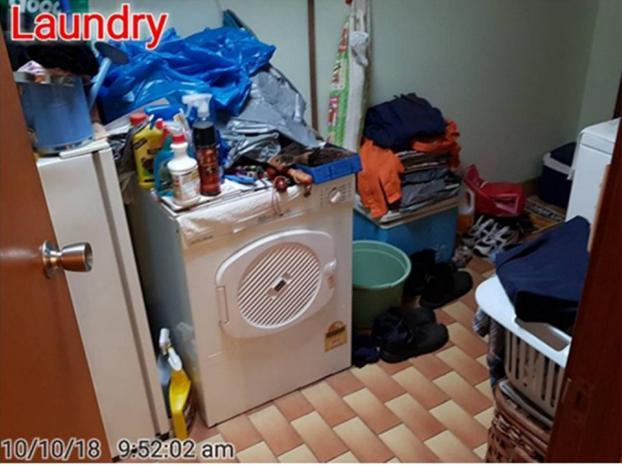
Room 7	
Room Description:	Laundry one
Image

Defects	
Defect 1	
Defect description:	Lining (Plasterboard) - cracking
Additional notes:	Nil
Defect location:	Eastern area of room - to central section
Defect image:

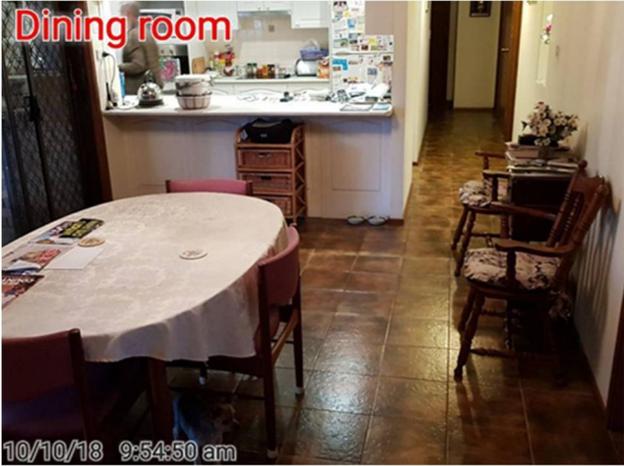
Room 8	
Room Description:	Dining
Image

<p>Dining room</p> <p>10/10/18 9:54:50 am</p>	
Defects	
Defect 1	
Defect description:	Lining (Plasterboard) - cracking
Additional notes:	Nil
Defect location:	Multiple locations throughout
Defect image:

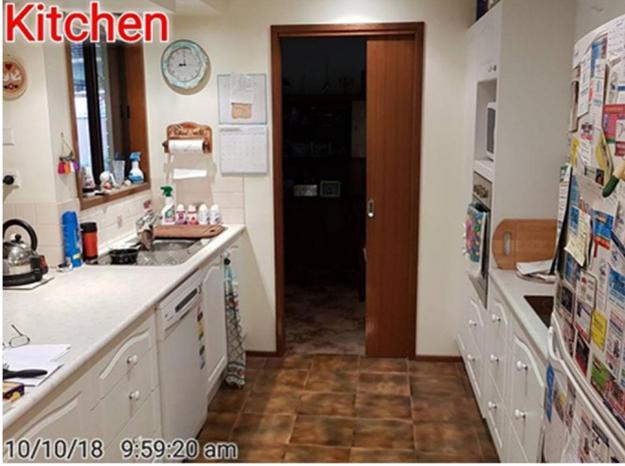
Room 9	
Room Description:	Kitchen one
Image

<p>Kitchen</p> <p>10/10/18 9:59:20 am</p>	
Defects	
Defect 1	
Defect description:	Lining (Plasterboard) - cracking
Additional notes:	Nil
Defect location:	Western area of room - to northern section
Defect image:

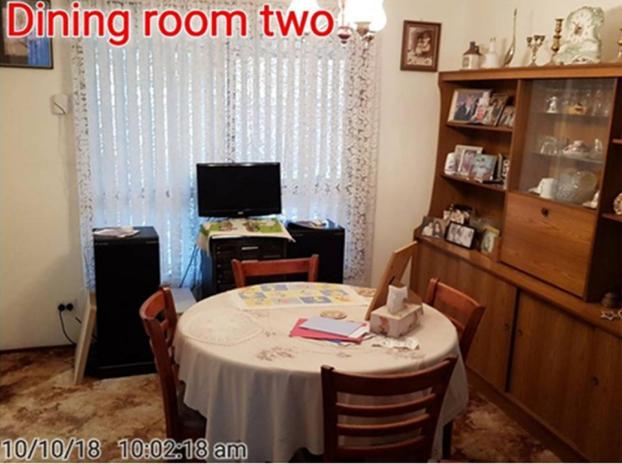
Room 10	
Room Description:	Dining
Image

<p>Dining room two</p> <p>10/10/18 10:02:18 am</p>	
Defects	
Defect 1	
Defect description:	Lining (Plasterboard) - cracking
Additional notes:	Nil
Defect location:	Multiple locations throughout
Defect image:

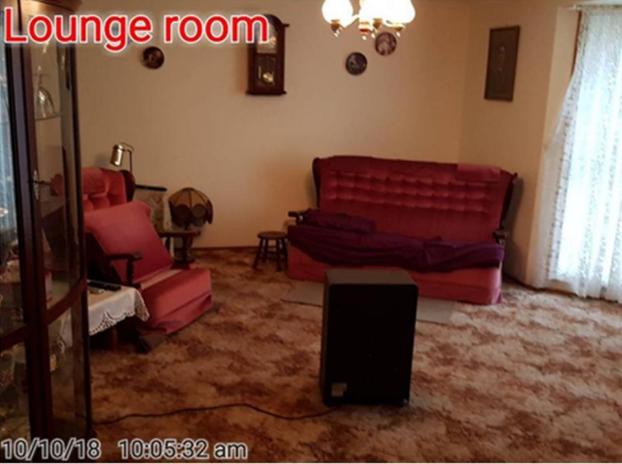
Room 11	
Room Description:	Lounge
Image

<p>Lounge room</p>	
Defects	
Defect 1	
Defect description:	Cornice - cracked
Additional notes:	Nil
Defect location:	Western area of room - to central section
Defect image:

Defect 2	
Defect description:	Lining (Plasterboard) - cracking
Additional notes:	Nil
Defect location:	Eastern area of room - to northern section
Defect image:

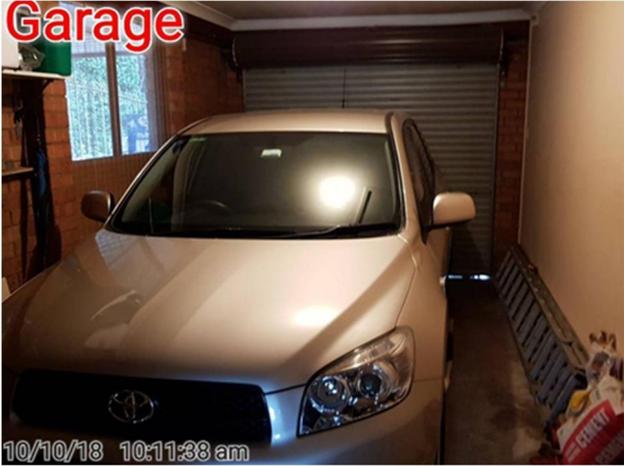
Room 12	
Room Description:	Garage
Image

Defects	
Defect 1	
Defect description:	Floor (Concrete) - cracked
Additional notes:	Nil
Defect location:	Multiple locations throughout
Defect image:

Defect description:	Cornice - cracked
Additional notes:	Nil
Defect location:	Northern area of room - to central section

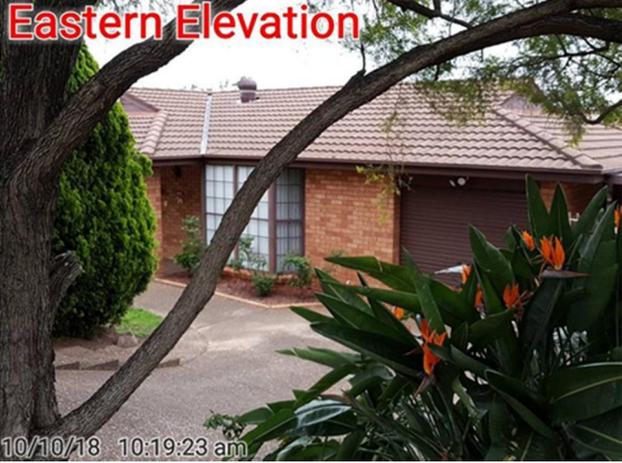
EXTERNAL	
Elevation/Area Assessed	
Elevation/Area 1	
Elevation Description:	Eastern elevation
Image

Defects	
Defect 1	
Defect description:	Driveway - uneven
Additional notes:	Nil
Defect location:	Northern area
Defect image:

Defect 2	
Defect description:	Concrete steps - damaged
Additional notes:	Nil
Defect location:	Central area
Defect image:

<p>Concrete steps edge damaged</p> <p>10/10/18 10:22:48 am</p>	
Defect 3	
Defect description:	Driveway - cracking
Additional notes:	Nil
Defect location:	Northern area
Defect image:

Defect 4	
Defect description:	Paths - cracked
Additional notes:	Nil
Defect location:	Multiple locations

Defect 5	
Defect description:	Tiles - cracked
Additional notes:	Nil
Defect location:	Central area

Defect 6	
Defect description:	Brickwork - damaged
Additional notes:	Nil
Defect location:	Multiple locations

Defect 7	
Defect description:	Eaves - loose trim
Additional notes:	Nil
Defect location:	Multiple locations

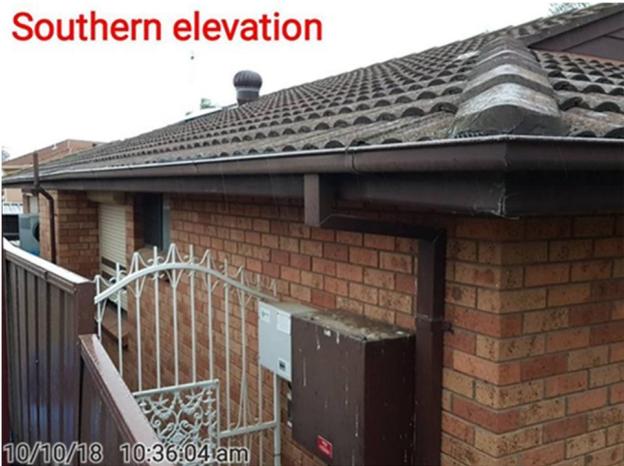
Elevation/Area 2	
Elevation Description:	Southern elevation
Image Southern elevation

Defects	
Defect 1	
Defect description:	Paths - cracked
Additional notes:	Nil
Defect location:	Multiple locations
Defect image: Concrete path cracking

Defect description:	Eaves - loose trim
Additional notes:	Nil
Defect location:	Eastern area
