## Footing & Slab Report

SAMPLE

Report Details	
Job Address:	SAMPLE
Clients Email Address:	<a href="#">SAMPLE</a>
Clients Name:	SAMPLE
Clients Phone Number:	SAMPLE
Conducted on:	22 Apr 2022 14:00 AEST
Assessor Name:	Grant Johnston
Assessor's Contact Number:	SAMPLE
Assessor's Accreditation:	Grant Johnston: I am a Licensed Builder and a Trade Qualified Carpenter. I have been involved in the construction and inspection of both commercial and residential buildings, which have included construction such as that existing at the above address.
Our Job Number:	5991
Builders details:	
Builders name:	SAMPLE
Builders supervisor name:	SAMPLE
Contact number:	SAMPLE
Builders email address:	<a href="#">SAMPLE</a>

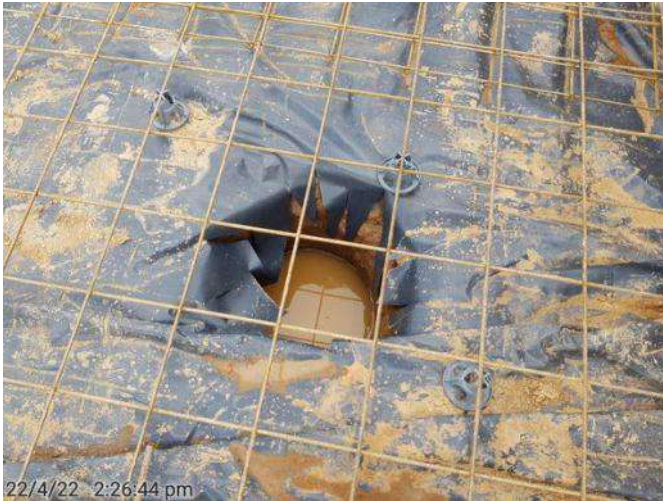
Photo 13

Loose soil and debris is in the pier footings and needs to be removed. As per the NCC 2019 National Construction Code of Australia - Volume Two. PART 3.2.2 FOOTINGS AND SLABS PREPARATION. 3.2.2.1 Excavation for footings. (c) Footing excavations must be free of loose earth, tree roots, mud or debris immediately before pouring concrete.

Pier/s have water in the base which needs to be removed before pouring. As per the NCC 2019 National Construction Code of Australia - Volume Two. PART 3.2.2 FOOTINGS AND SLABS PREPARATION. 3.2.2.1 Excavation for footings. (c) Footing excavations must be free of loose earth, tree roots, mud or debris immediately before pouring concrete.
