New Construction Sample Report

The purpose of the assessment is to provide detail on the quality and adequacy of the completed structure and finishes for a newly constructed building or addition to a building.

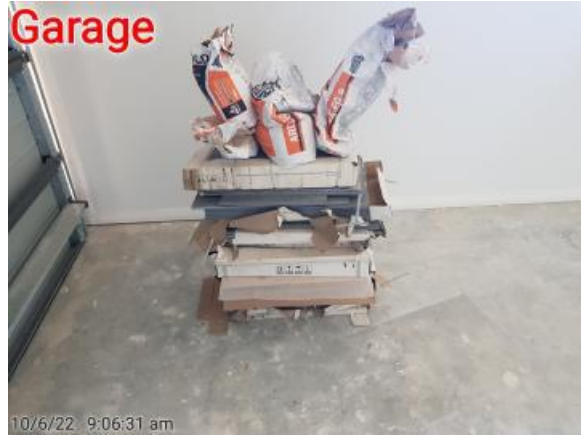
Excess building materials to be removed from various location around the site.

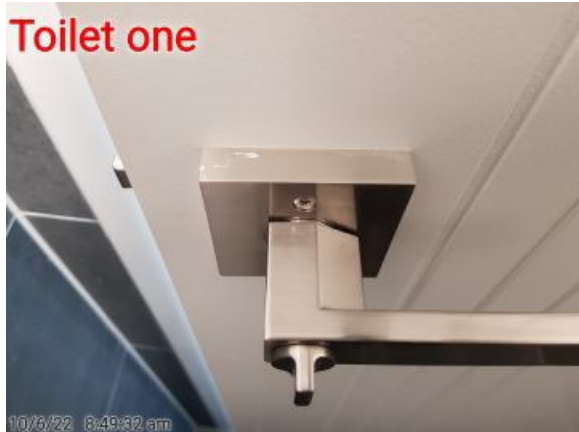
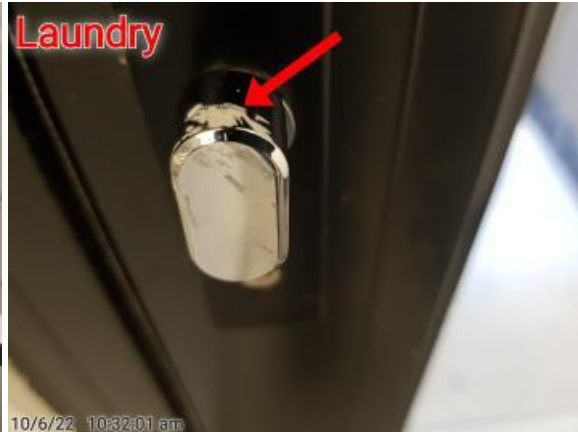
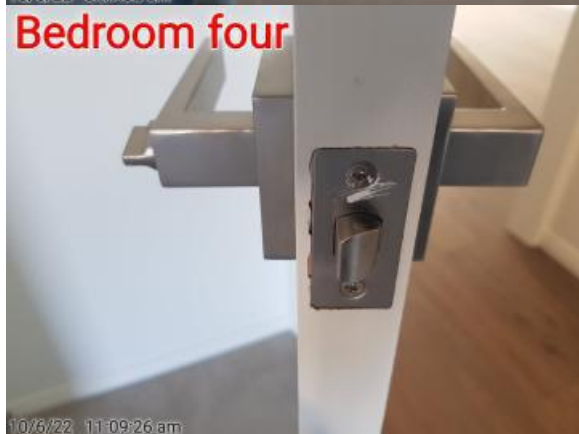
Door (Internal Sliding)

PAINT FINISH NOT TO AN ACCEPTABLE STANDARD

Location: The item identified is located in Entry

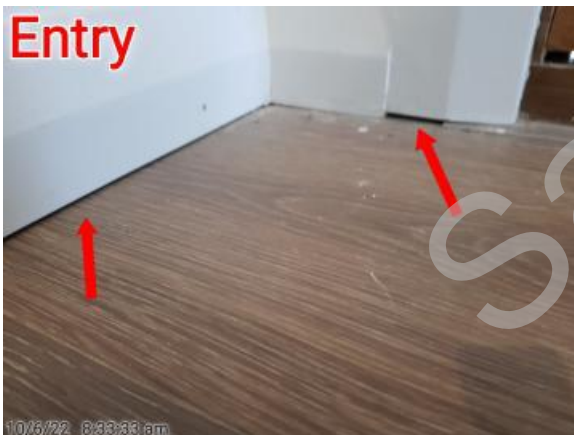
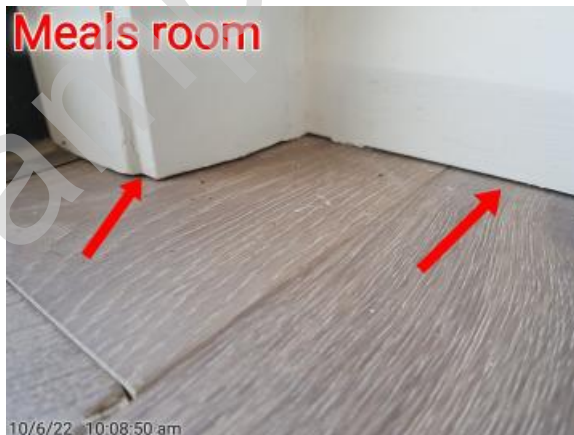
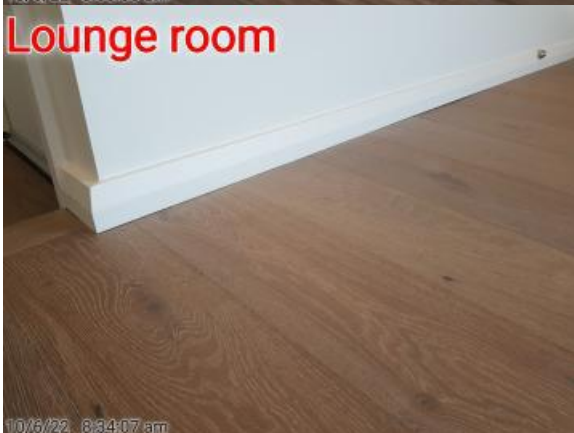
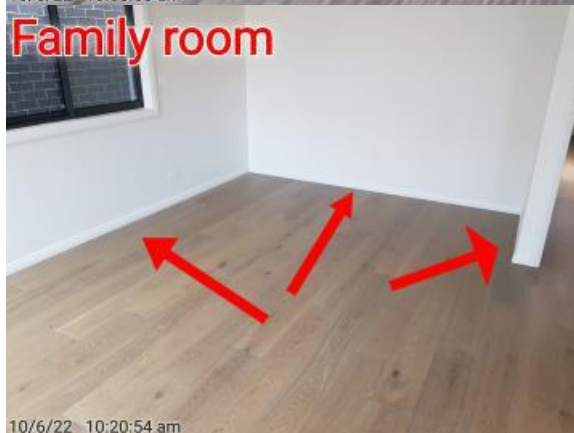
Location: The item identified is located throughout the dwelling where the timber floor is installed

Floor (Timber)

FINISH TO FLOOR NOT TO AN ACCEPTABLE STANDARD

There are gaps between the skirting and the floor throughout the dwelling. This should be sealed correctly and neatly to provide a neat finish. Must be repaired and finished correctly. Repairs required immediately.

Repair priority: Immediate

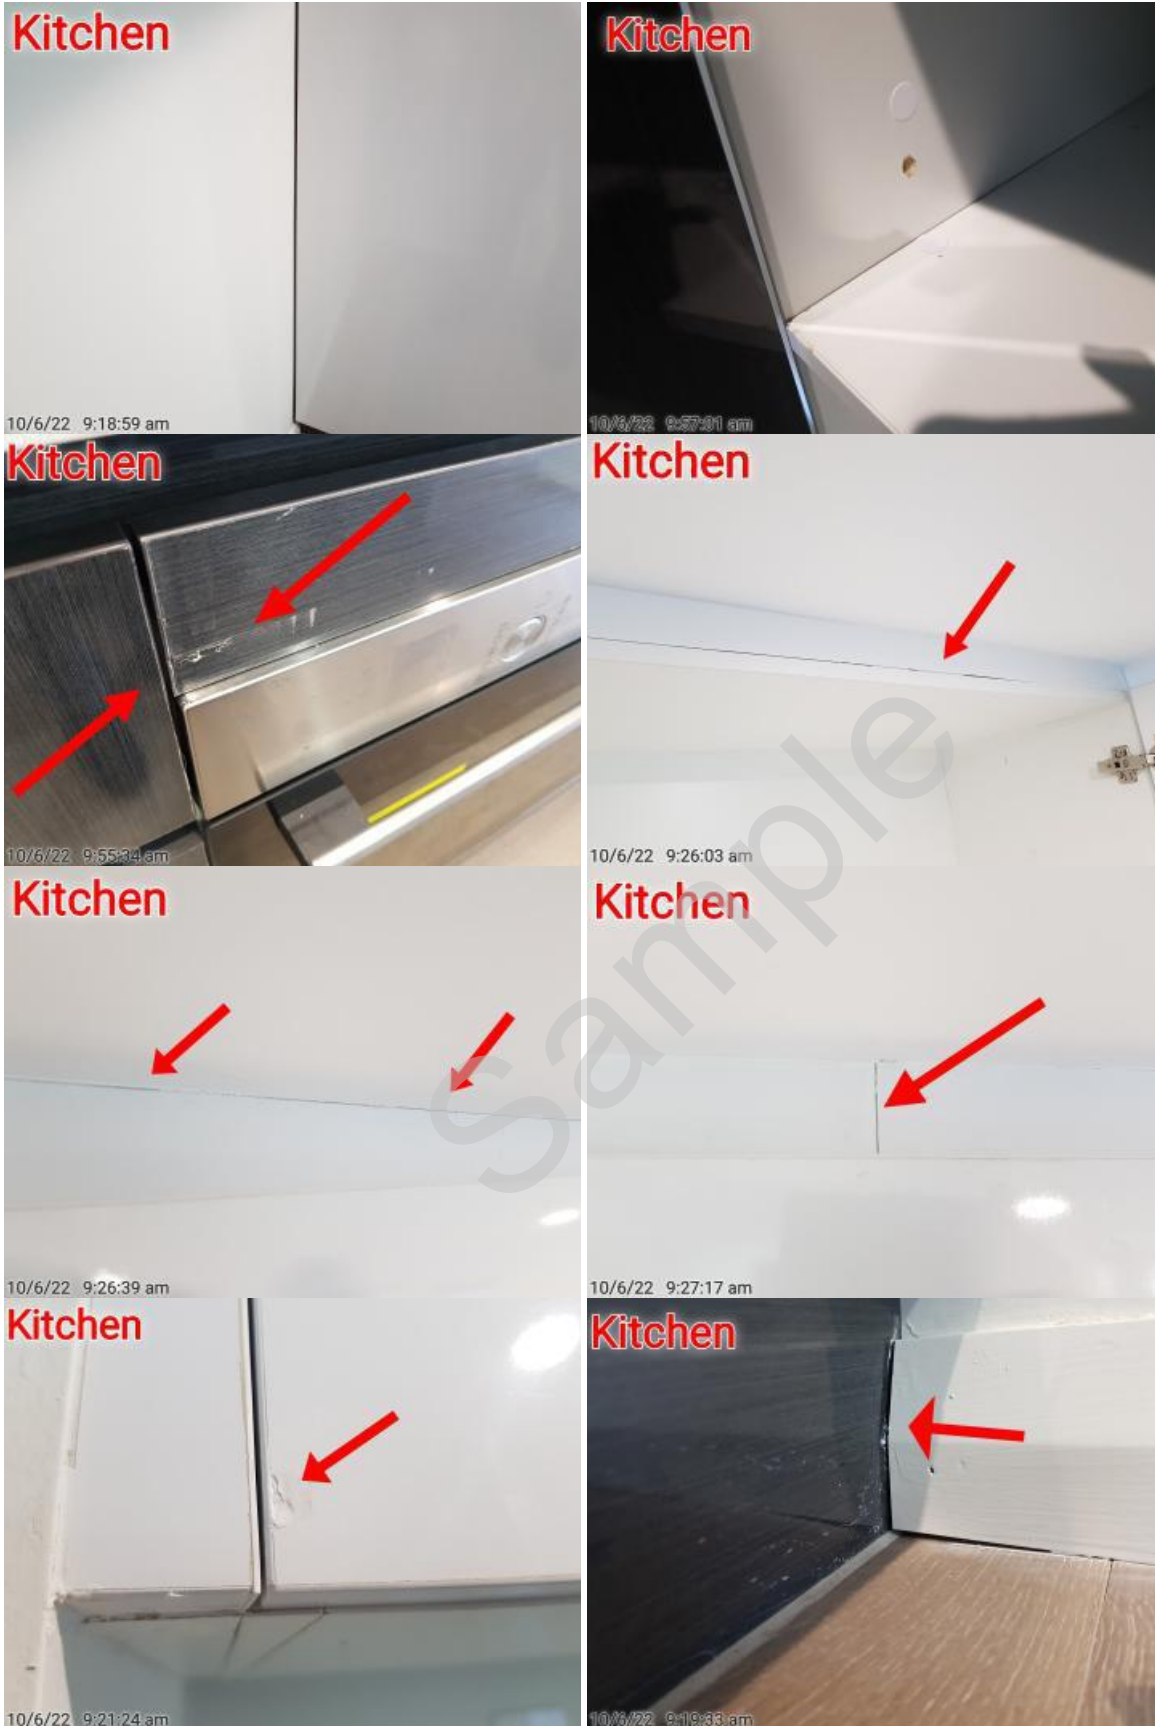
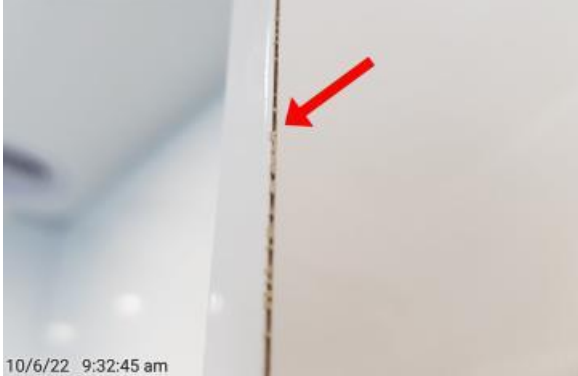
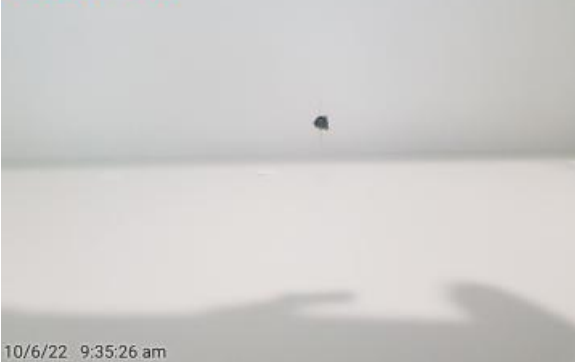
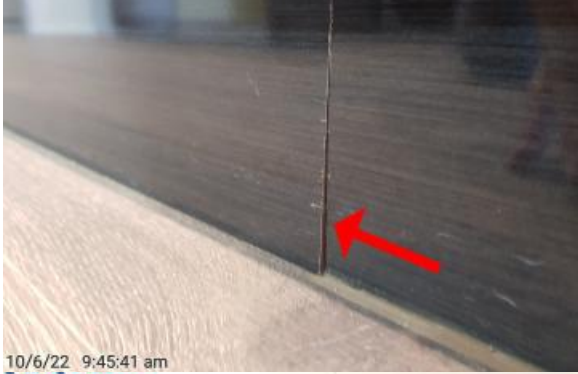
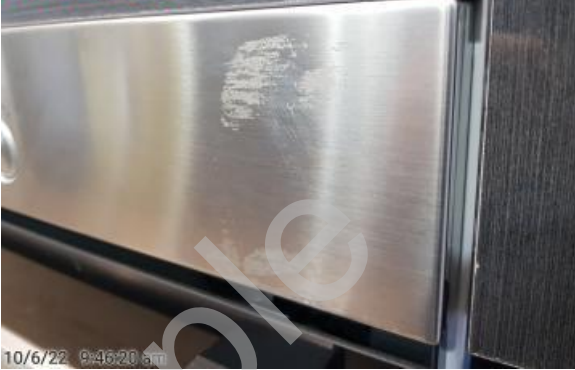
Location: The item identified is located in Kitchen one

NOTABLE DAMAGE TO DOOR FINISH

Must be repaired to achieve an acceptable standard of finish or replaced with new door/s. Repairs required immediately.

Must be removed correctly and installed to a smooth and uniform finish. Repairs required immediately.

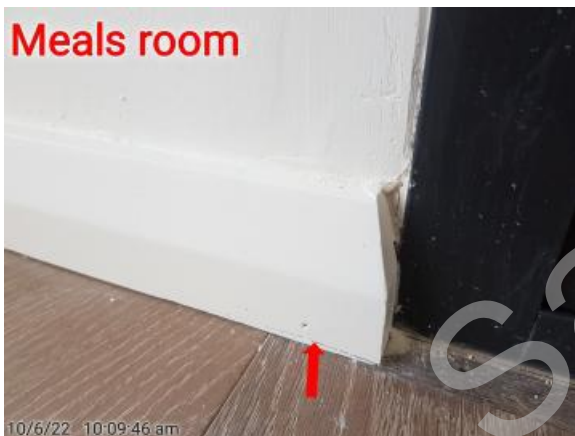
Location: The item identified is located in Meals room and Kitchen

Skirting

Must be repaired and repainted correctly. Repairs required immediately.

Repair priority: Immediate

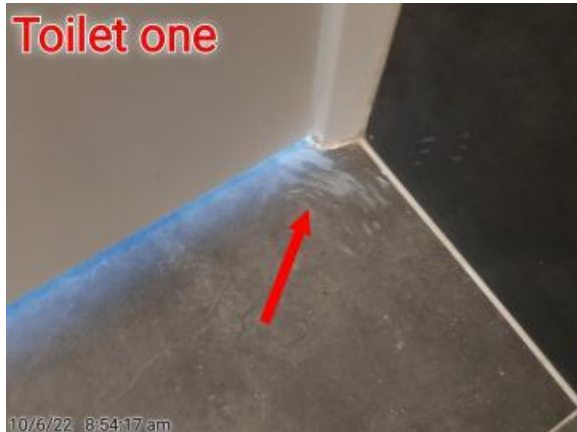
Location: The item identified is located in Toilet

Tiles (Floor)

RESIDUE TO FINISH

Must be removed without damaging the surface beneath. Repairs required immediately.

Repair priority: Immediate

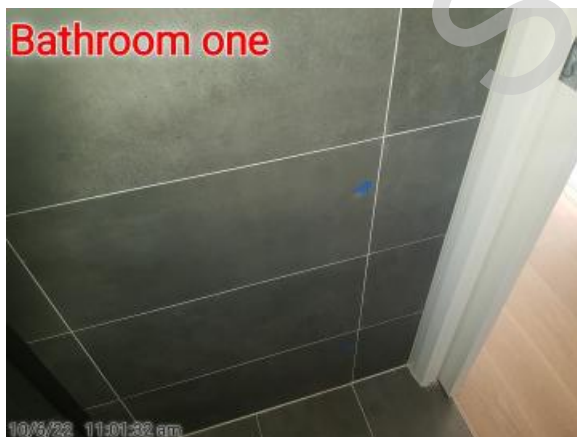
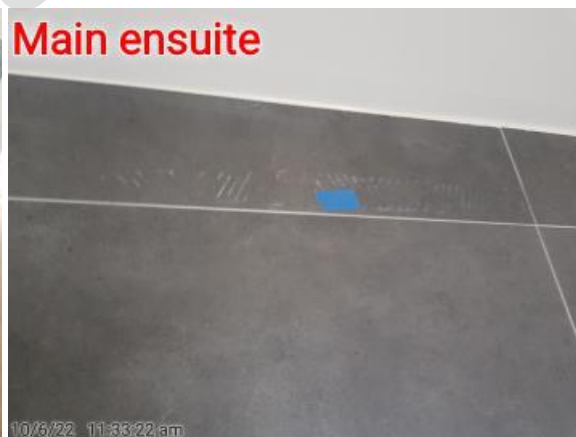
Location: The item identified is located in Bathroom one, Main ensuite, Toilet one and Toilet two

Tiles (Wall)

RESIDUE TO FINISH

Must be removed without damaging the surface beneath. All tile surfaces affected. Repairs required immediately.

Repair priority: Immediate

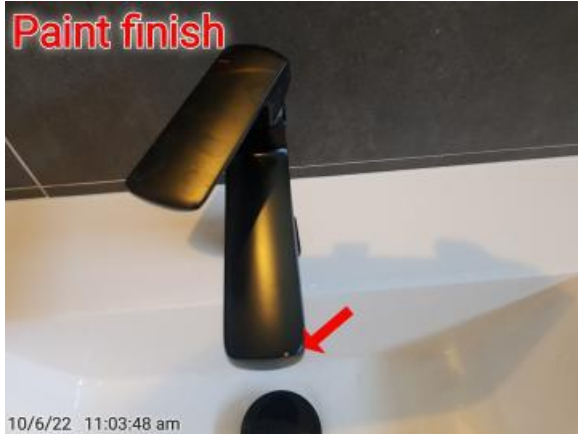
Location: The item identified is located in Bathroom one

CHIPPED/DAMAGED SPOUT

Must be repaired or replaced.

Repair priority: Immediate

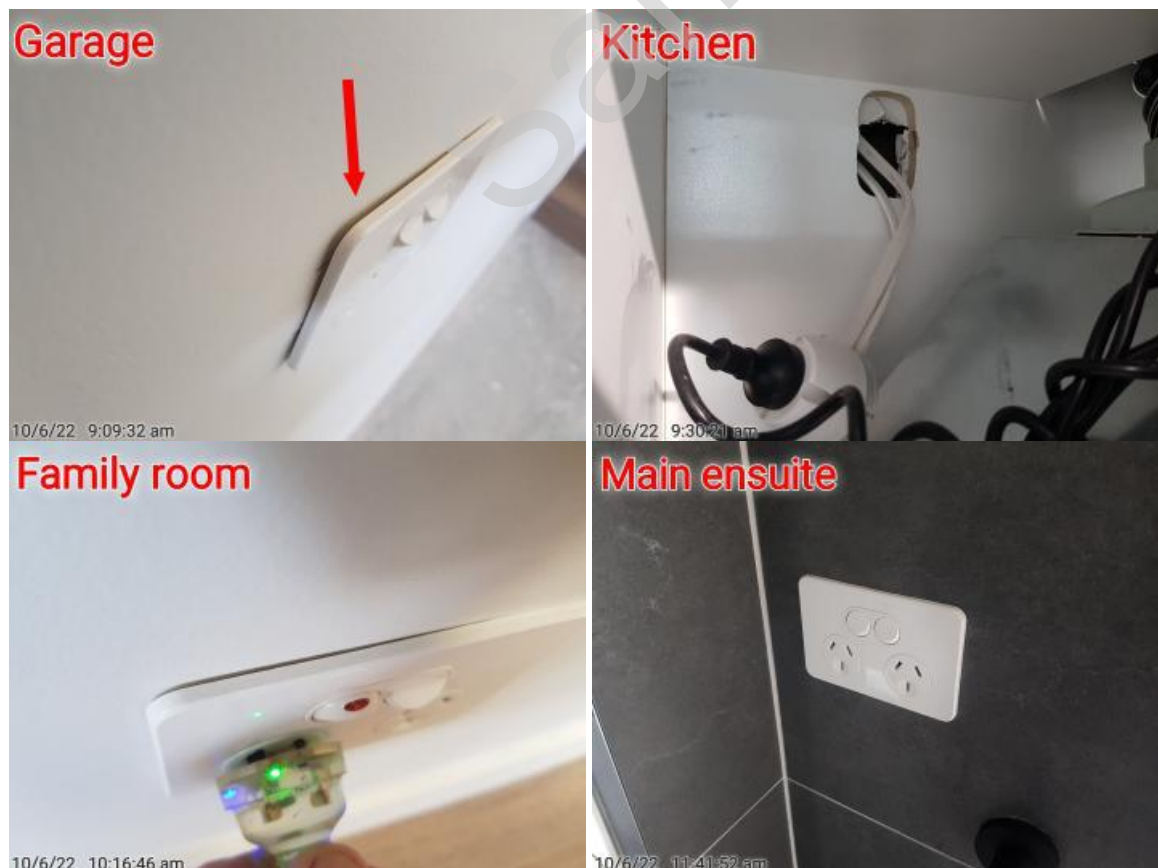
Location: The item identified is located in the Kitchen one

Repair priority: Immediate

Further inspection or advice required from specialist: Yes, by the licensed builder and a qualified technician

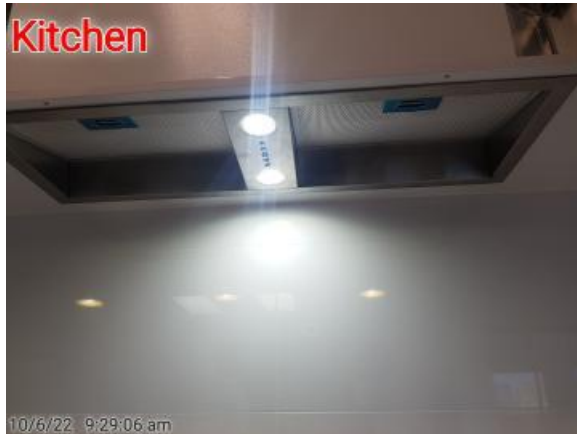
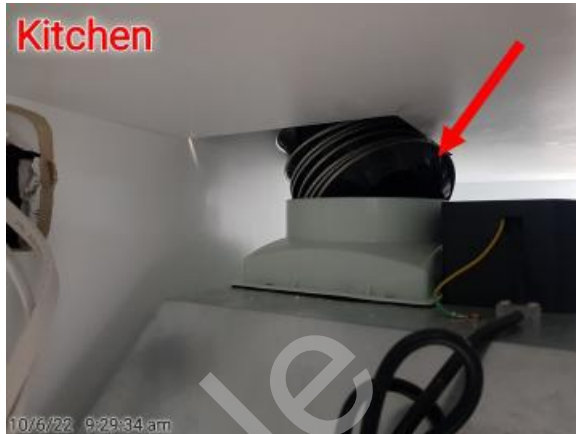
Location: The item identified is located in Kitchen one

Rangehood

NOT OPERATING CORRECTLY

Repair priority: Immediate

Further inspection or advice required from specialist: Yes, by the licensed builder

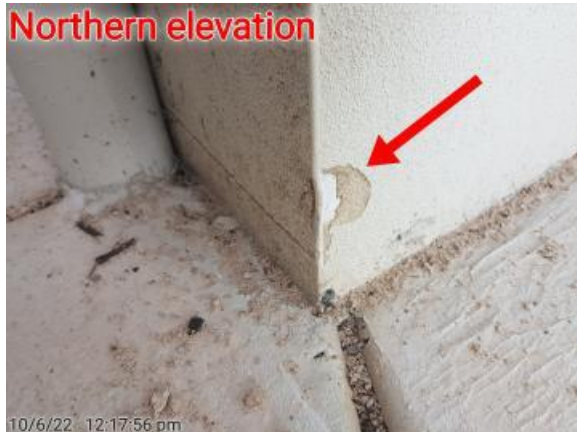
Location: The item identified is located in the Northern elevation

Repair priority: Immediate

Must repair. To be fixed without delay.

Further inspection or advice required from specialist: Yes, by the licensed builder

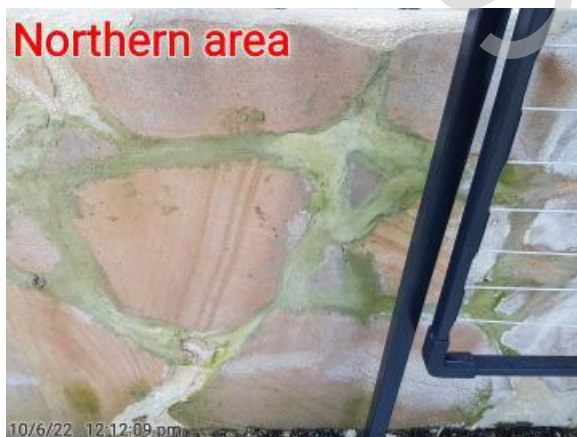
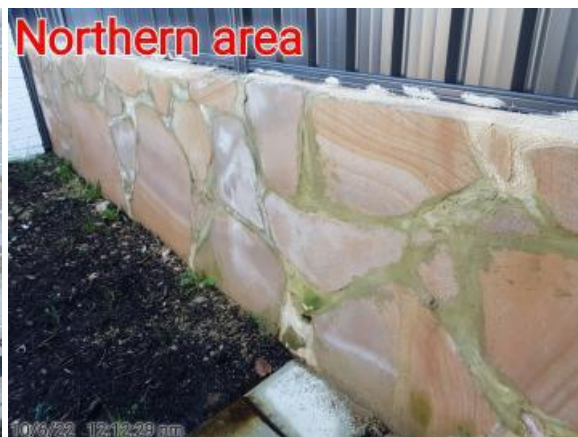
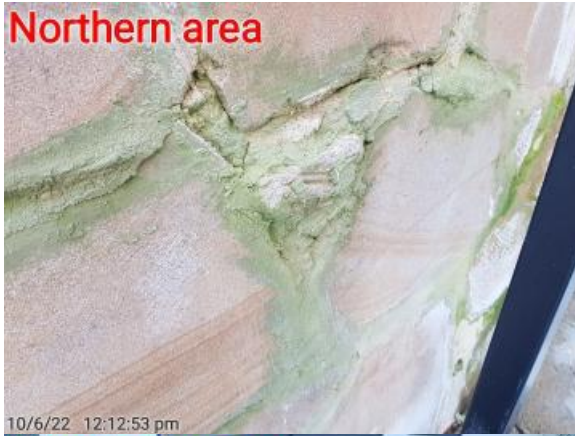
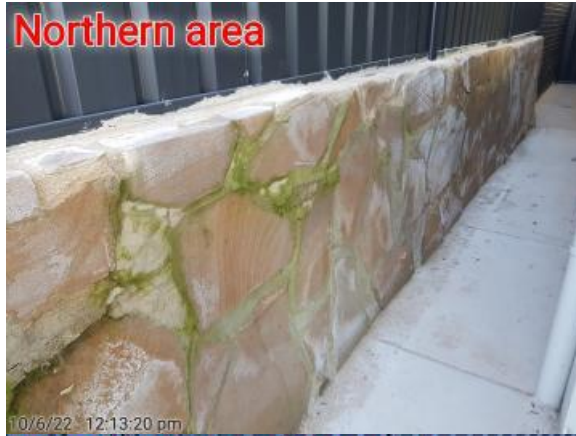
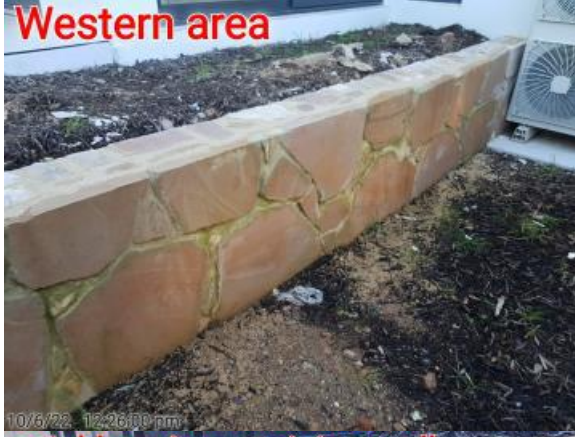
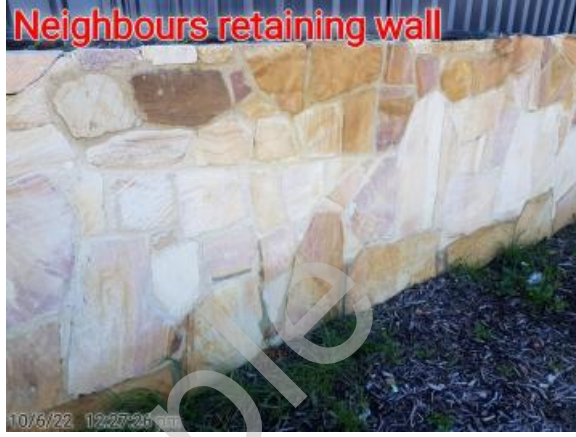
Location: The item identified is located in the Northern elevation

Retaining Walls

INCORRECTLY INSTALLED RETAINING WALL

Repair priority: Immediate

Must be repaired or replaced. To be constructed to an acceptable standard. The finish is not consistent to the neighbouring retaining walls in the complex with the finish of the mortar and with mould growing to the surface of the retaining wall due to inadequate waterproofing. To be fixed without delay.

Further inspection or advice required from specialist: Yes by the licensed builder

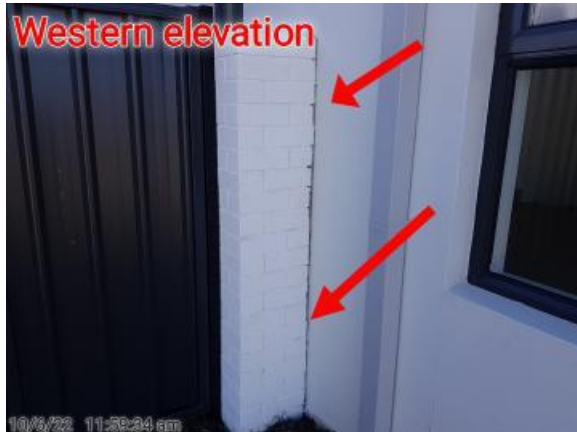
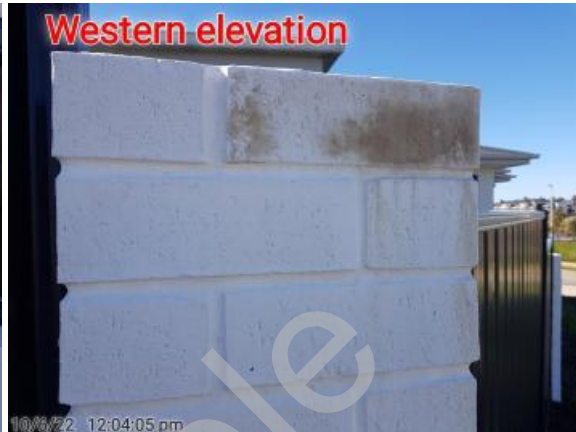
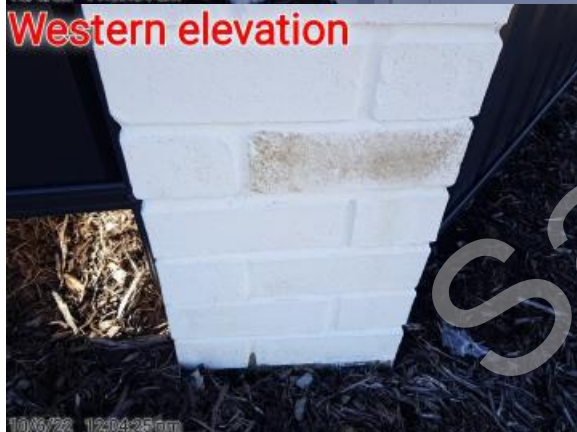
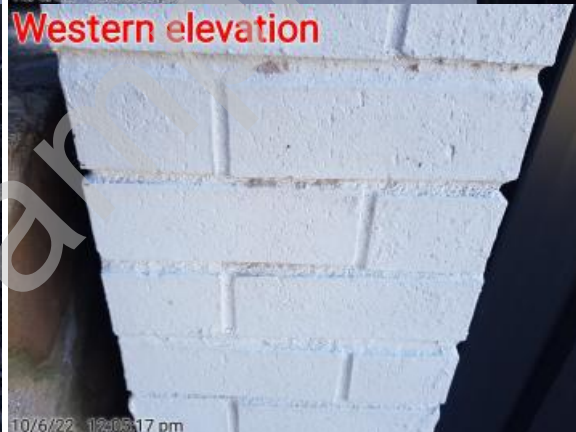
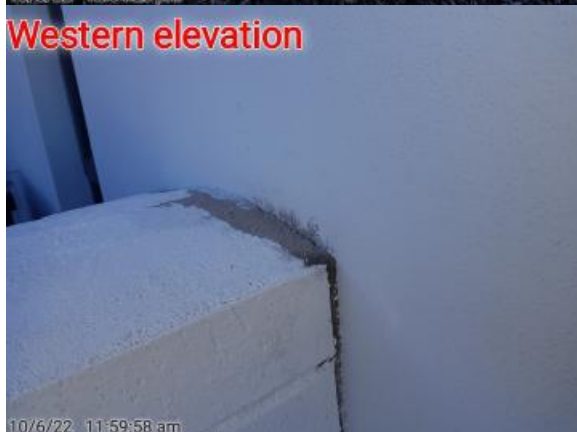
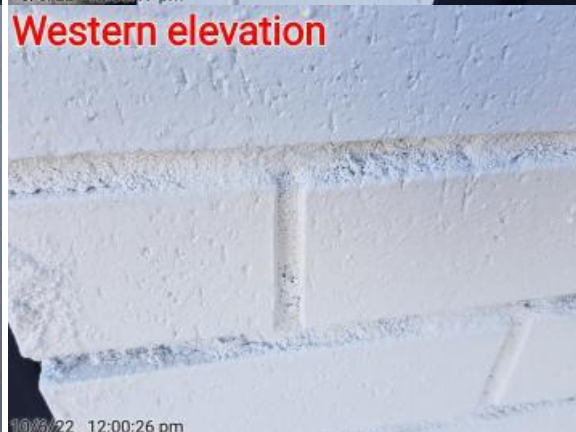
Location: The item identified is located in Western elevation

Brickwork painted

Repair priority: Immediate

Must be repaired and repainted correctly. Repairs required immediately.

Further inspection or advice required from specialist: Yes, by the licensed builder

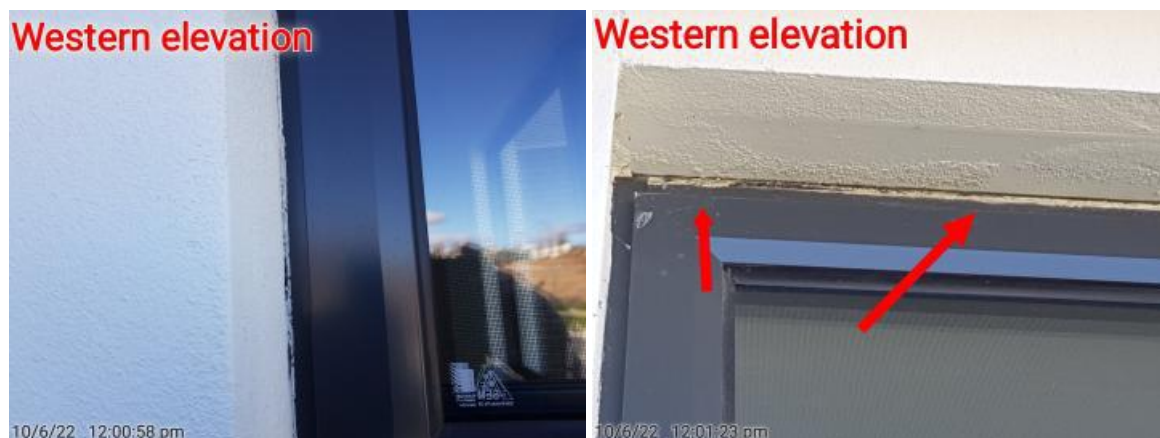
Must be removed without damaging the surface beneath. Repairs required immediately.

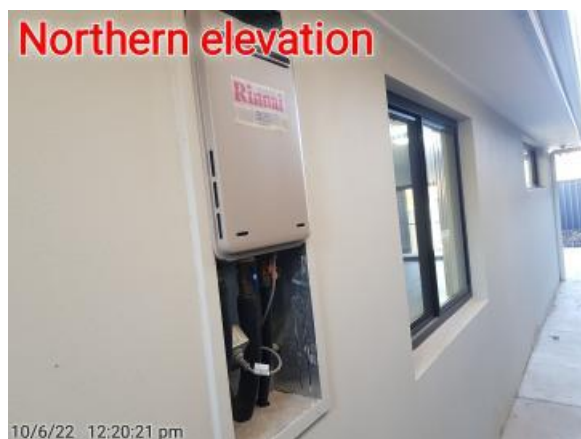
Repair priority: Immediate

Location: The item identified is located in Northern elevation

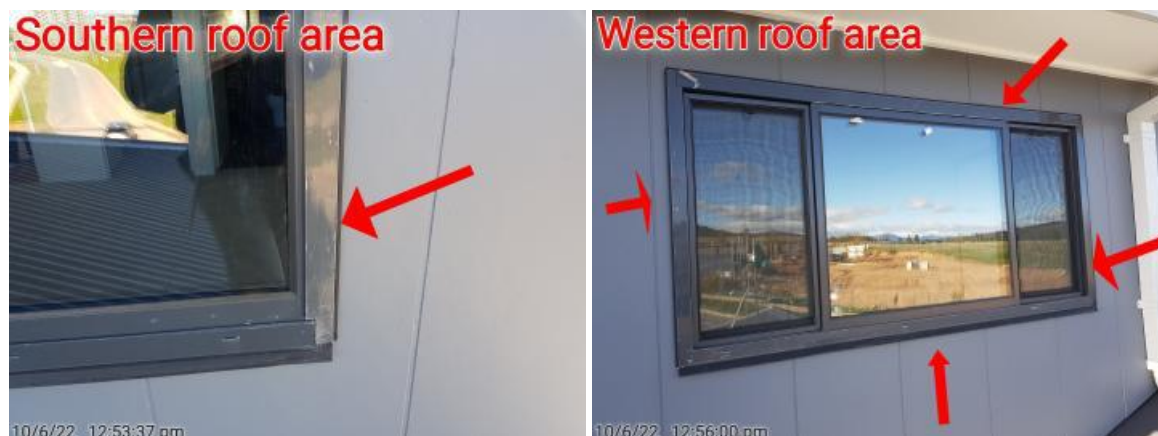
Must remove the plastic protective cover correctly as this will deteriorate and become difficult to remove with time. Must be fixed without delay.

Location: The item identified is located in the Main dwelling Southern section and Western section
