## New Construction Final Handover Report

4 Smith Street  
Smithtown NSW/ACT

11/01/2016.

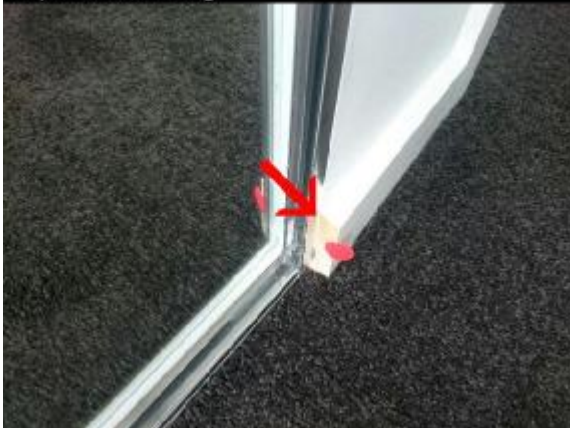
### Carpet

#### POORLY CUT IN

**Location:** The item identified is located in Bedroom three, Hall one, Main bedroom, and Stairwell
