Peace of Mind Building, Timber Pest & Compliance Report

4 Smith Place
Smithtown NSW/ACT

4 Smith Street, Smithtown

13/02/2016.

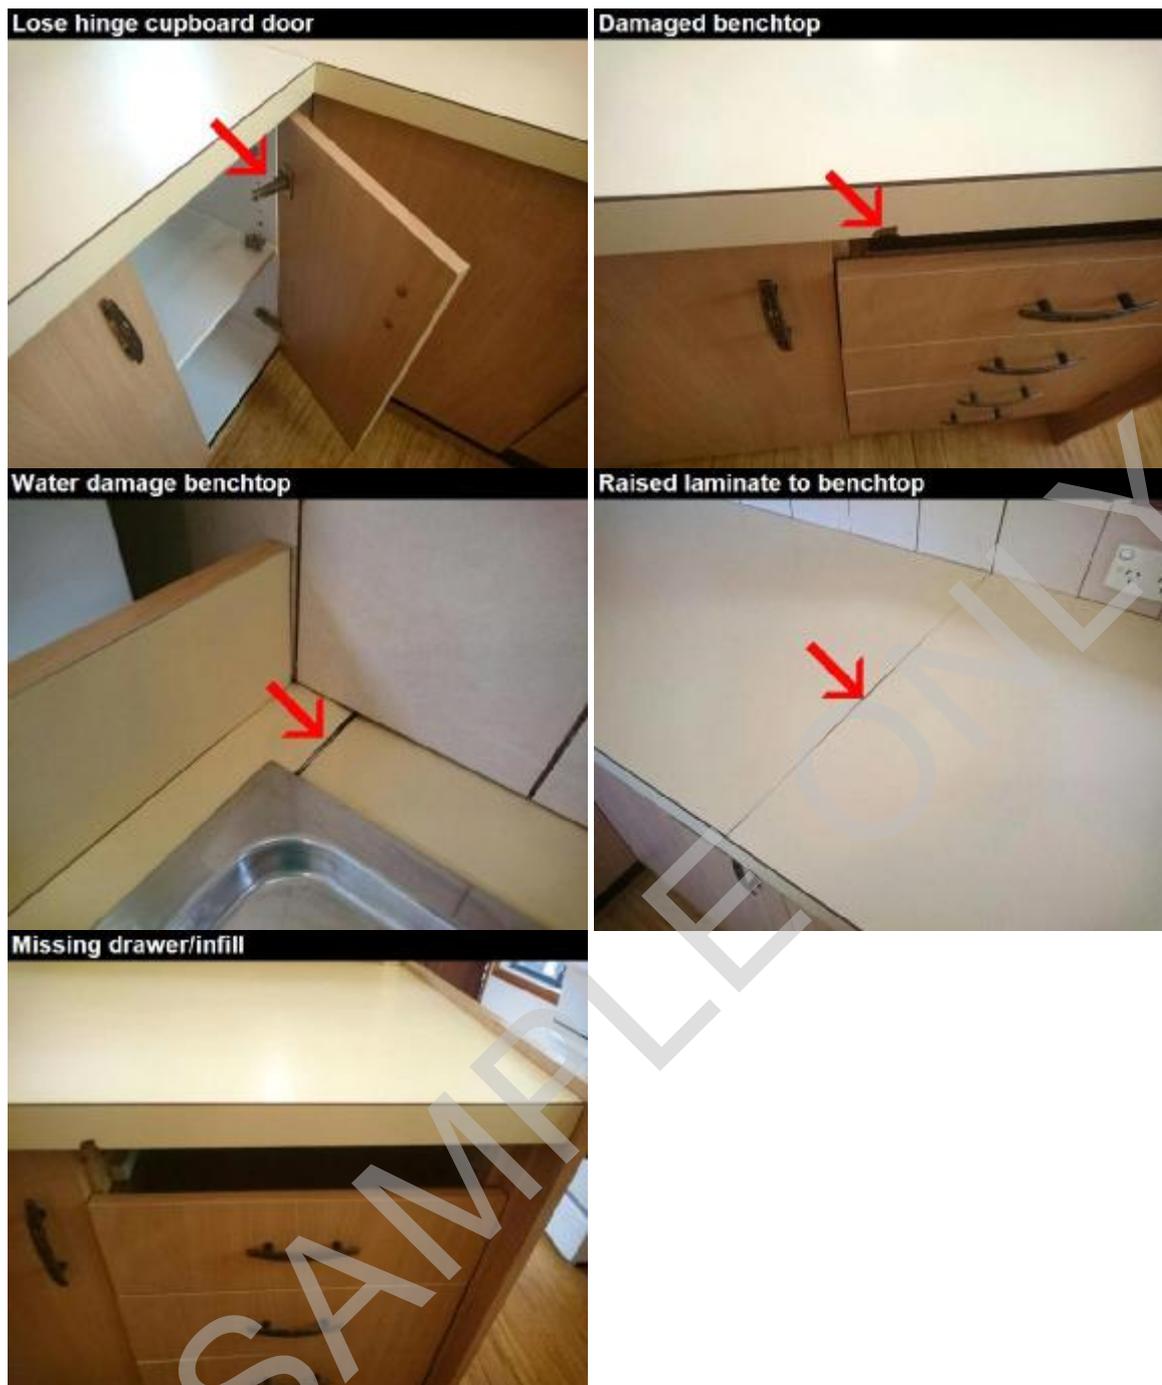
MISSING DRAWER/INFILL

Location: The item identified is located in Kitchen one

Should be replaced. To be fixed in the near future.

Repair priority: Within one year

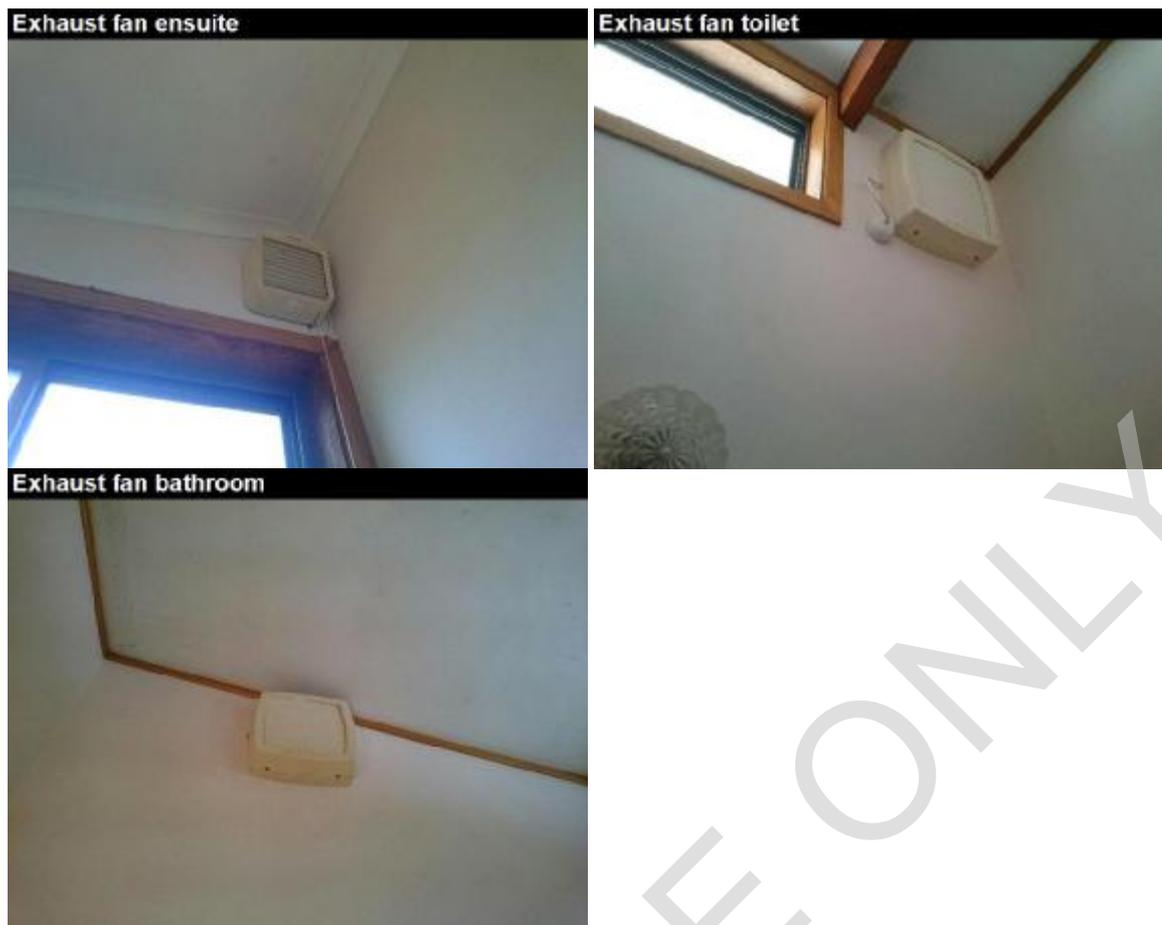
NOT OPERATING CORRECTLY

Location: The item identified is located in Main ensuite and Toilet

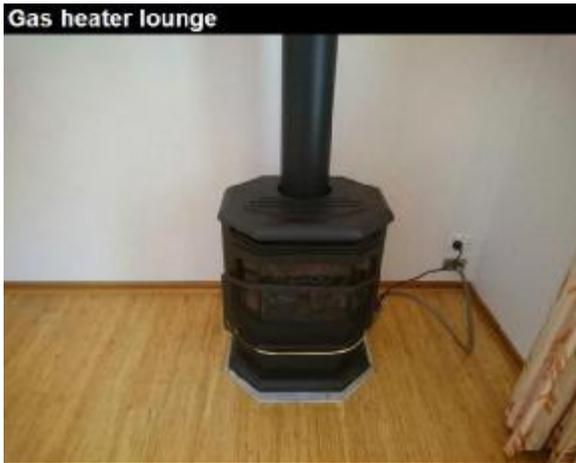
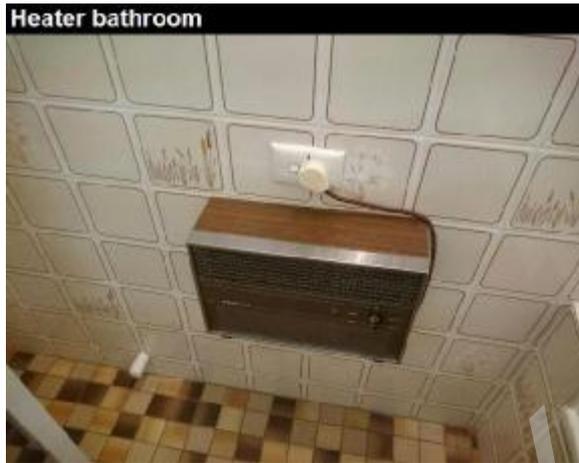
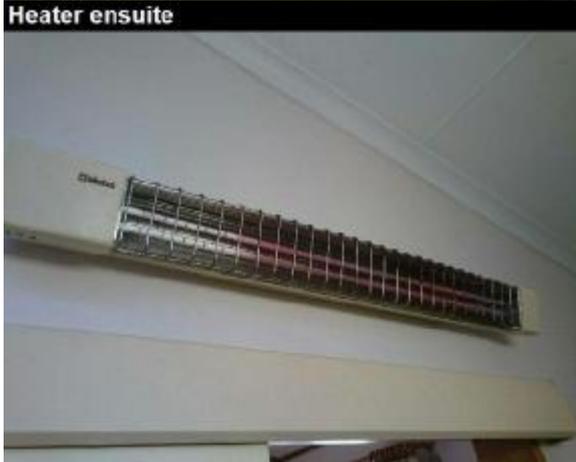
Notes: Fan not working to gas heater, Heater to bathroom noisy during operation.

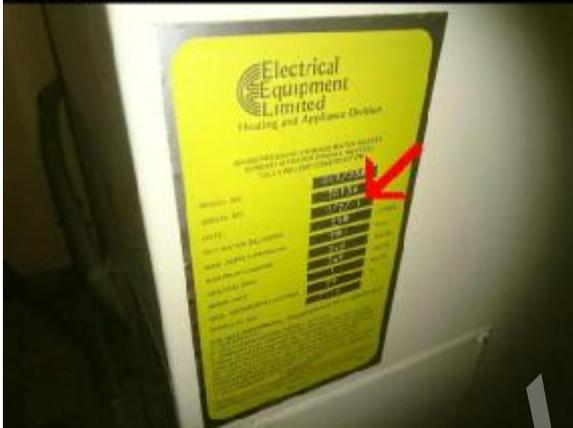
HWS dated 1981

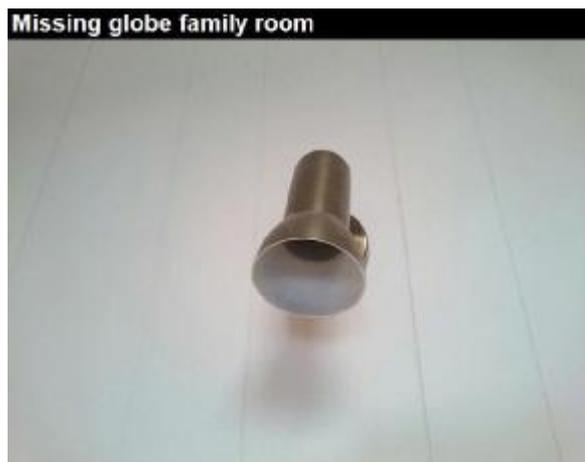
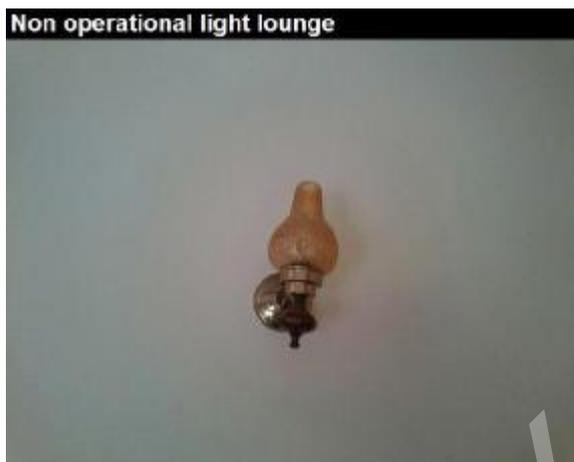
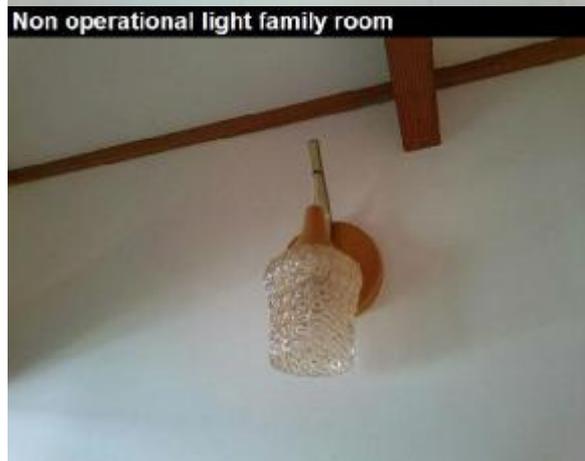
LIGHT IS NOT OPERATING

Notes: Dimmer not operating to bedroom two.

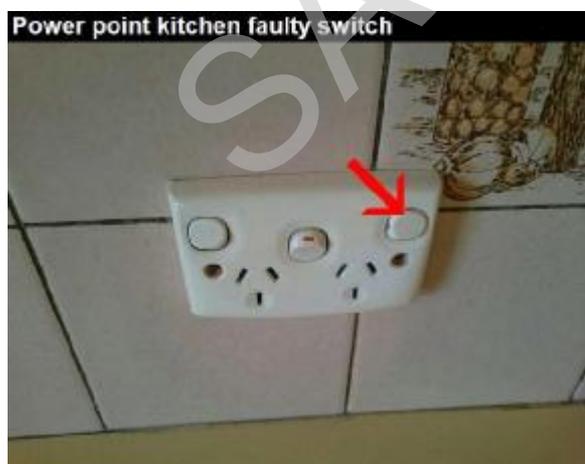
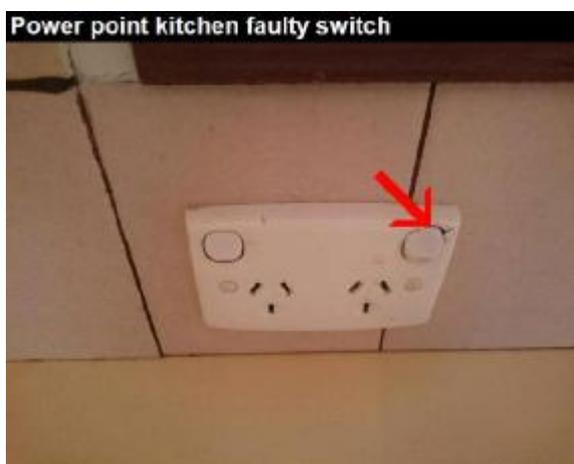
Notes: Some switches worn and damaged to kitchen.

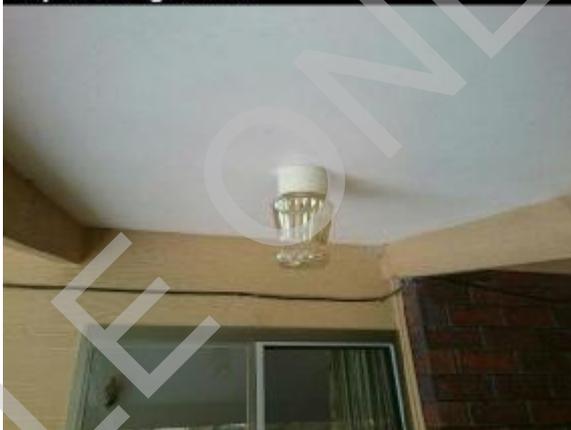
Inoperable light north

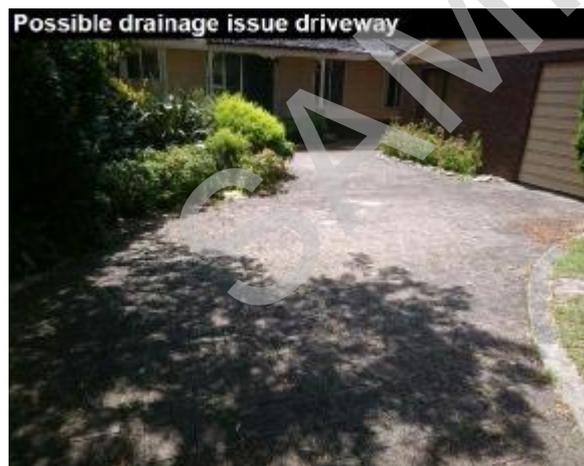
Notes: The soil in this area is quite sandy and surface water is likely to drain away quite quickly naturally

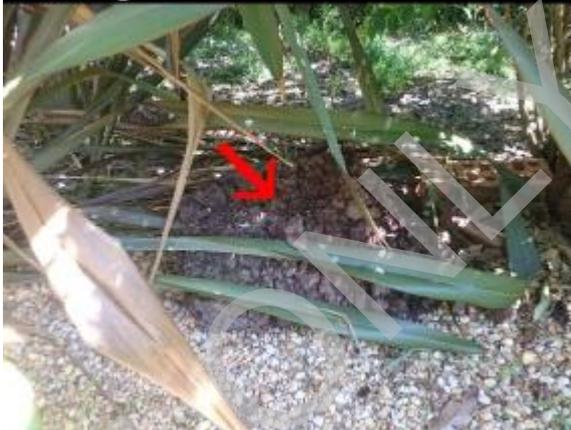
Timber log

Evidence of active termites
