# Frame & Brickwork Report

### INSPECTION SCOPE AND INSPECTION REPORT

**Report Purpose:**

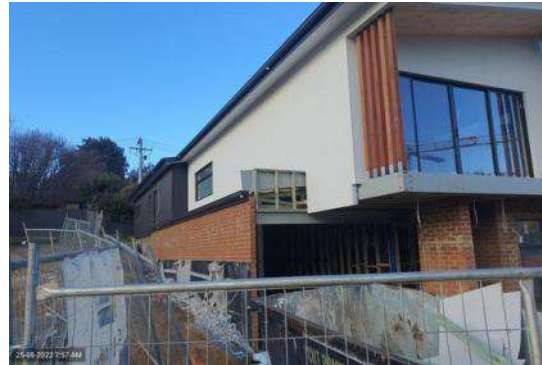
Photo 9

Inadequate

**What is the defect?**

Sediment control is not installed correctly or is missing crucial areas where sediment may escape the property during rain periods.

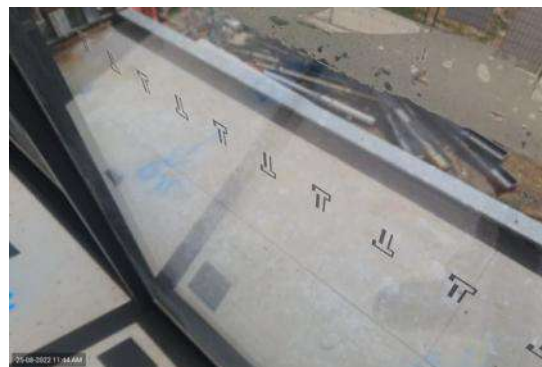
Photo 129

Are there any defects with the roof, fascia, guttering or downpipes?	N/A
Is there any decks, porches, pergola's or posts on this elevation?	Yes
Is there any defects with the them?	Not completed at this stage

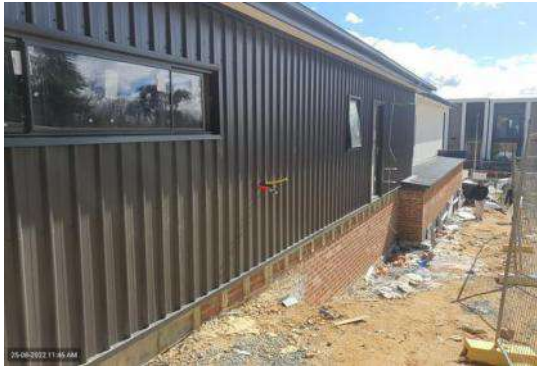
Photo 130

Are there any grounds to this elevation?	Yes
Is there defects with the grounds on this elevation?	Not completed at this stage
Is there any other defects on this elevation?	No

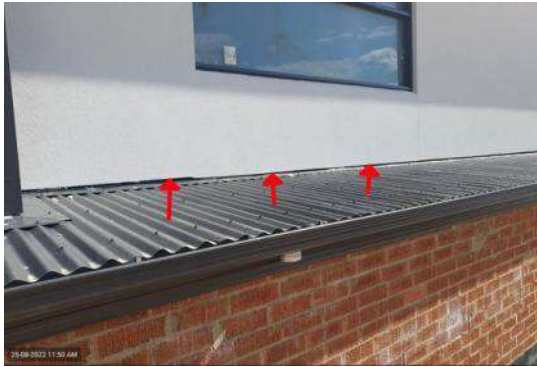
Photo 138

Render – bottom edge not completed to a satisfactory condition and requires the correct rectification

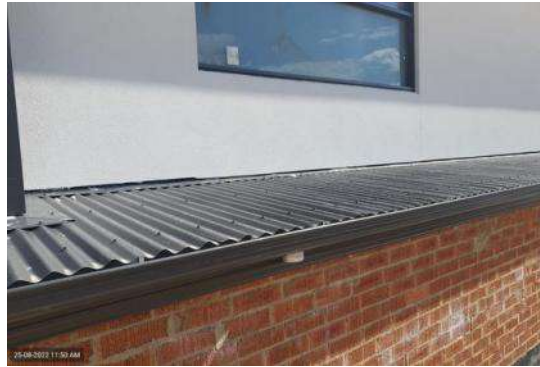
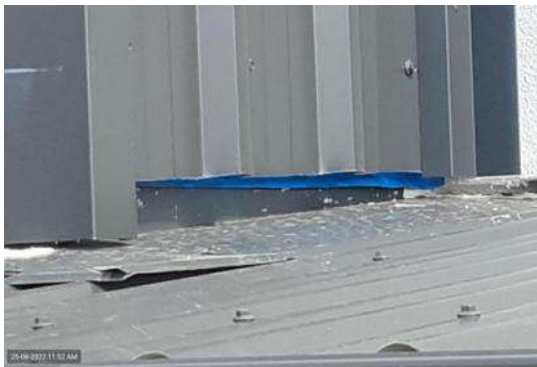
Cladding – the blue sarking at the bottom of the cladding is visible and requires repair

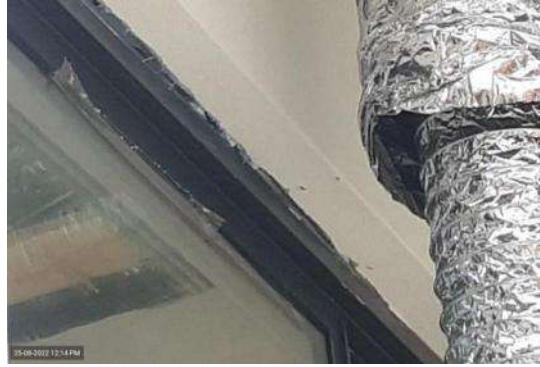
Photo 171

What is the defect?

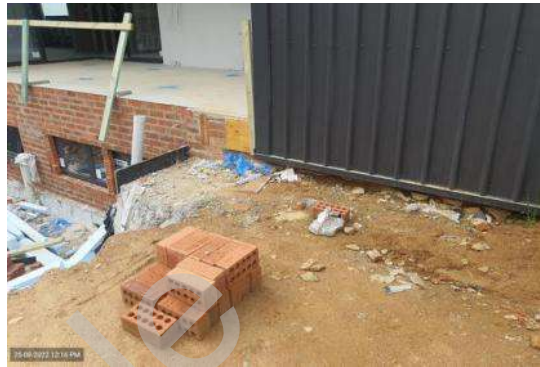
Photo 173

**What is the defect?**

This will now also affect the subfloor vent below this area. It is recommended that a second mechanical vent be installed through the new path to allow for the correct air movement of the subfloor on this side of the dwelling.

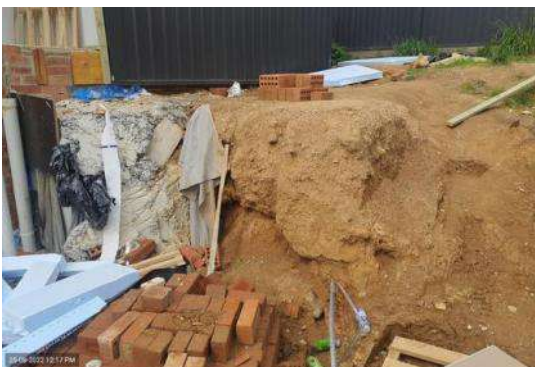
Photo 176

What is the defect?
